**ADEN HOUSE  
MINTLAW  
ABERDEENSHIRE**

**- Structural Recording -**  
Carried out 2<sup>nd</sup> July, 13<sup>th</sup>-15<sup>th</sup> July 2015  
by  
**Murray Archaeological Services Ltd**

**Report No: MAS 2015-21**  
by  
**H K Murray & J C Murray**

**ADEN HOUSE  
MINTLAW  
ABERDEENSHIRE  
RECORDING OF ENTRANCE HALL  
AND TEST PITS**

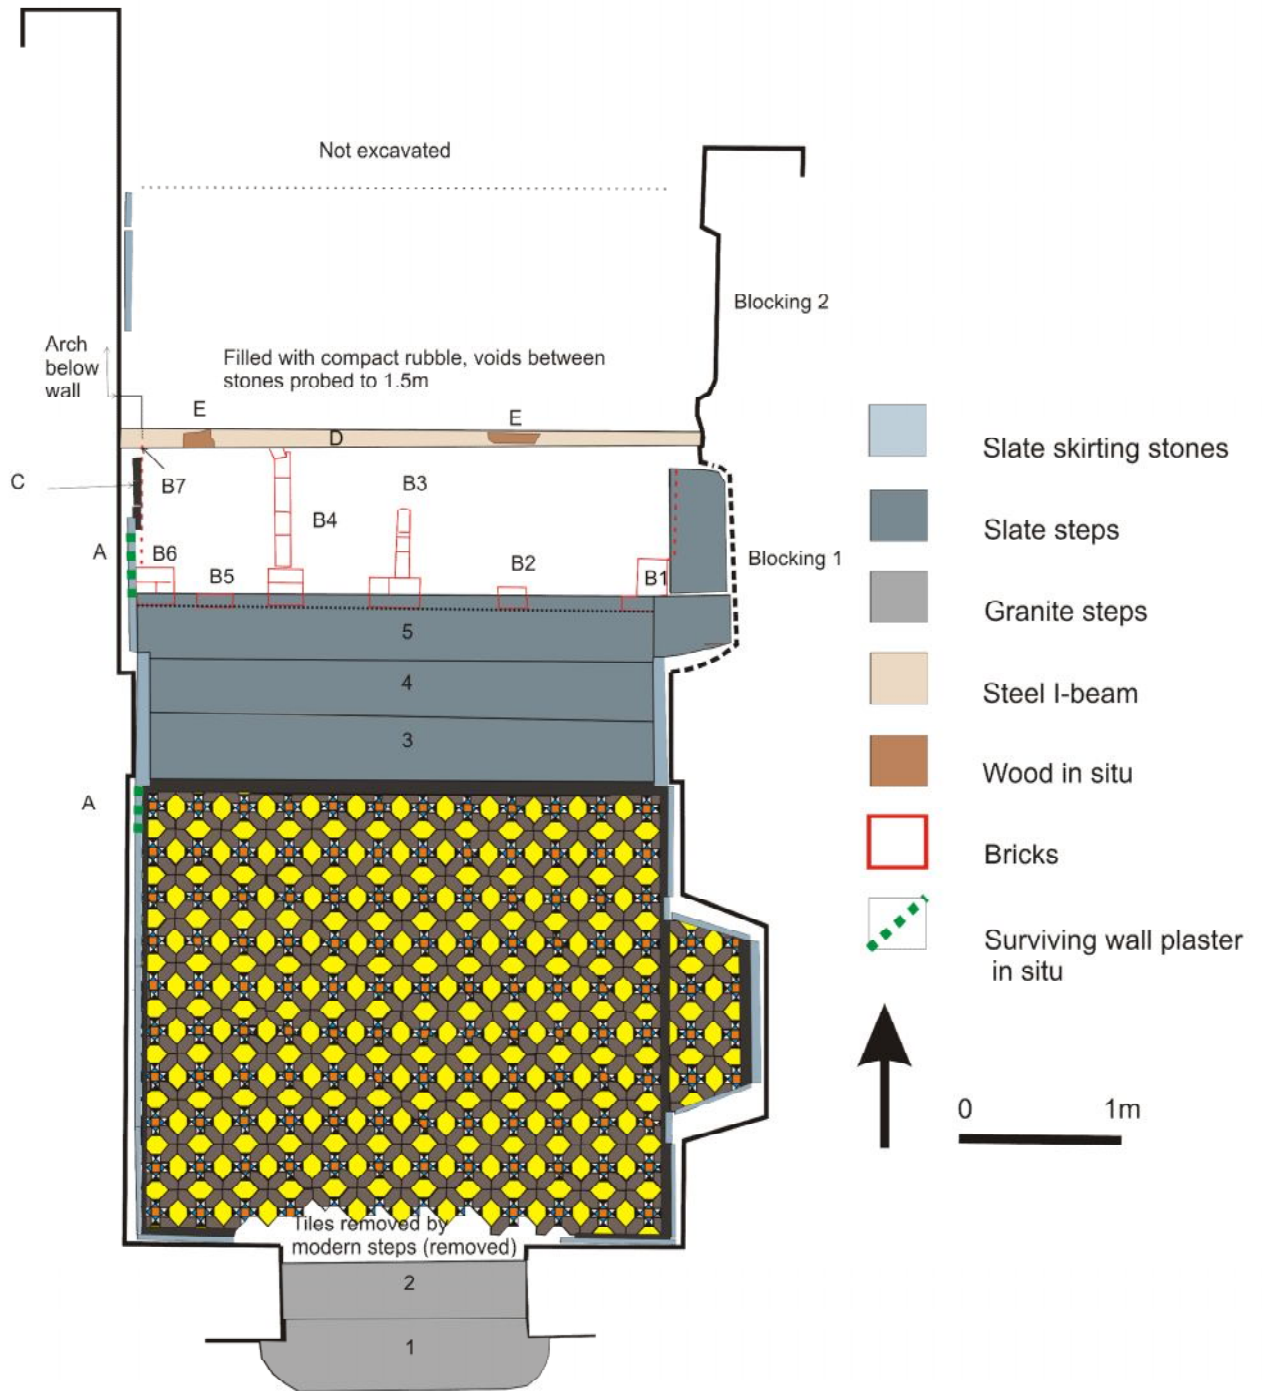
Illus 2 Detail of the Entrance hall as recorded July 2015

The Entrance Hall comprises two areas at different levels. Just inside the outer door is an outer area 3.45m wide and 2.8m long between the two outer granite steps and the inner set of three slate steps. At the top of the inner steps there is an inner area, c.430mm higher, and c.3.55m wide and c.3.6m long.

The three slate steps (Illus 2: steps 3-5) appear to be of the same, or very similar, slate as the skirting. The difference between these and the granite steps (1 & 2) may be one of date or may mark a difference between internal and external stonework.

All three extend across the full width. Only step 5 shows any damage, possibly from the later access steps or their removal. Step 3 is placed at the point where the side walls both project inwards slightly; the walling from this point was considered by RCAHMS (Illus 1) to be of early 18<sup>th</sup>-century date.

The upper step (5) is clearly supported on a stone wall c. 100mm in from N edge of the step. There is further support provided by a number of brick pillars (see below). The slate skirting is continued on either side of the lower steps 3 and 4, with slabs 70 and 85mm thick. To the E of the top step (5), two slate slabs continue the slate flooring into the recess of a former door (Illus 2: Blocking 1). To the W of the top step, the thinner slate skirting is continued.

Six brick pillars were set below the edge of step 5 (Illus 2: B1-B6, Illus 8). B1 and B6/7 extended as narrow wall facings on the E and W walls below floor level (to cellar level). Two of the intervening pillars (B3 and B4) also appear to have extended at least to the I-beam. Of particular interest is B7 which was very clearly built to the I-beam and extended between the upper and lower flanges- the bricks had to have been put in, or at least extended/repared after the I-beam was in situ.

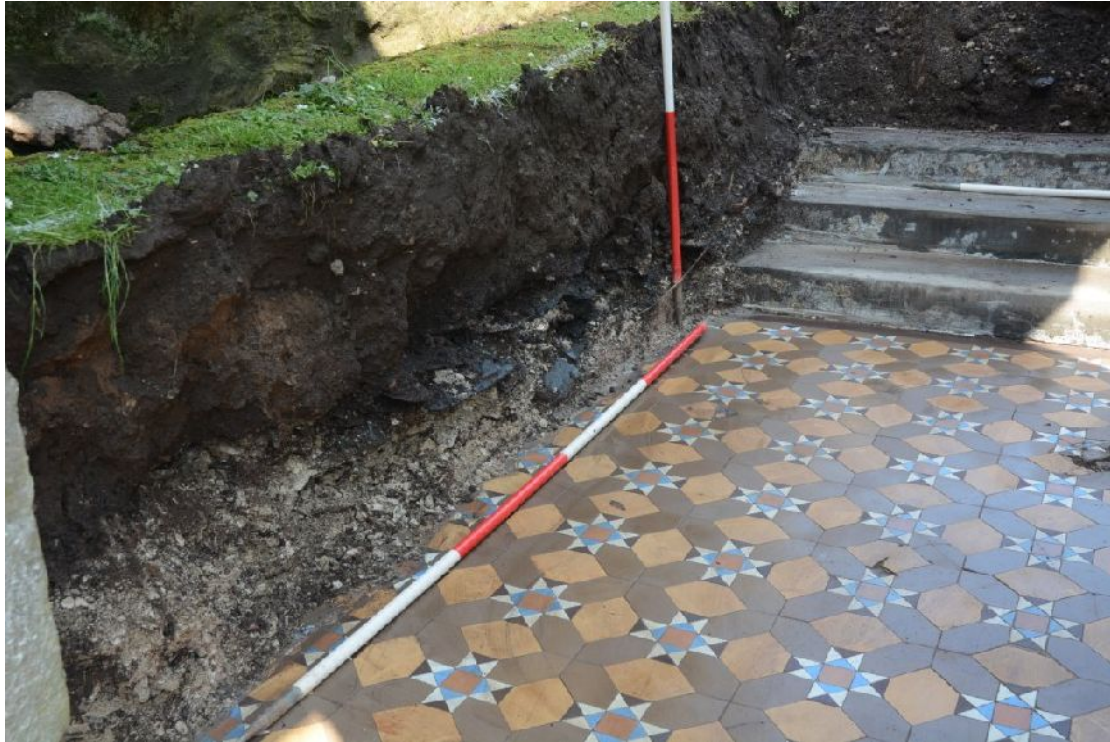
The soil dug from beside the E and W walls of the outer area consisted of c. 750-850mm of deliberate build up; comprising 350-400mm of building rubble, covered by c. 400mm imported garden soil (Illus 3). The building rubble included mortar, plaster, some slate, glass near the window and some slate. It appears to have been levelled and covered at the time of demolition.

**Illus 3 Detail of overburden beside W wall of Entrance Hall. July 2<sup>nd</sup> 2015**

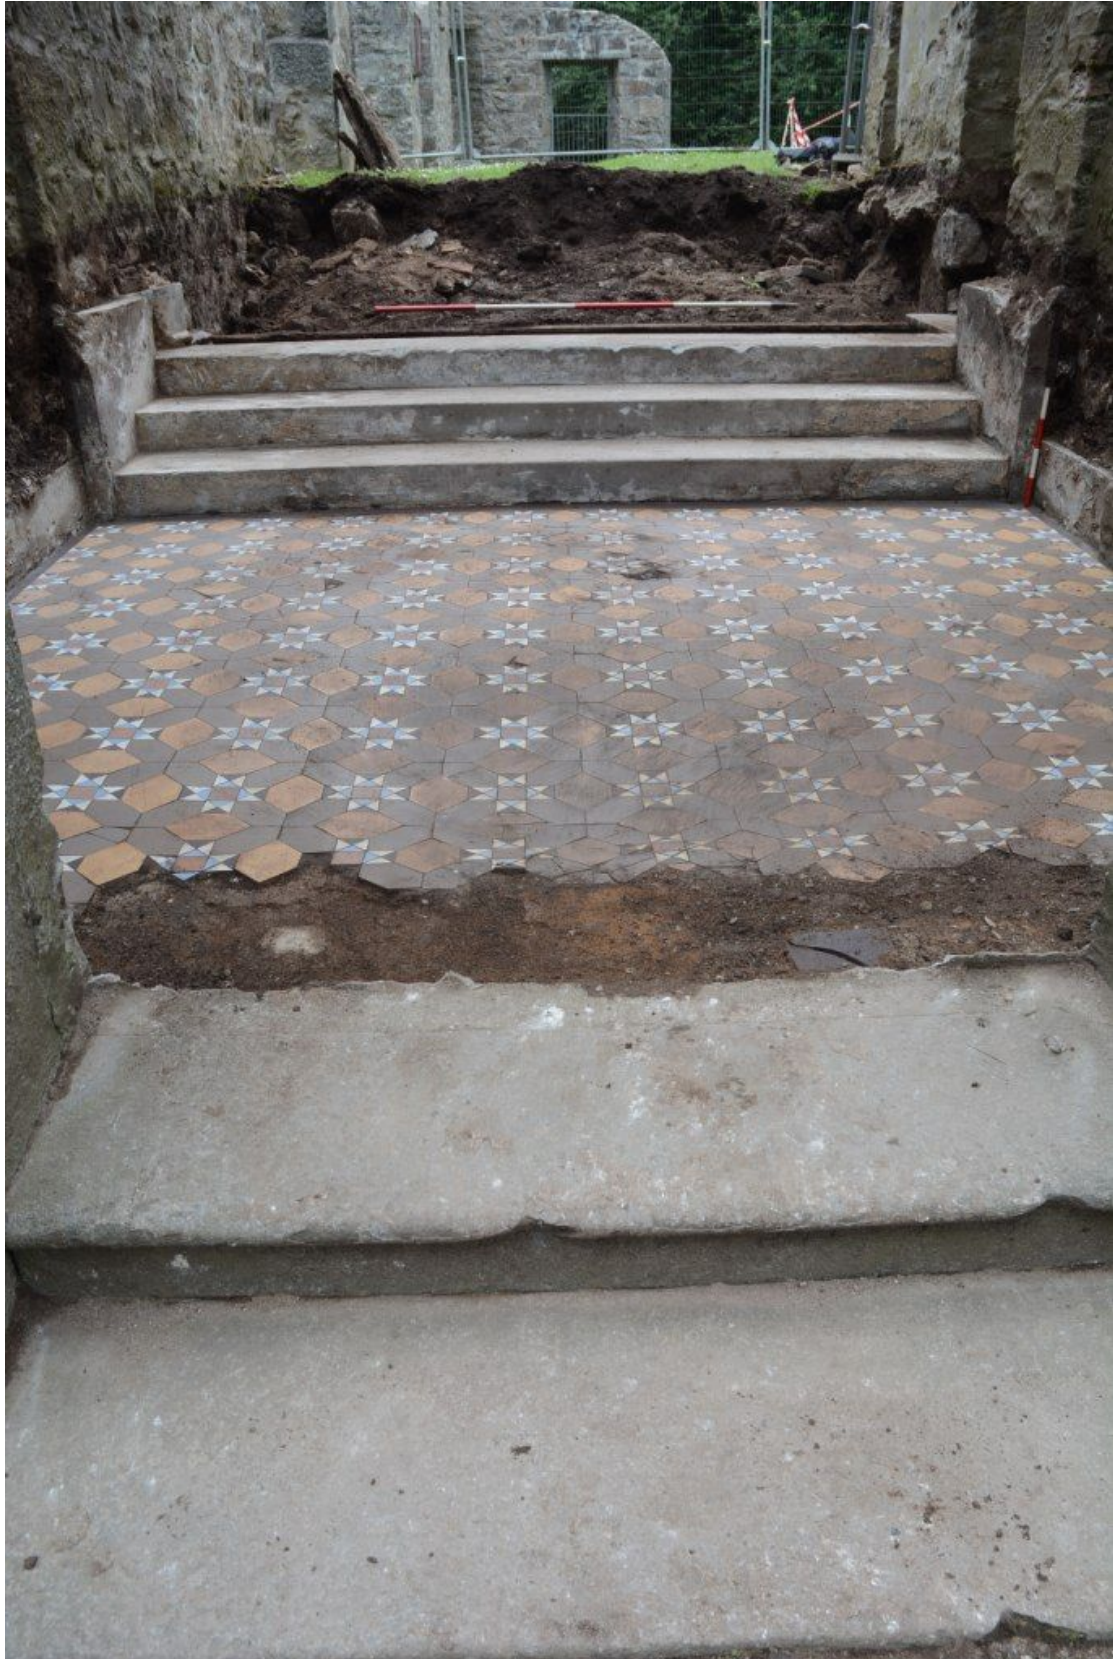
In the outer area of the Entrance Hall there was a well-preserved floor of geometric pattern tiles, extending the full width of the hall and into the window bay (Illus 2, 4-5, 21). These had only been removed just at the S end where they had been broken by the insertion of one of the access steps. There was also an area where the tiles had sunk, forming an area that puddled; the cause of the sinking was not clear.

The tiles were in a pattern of small crosses formed of triangular white, blue and dark chocolate-brown tiles in 4 squares around a central ochre square. Between each set there were X patterns formed of mid-brown hexagonal tiles, with pale sandy yellow tiles filling in the gaps. The whole pattern was surrounded by a border of dark brown tiles; this was 85mm wide by the step and below the window, but elsewhere c500mm wide. Where it was possible to examine, the tiles appeared to have been set into a dark yellow/brown very fine, very hard sandy mortar c.10mm thick.

**Illus 4 View of tiles in lower area of Entrance Hall, looking N**

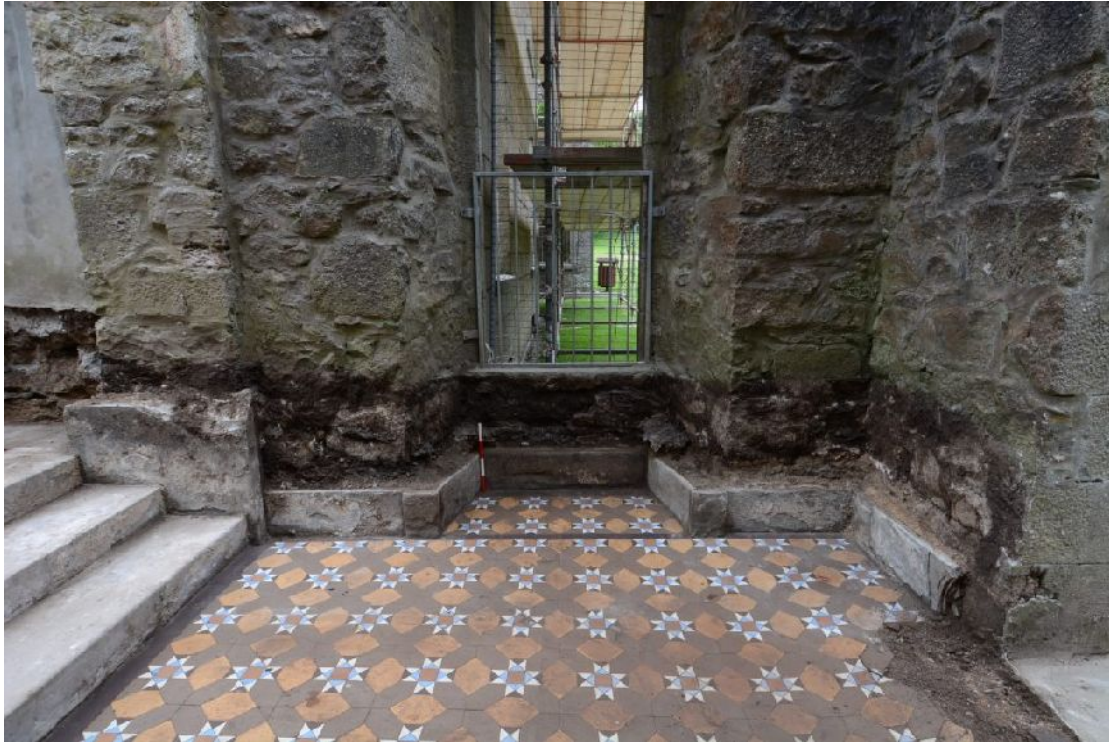
**Illus 5 Tiled floor in window area of lower part of Entrance hall**

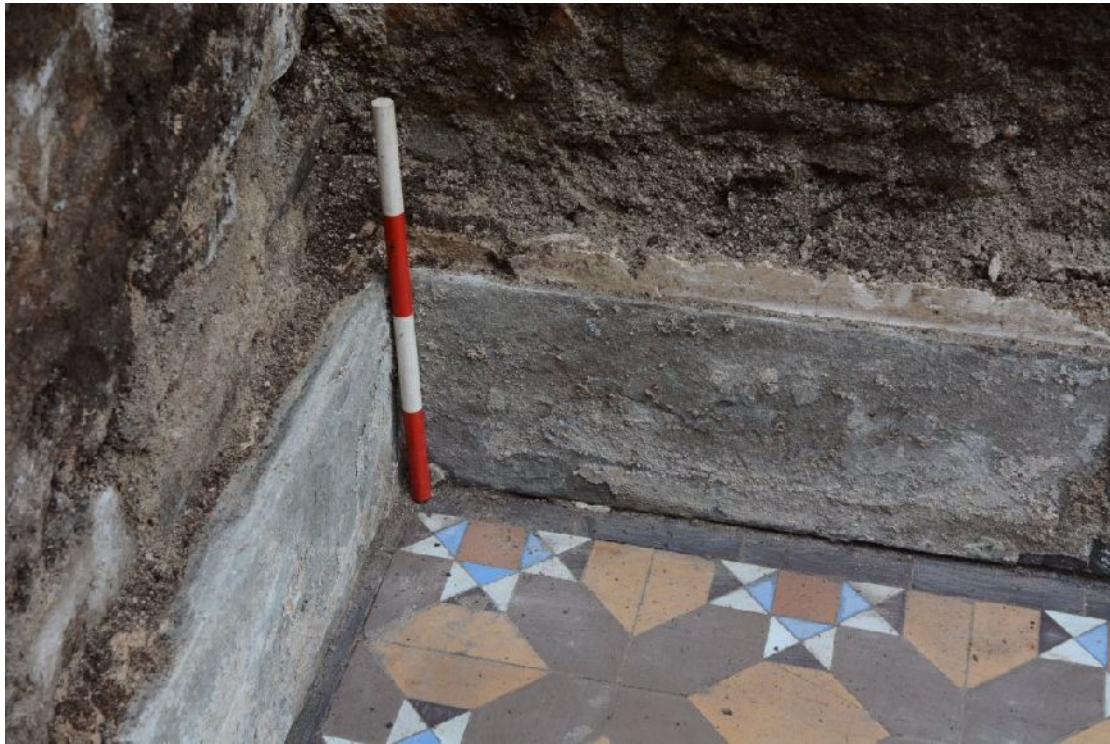
The space between the skirting and the stone wall was filled with coarse sandy mortar. In a few instances the fine, smooth wall plaster of the inner wall face survived, standing approximately along the mid line of the skirting (Illus 2: A, Illus 6).

**Illus 6 Detail of SW corner of lower part of Entrance Hall showing stratigraphic relationship of tiles, slate skirting and wall plaster**

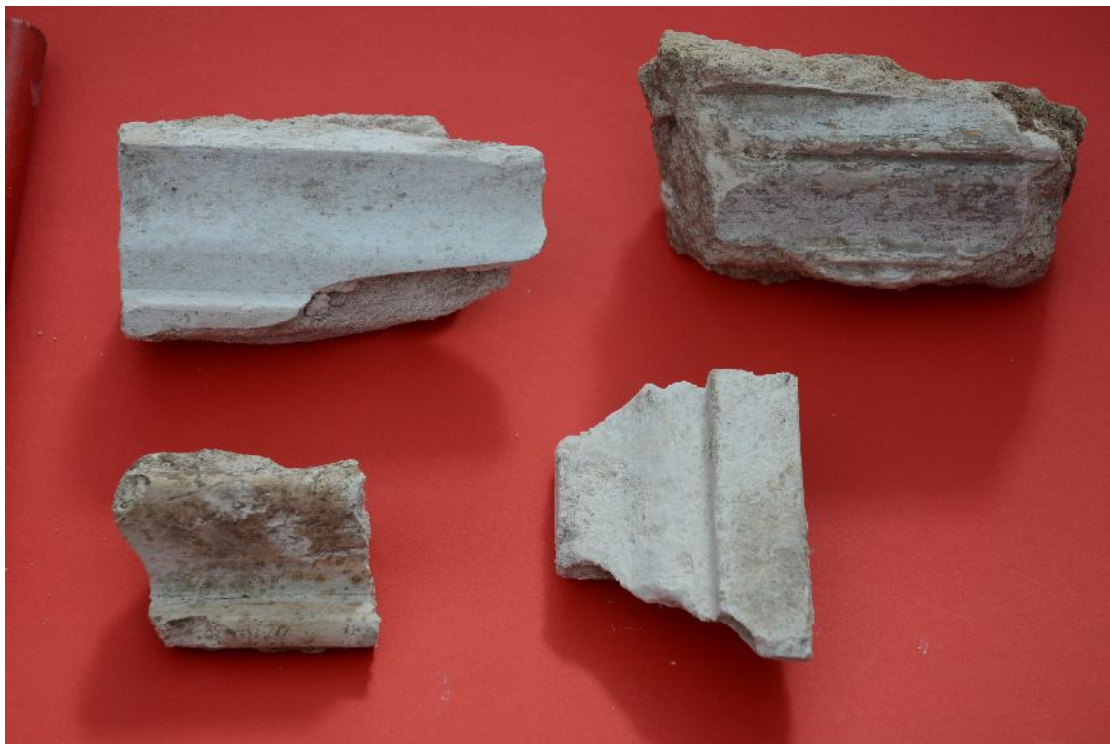
A number of moulded plaster fragments found in the demolition debris may have derived from a plaster cornice at the top of the wall (Illus 7).

**Illus 7 Detail of moulded plaster fragments from building rubble in Entrance hall**

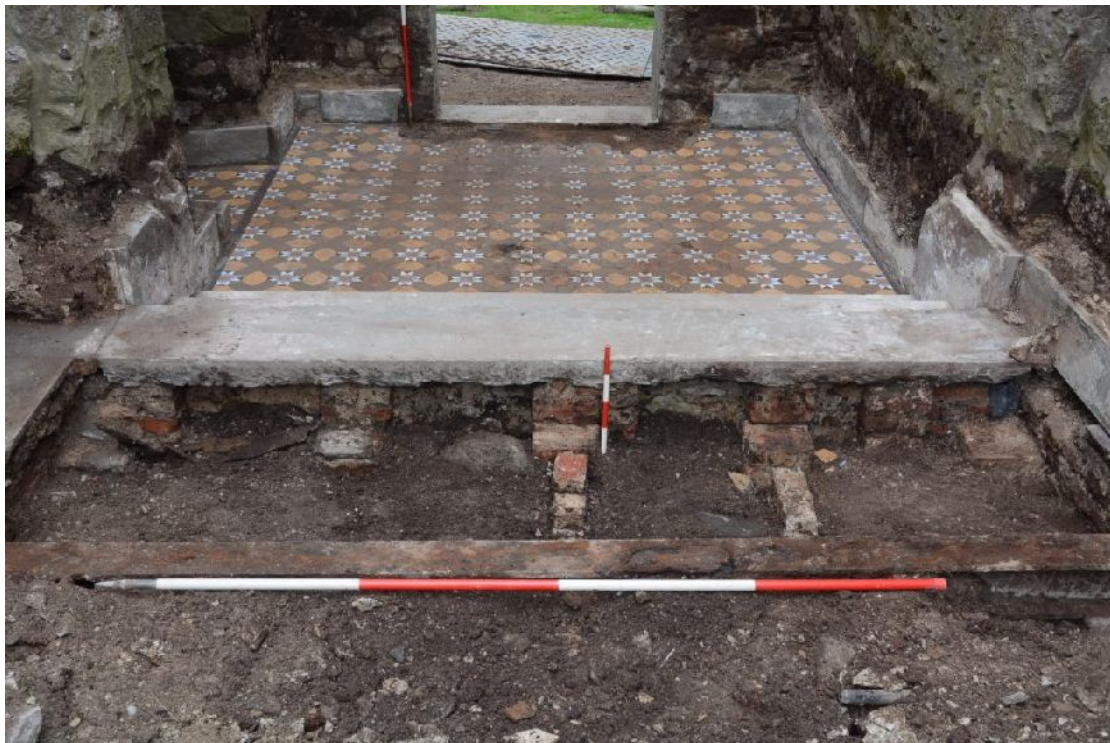
**Illus 8 Entrance Hall looking S to doorway. Detail of area below step 5**

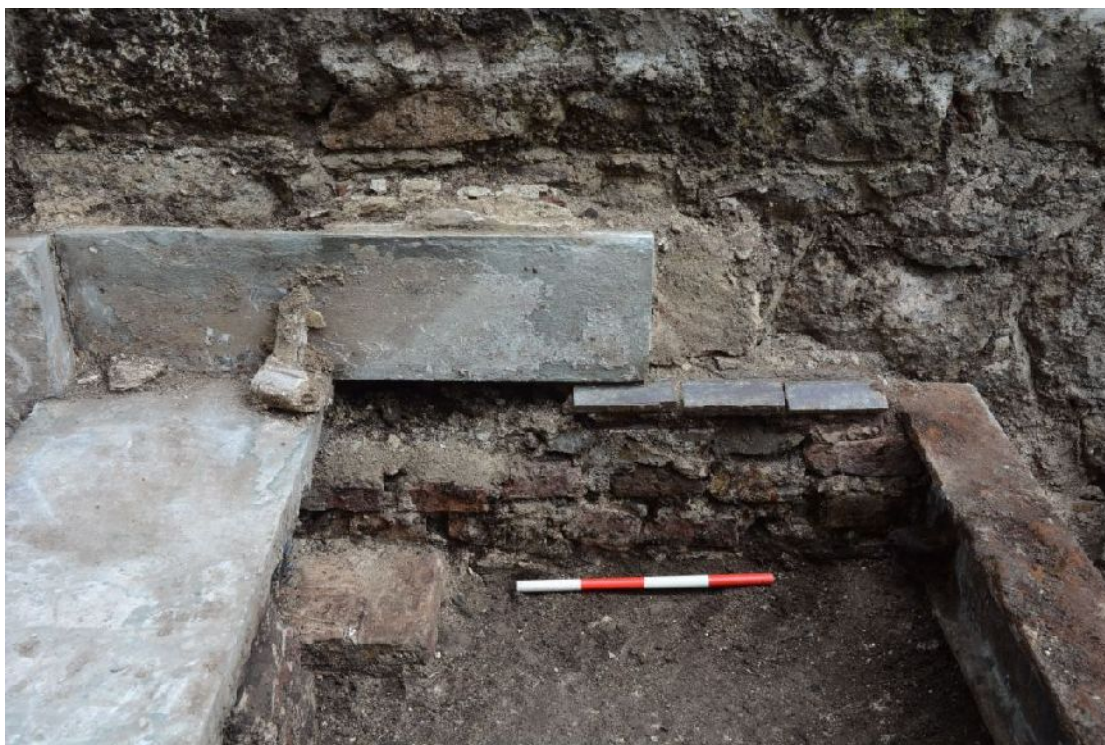
The upper part of the Entrance Hall, N of step 5, had been in-filled with compact rubble stone and mortar debris, with small voids which could be probed to c.1.5m depth. A few pieces of timber projected vertically from the infill. A number of ceramic tile pieces lay in the fill- all were of tiles that would have fitted the same pattern that was recorded S of the steps. Three edging tiles lay in situ alongside the W wall, set on a mortar base that was laid on a brick wall facing alongside the stone wall at this point (Illus 2: C, Illus 9). Part of the wall plaster was in situ on the slate skirting above the tiles.

**Illus 9 W side of area N of step 5 (LHS) showing stratigraphy of wall plaster on slate skirting over border tiles laid on brickwork which is built in between flanges of I-beam (RHS)**

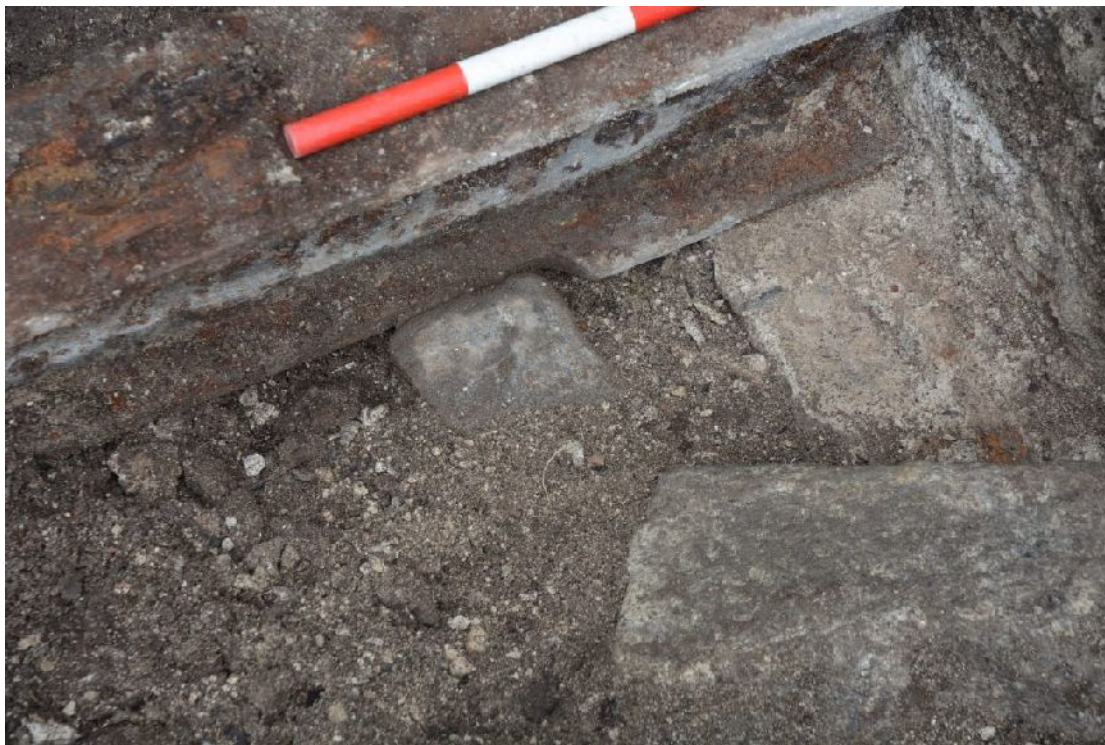
At 0.90-1m N of the N edge of step 5, there was an E/W I-section iron or steel beam. The beam was 135mm wide (5 ¼ “) and 215mm (8 ½ “) high with metal 20mm (¾ “) thick. Both flanges were of equal width. On the N side of the lower flange at the W end, there was a curved notch in the beam (Illus 10). On the upper surface of the beam there were traces of a surviving horizontal timber beam; in many areas this had been destroyed during the original uncovering of the structure by machine (Illus 11). However it does appear likely to have been original as in patches the iron retains ‘rusted on’ wood impressions. At the E side the beam was set into a rough socket knocked into the 18<sup>th</sup>-century stone wall (Illus 12). At the W end it was supported on a stone wall from cellar level, but only abutted the main wall (Illus 10).

**Illus 10** W end of I-beam supported on stone wall. Shows notched lower flange.

The I-beam also suggests some changes that are later than the 1832 work. Although cast iron I-beams (with unequal flanges) were in use from the early 19<sup>th</sup>- century, wrought iron I-beams (with equal flanges), which were structurally stronger, were not invented until 1845 and not commercially available until some years later (Peterson, 1980) - and later steel was used, by the last decades of the 19<sup>th</sup>-century virtually replacing wrought iron for I-beams (Bates, 1984, 8-9). Although the present authors can not distinguish between wrought or cast iron or steel, the equal flanges suggest this beam is of wrought iron or steel.

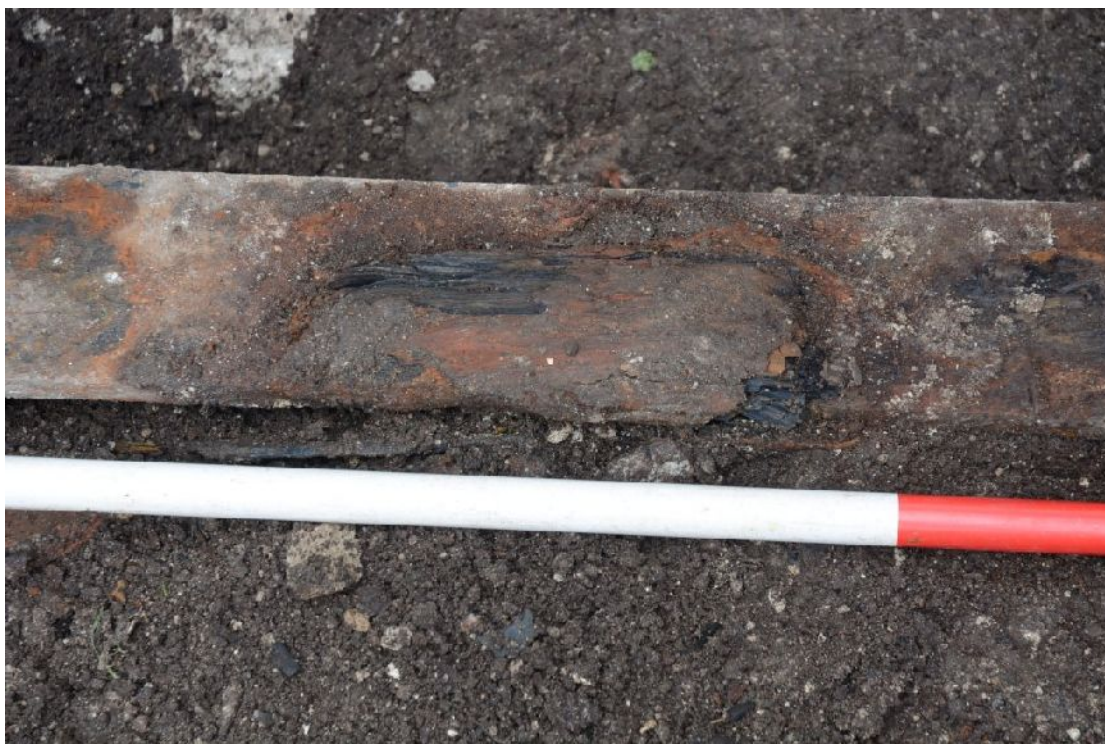
**Illus 11** Detail of timber beam in situ along top of I-beam

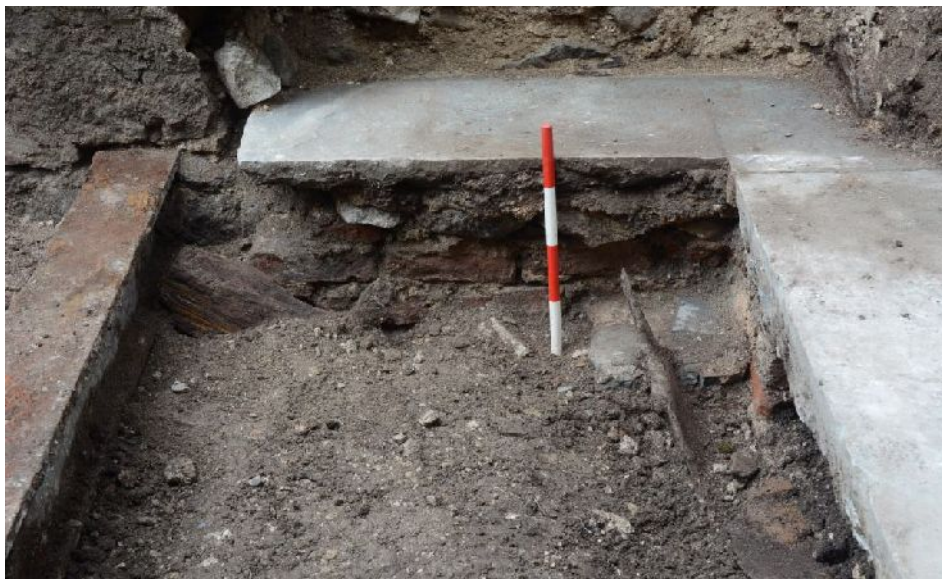
**Illus 12** Detail of E end of I-beam slotted into main wall. Note vertical timbers in building rubble infill.

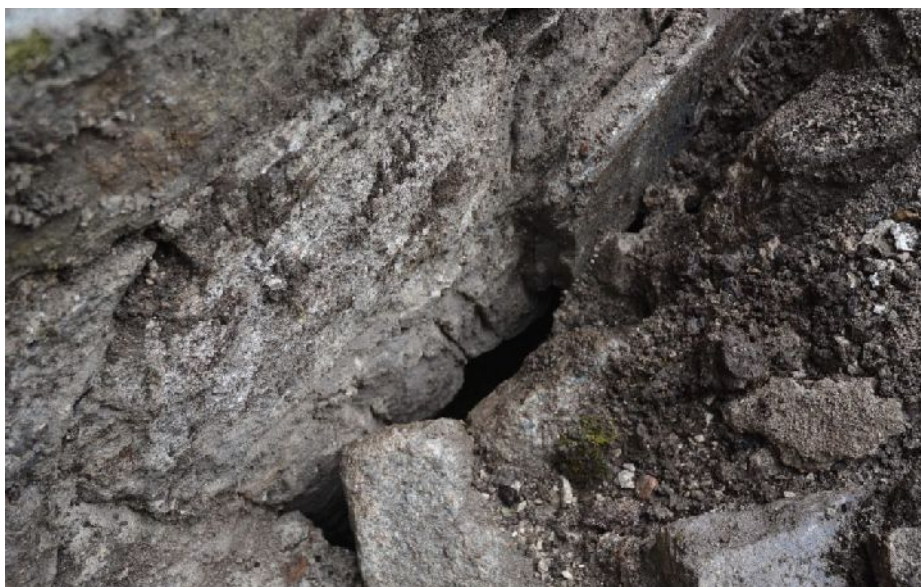
**Illus 13** Detail of arch built into base of wall

The area N of step 5 appears to have been cellared. As noted above, probes between the fill stones extended to at least 1.5m. The infilling material was compact and was not removed. On the W side of the Entrance Hall and N of the I-beam, part of an arch

built into the base of the 18<sup>th</sup>-century wall was observed, with a void below the wall itself (Illus 13).

There is clear indication of cellarage to at least 1.5m below the 19<sup>th</sup>-century floor level in the area N of Step 5 in the Entrance Hall. This cellarage is likely to be of 18<sup>th</sup>-century date as the arch below the W side of this area is an integral part of a wall thought to be of 18<sup>th</sup>-century date.

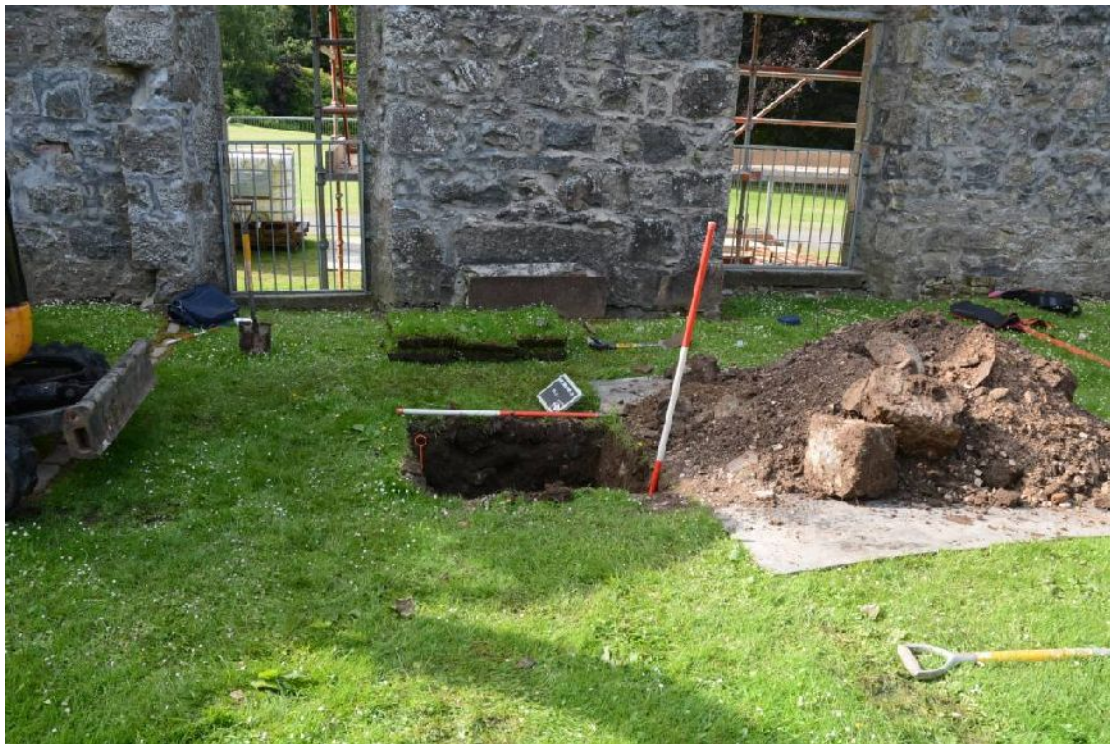
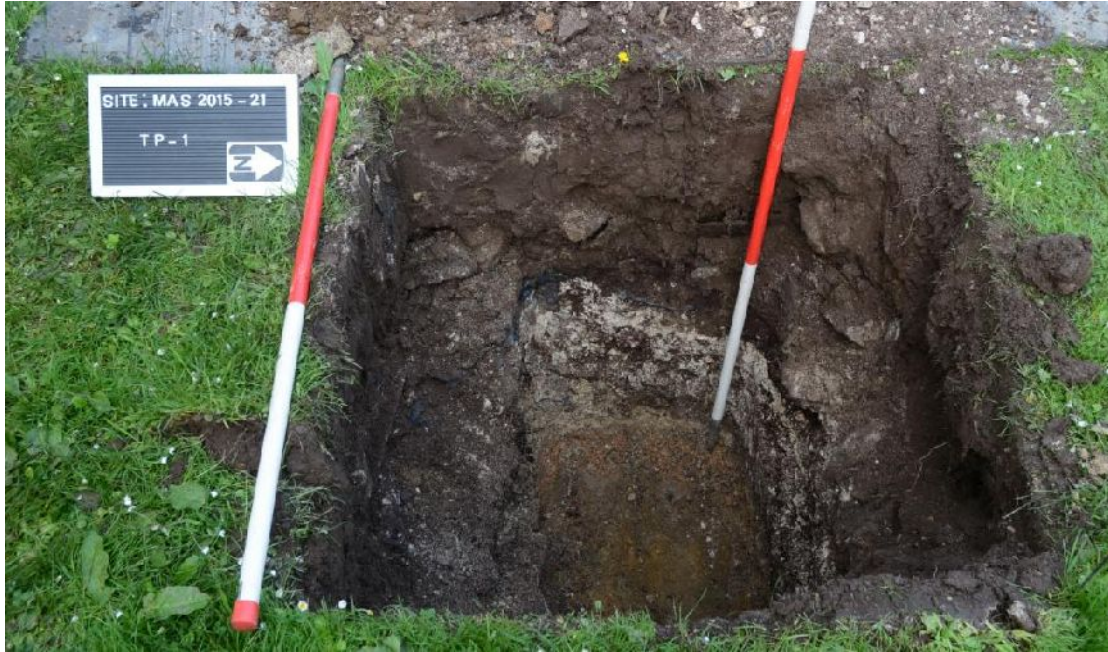
620mm Topsoil, some stone

360mm Rubble, stone, slate, mortar, occasional wood fragments.

150mm Hard compact yellow natural clay.

This area did not appear to have been cellared.

**Illus 14** Location of TP1, looking S

**Illus 15 Section of TP1**

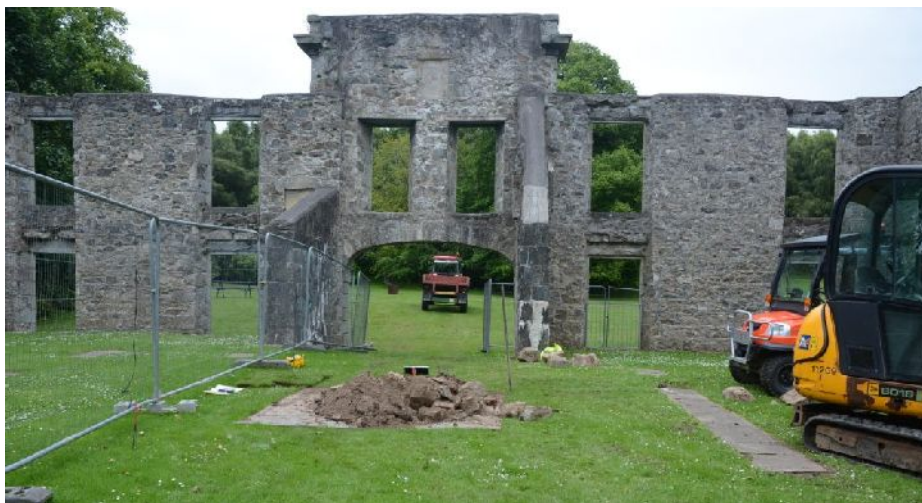
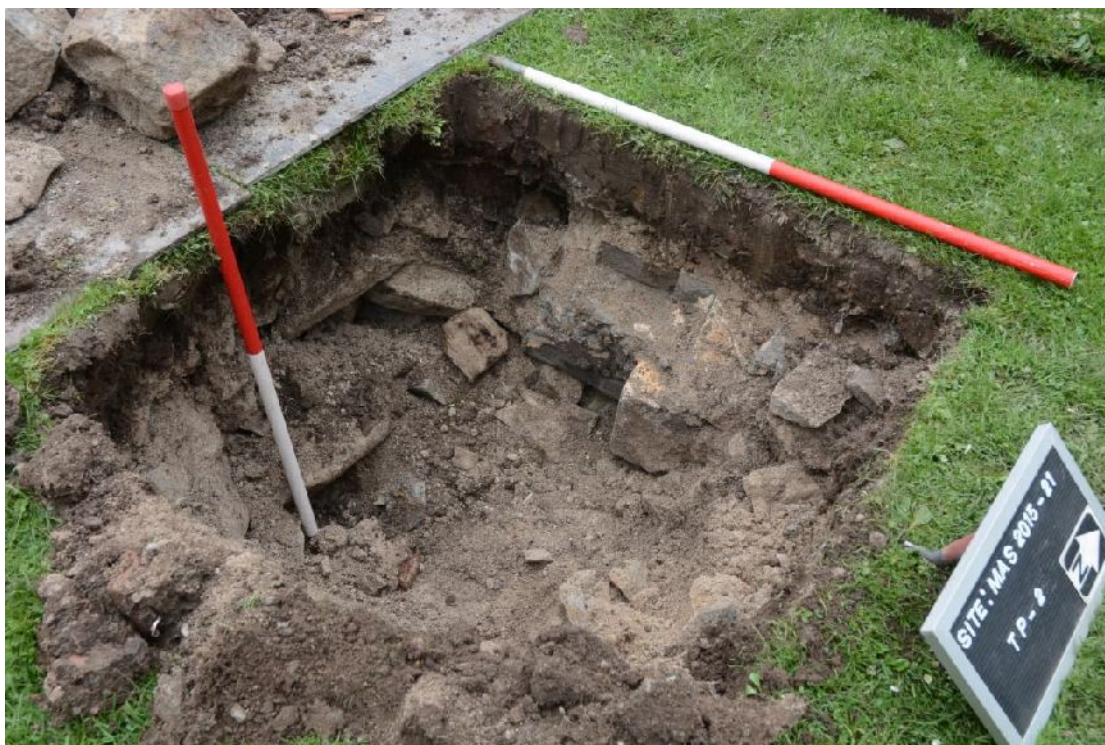
150mm Topsoil

650mm+ Building rubble. Stone, mortar, occasional brick, including a block of firebricks. Not excavated to base of rubble which was very firm and showed no evidence of voids or cellarage.

**Illus 16 Location of TP2 looking E**

**Illus 17** Section of TP2

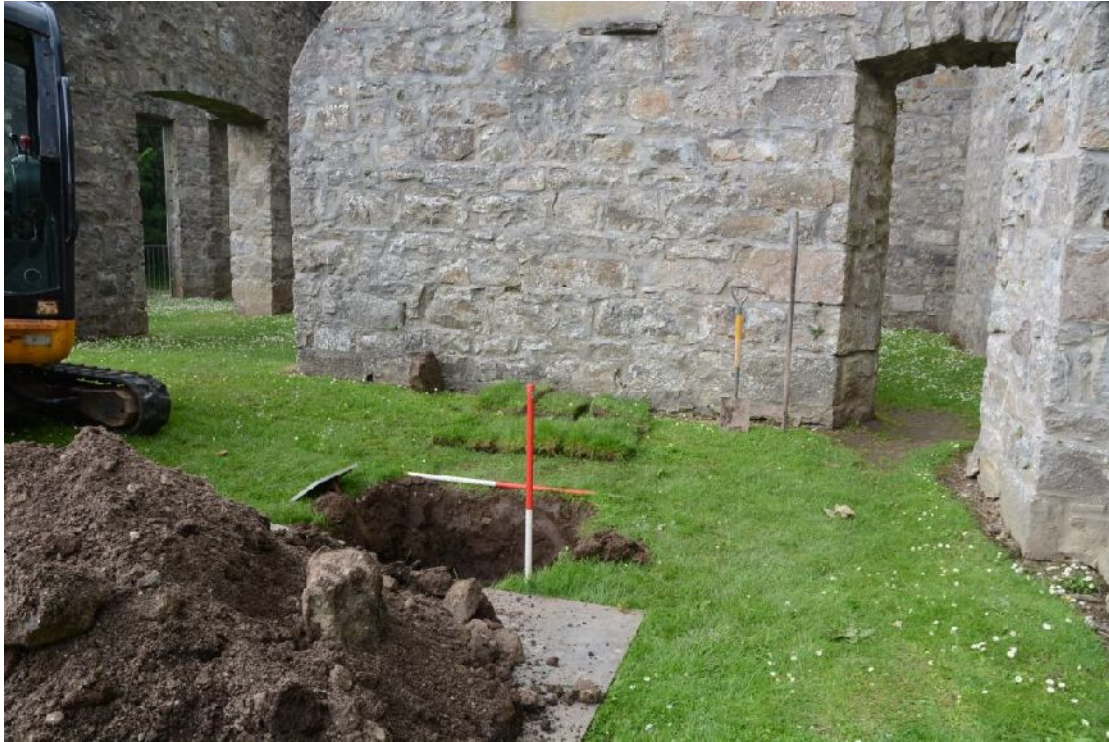
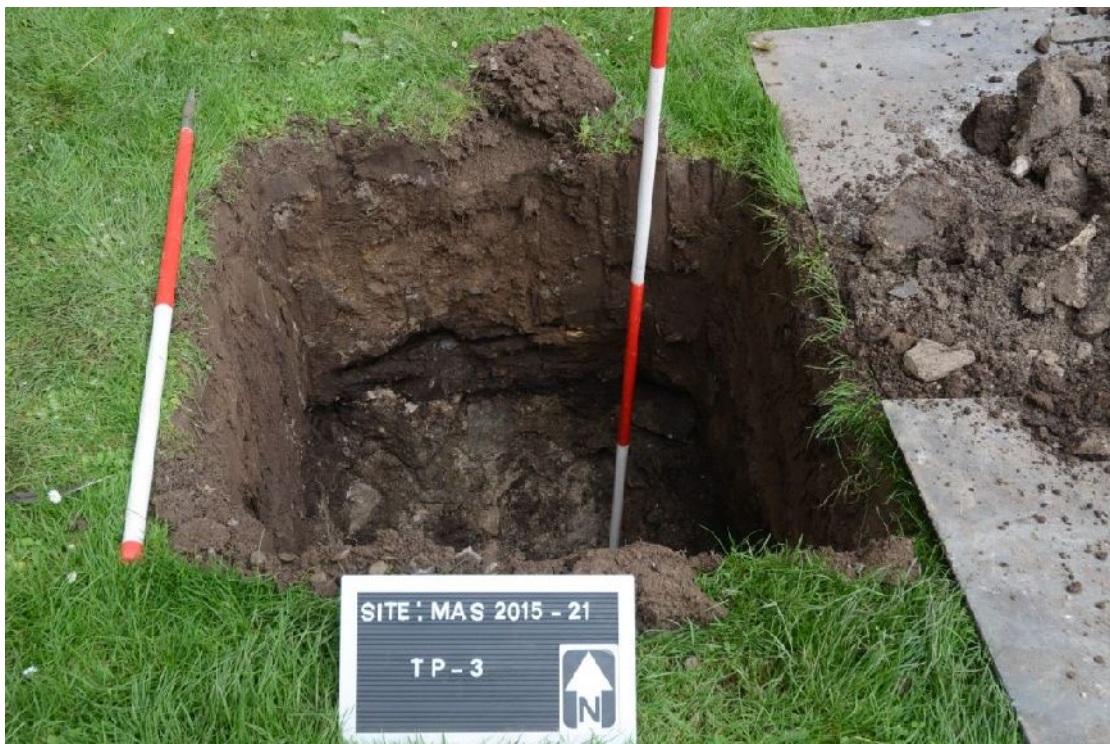
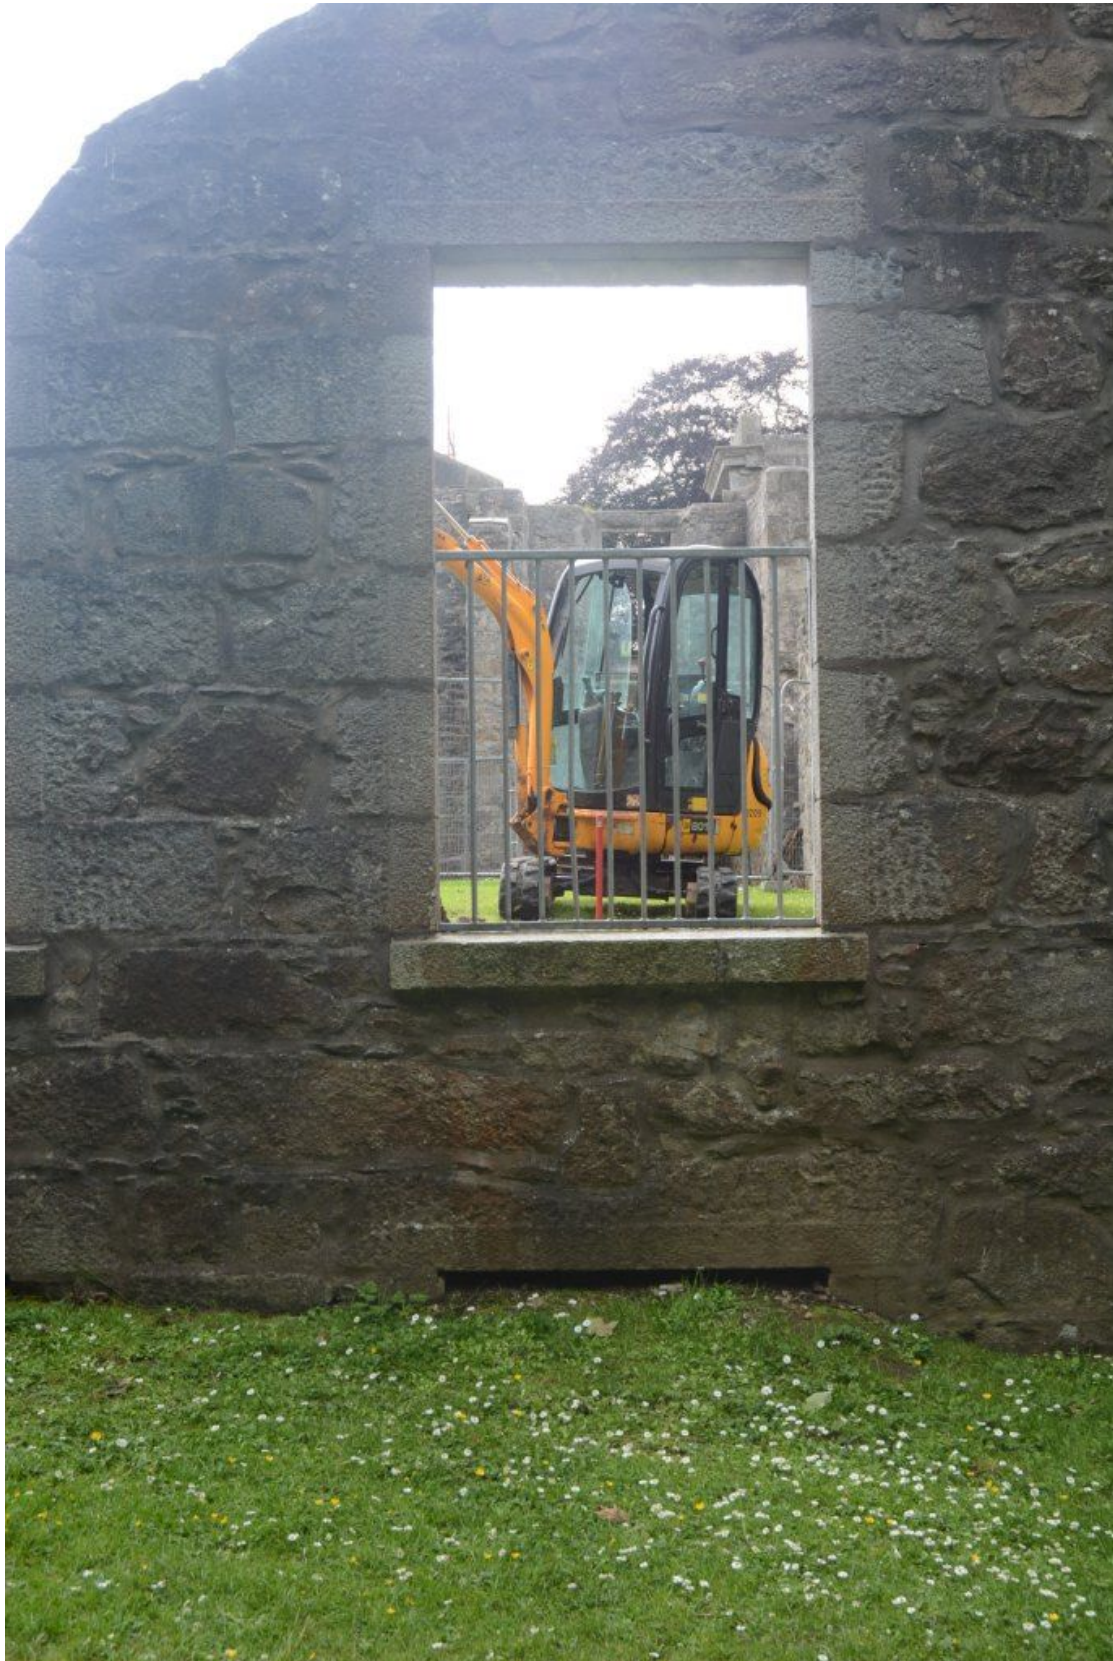
The depth would suggest this area was cellared. The rubble fill was very compact.

Sinkage/hollow in the grass in this area may be due to the greater depth of soft topsoil.

Below this window on the outside, there is the visible top of a lower 'vent', 930mm below the sill of the upper window (Illus 20).

**Illus 18** Location of TP3 looking W

**Illus 19** Section of TP3

**Illus 20 Location of TP3 in relation to window and vent in N wall of Small Pantry**

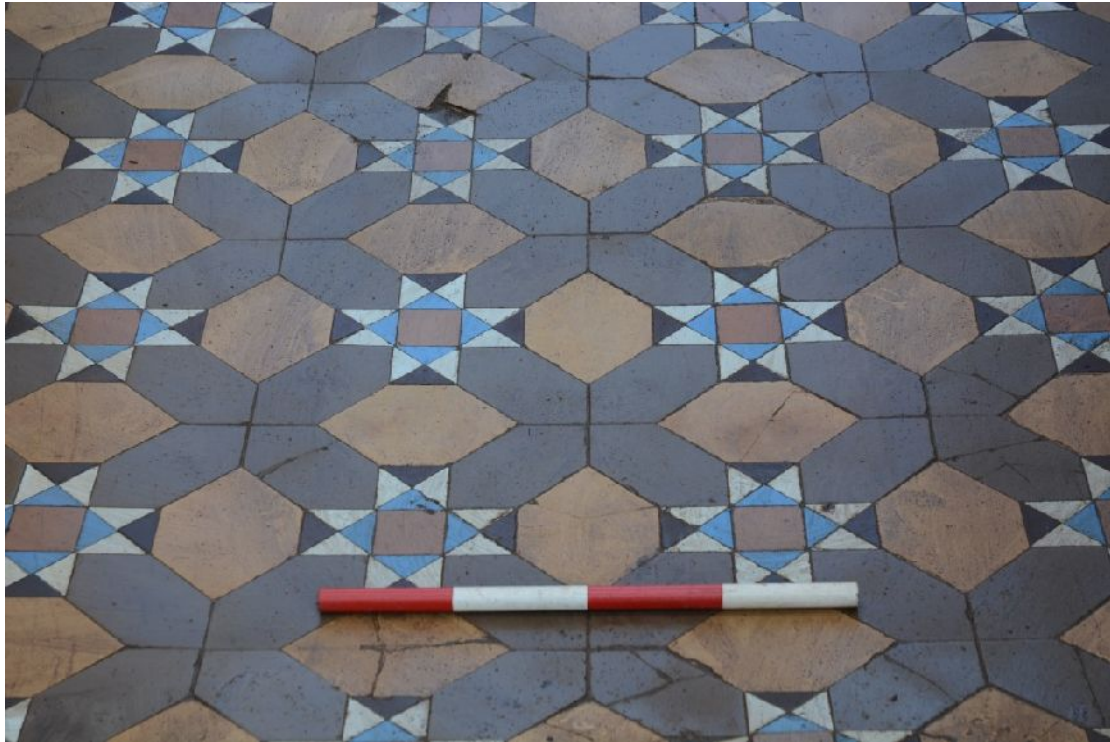
**Illus 21 Detail of tiles in lower part of Entrance Hall**

Historic Scotland’s Guide to ceramic floor tiles (Curtis, 2007) suggests that ceramic tiles became common in Scotland from c.1840. Thompson (2004) dates the use of such floors as becoming popular in public buildings, churches and large houses from the 1860s, spreading more generally from the 1890s. The fairly plain geometric pattern, lacking any decorated (encaustic) tiles is hard to date with any precision. If these sources are accepted for the dating of the tiles it may suggest that the tiles (and, by stratigraphic sequence, the stone skirting and the plaster above it), date to the mid 19<sup>th</sup> century, possibly indicating a re-flooring that post-dated the John Smith alterations. The evidence suggests that the same tiling, with the same pattern, was in use in the upper part of the Entrance Hall, N of step 5, possibly only to the line of the I- beam.
