**Aden Country Park, Aberdeenshire, AB42 5FQ
Excavation Report and Data Structure Report
CA509 August 2021
(incorporating CA267, CA464, CA509)**

**Alison Cameron
Cameron Archaeology
23 November 2021**

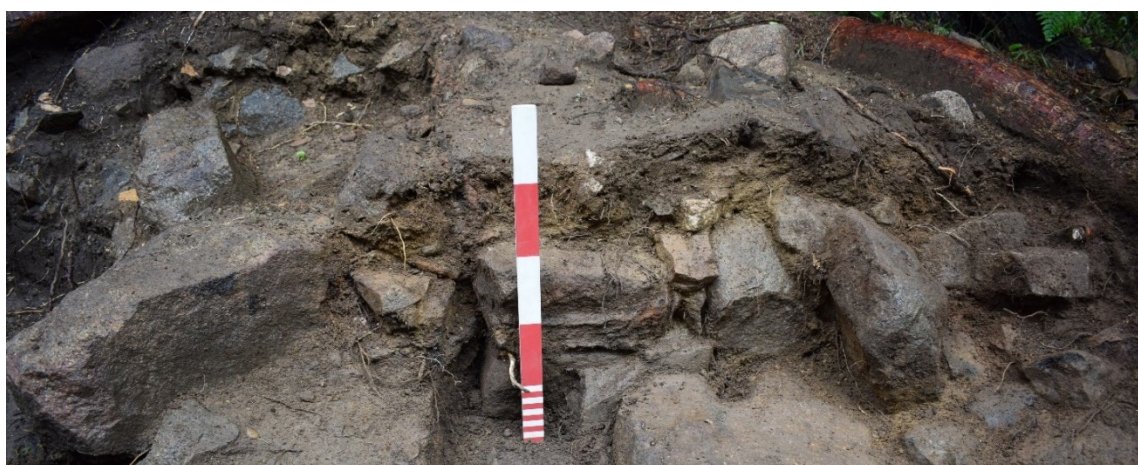
Illus 7 Section showing threshold 121 (right foreground), wall 151 (centre), wall foundation 124 (left) with stone demolition material (top and right); facing W East 'wing'

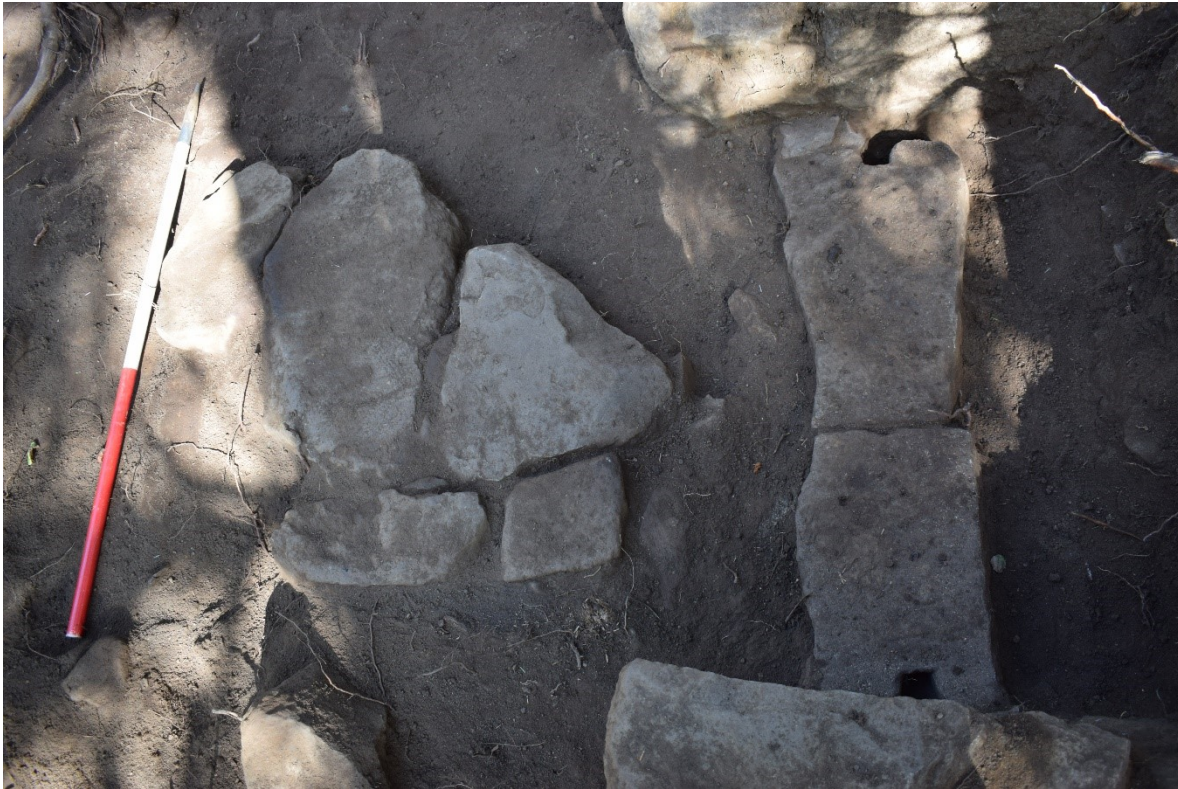
Illus 9 E door 246 with remains of interior cobbled surface (256; left); facing N

There are the remains of cobbled surface 256 (Illus 10) on the interior of door 246 slope up into the room at a slightly higher level from the threshold suggesting that they may be the remains of a later floor surface. Door 228 has internal (230) and external (229) cobbled surfaces. There was no possibility of excavating farther south as there are living trees with large roots along this edge of the structure. Discussion has been taking place with the park manager to remove these trees but at the present time they are creating a wind block and it would be detrimental to the rest of the wood to remove them at the present time (Jack Grant pers comm).

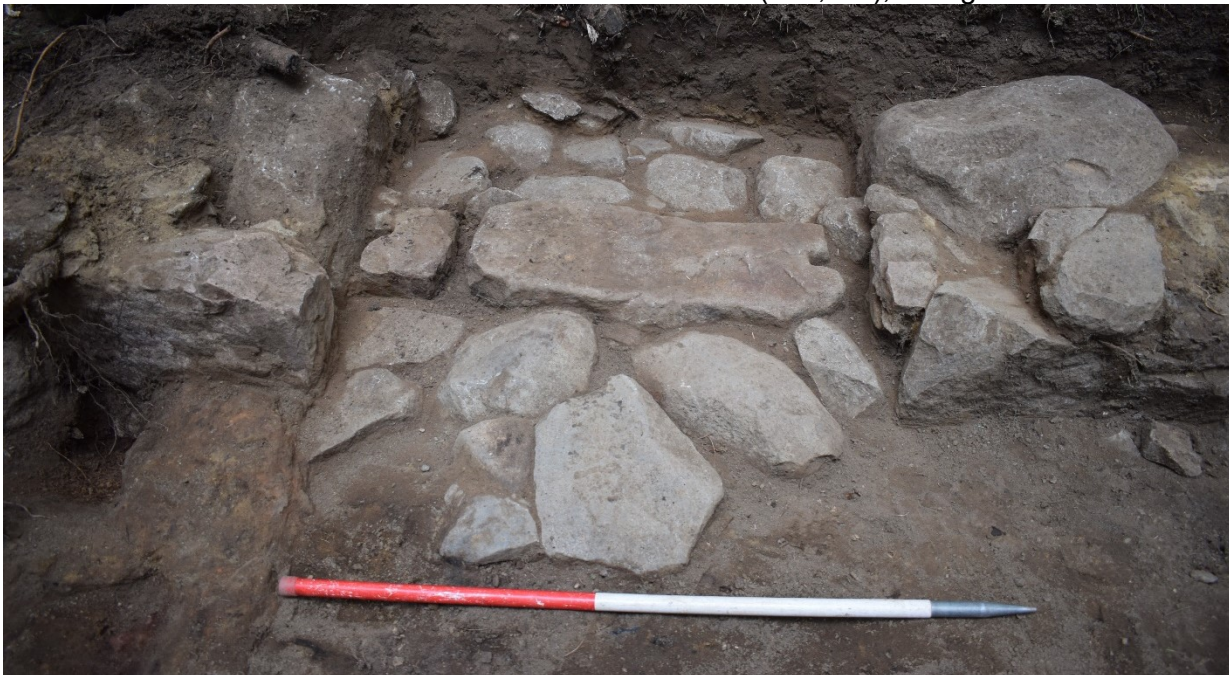
Illus 10 Door 228 with interior cobbles (230; foreground) and exterior cobbles (229, entre top); facing S

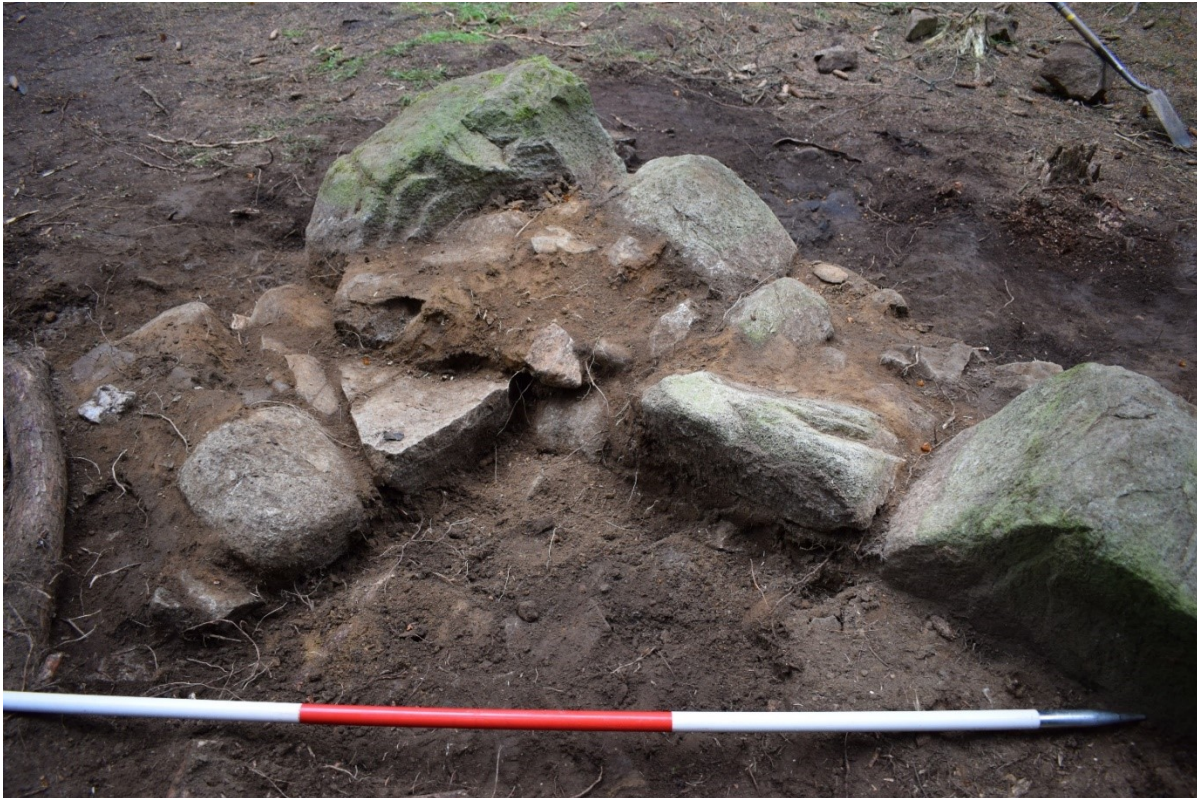
Illus 19 External corner junction of wall 11 (right) and wall 125 (left) after removal of demolition material showing they were constructed in one phase; facing SE

The junctions of the main rectangular structure and the extension were investigated (walls 7/129 and 11/125; Illus 10, 11) revealing that the T-shaped structure was built in one phase. On the interior of the structure several areas of possible floor levels were uncovered. In the main rectangular structure areas of floor 135 (Illus 4) and 114 consisted of compact level clay deposits. Along the interior edge of the walls at floor level are strips of light brown clay (137, 111), possibly sealing the top of the foundation. Under wall 7 is a shallow trench, 155, filled with medium grey clay loam (Illus 4), under clay 111. This was initially interpreted as a possible foundation cut for this wall but the stones of the wall sit on top of 155 and not on the natural subsoil layer into which it was cut. This cut is not seen in other locations and further investigation would be required to determine whether this is an earlier feature such as a furrow into which the wall was unintentionally constructed. One rim from a late medieval or early post-medieval jug was found associated with the construction of this building and there were no other finds from the Phase 1 structures.

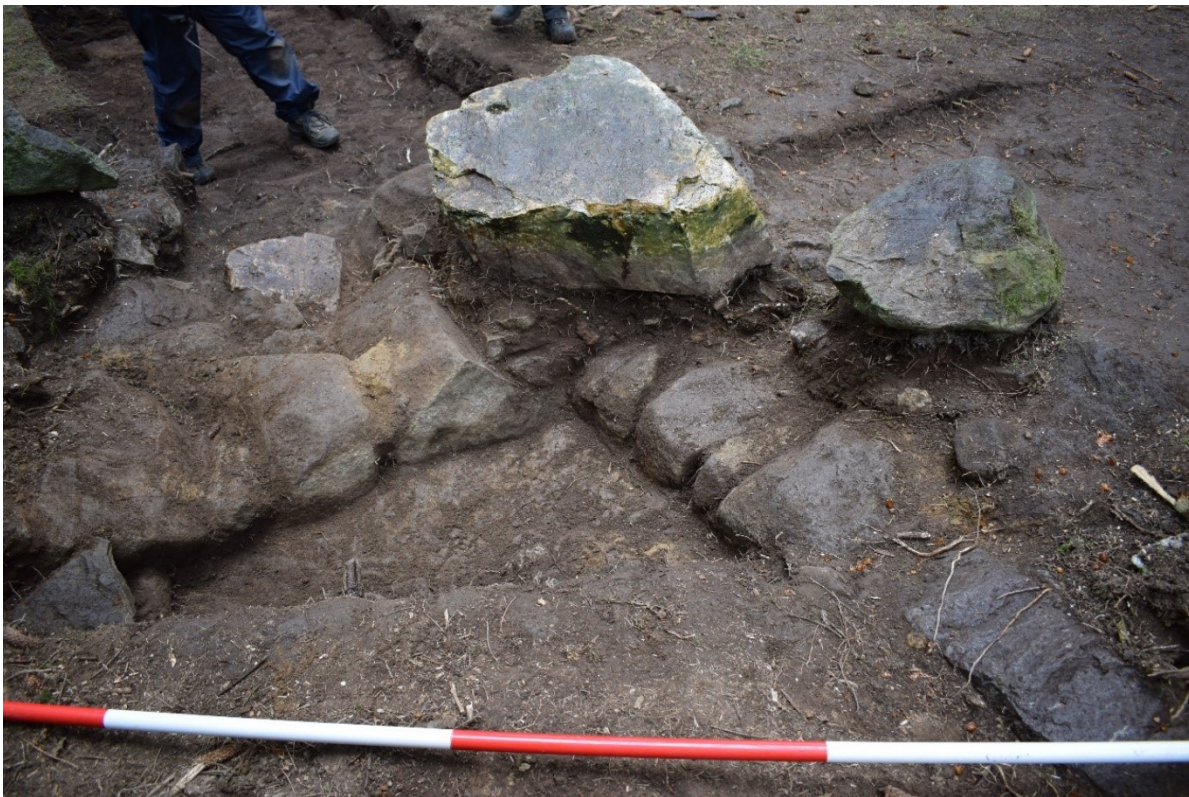
Illus 20 External junction walls 7 (right) and 129 (left) after removal of demolition material with Phase 3 dumped stones (2) on top; facing SW

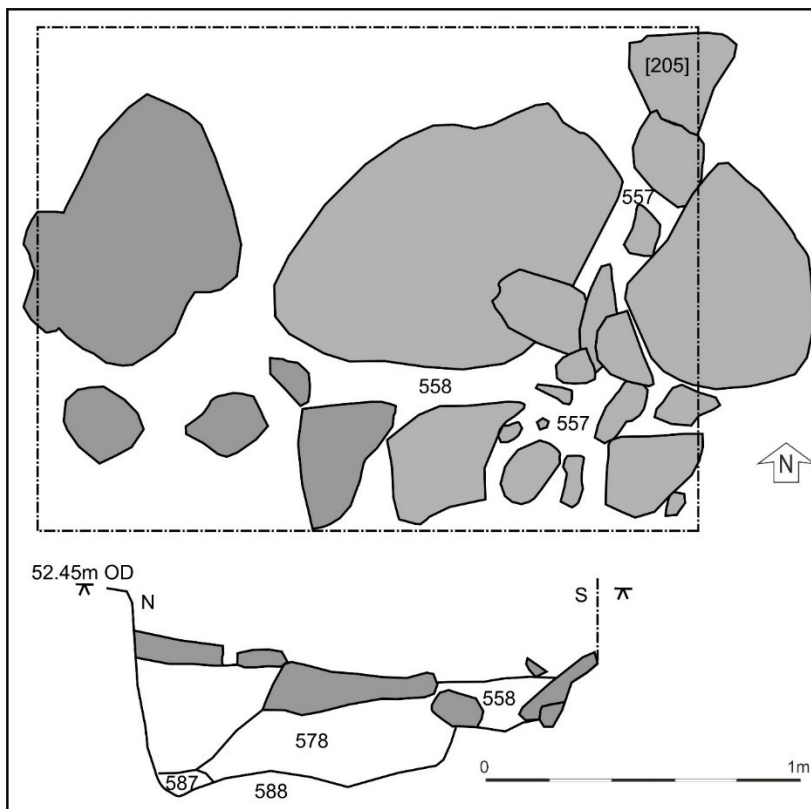
This was excavated through the S wall of the building between doors (Illus 35) showing large stone foundation, small stone and sandy clay infill and demolition material spread on top.

Illus 35 Test pit 32

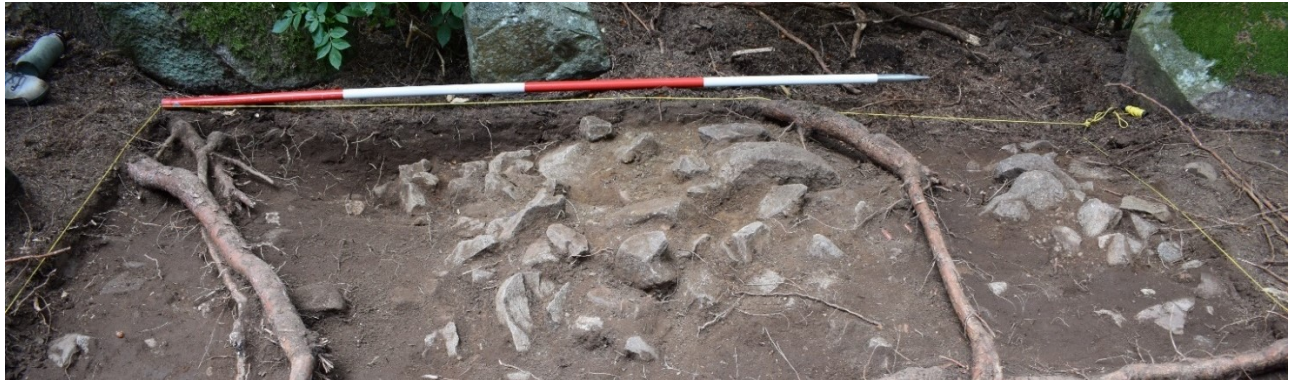
Illus 37 Stone demolition material 117 over wall 125; facing W, note the root tracks which have damaged the structures and moved stones

In both 2016 and 2019 excavations several areas of stone demolition were removed (103, 112, 115, 117, 118, 139; Illus 37, 38). These consisted of small stones with lumps of walling (eg 118) and light brown sandy clay wall bonding material. These layers overlay the burnt wood layers of Phase 2a and because of their loose nature they were badly disturbed by tree roots.

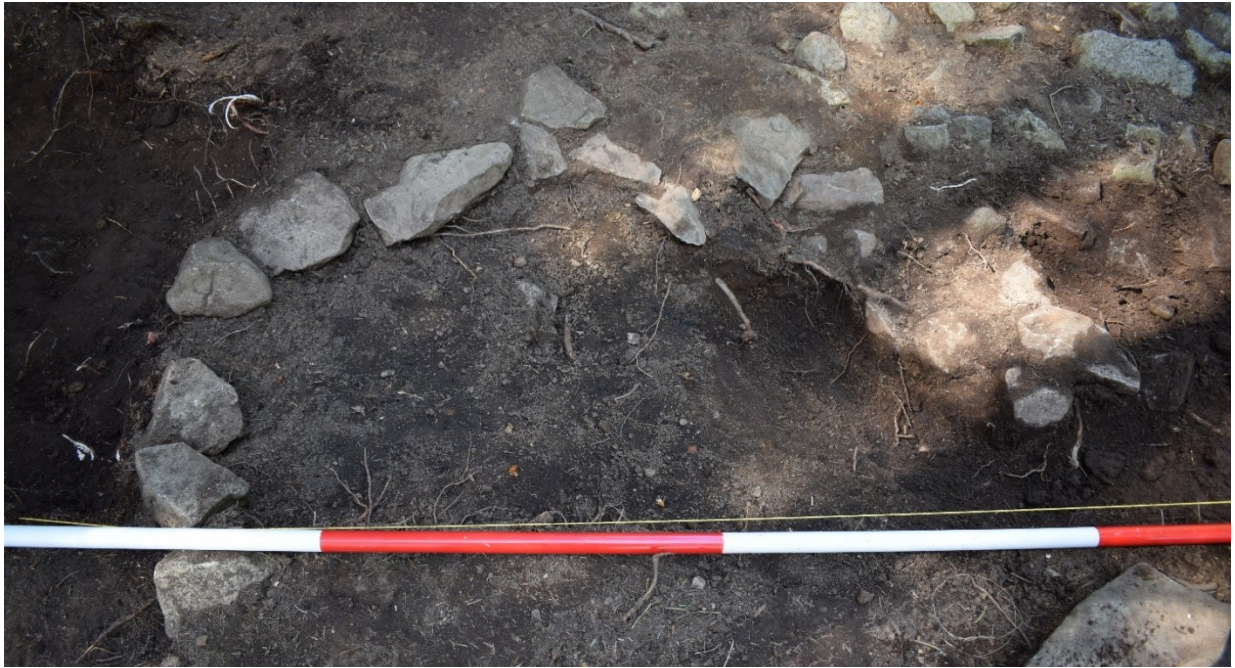
A semi-circular setting of medium stones, 109 (Illus 42), 1.2m diameter was probably constructed for a fire setting. This feature is sitting on top of Structure 1 demolition material 106, and may therefore be associated with the Phase 3 stone setting or may be later. The Phase 4 activity at this building includes at least two of the Phase 2 stones being relocated and a small number of modern finds from visitors to the park. There is a possibility that this was a fire setting for the Phase 3 structure but it could equally be a later feature. The stones are not themselves burned.

Illus 42 Phase 3 or 4 stone setting 109; facing NN

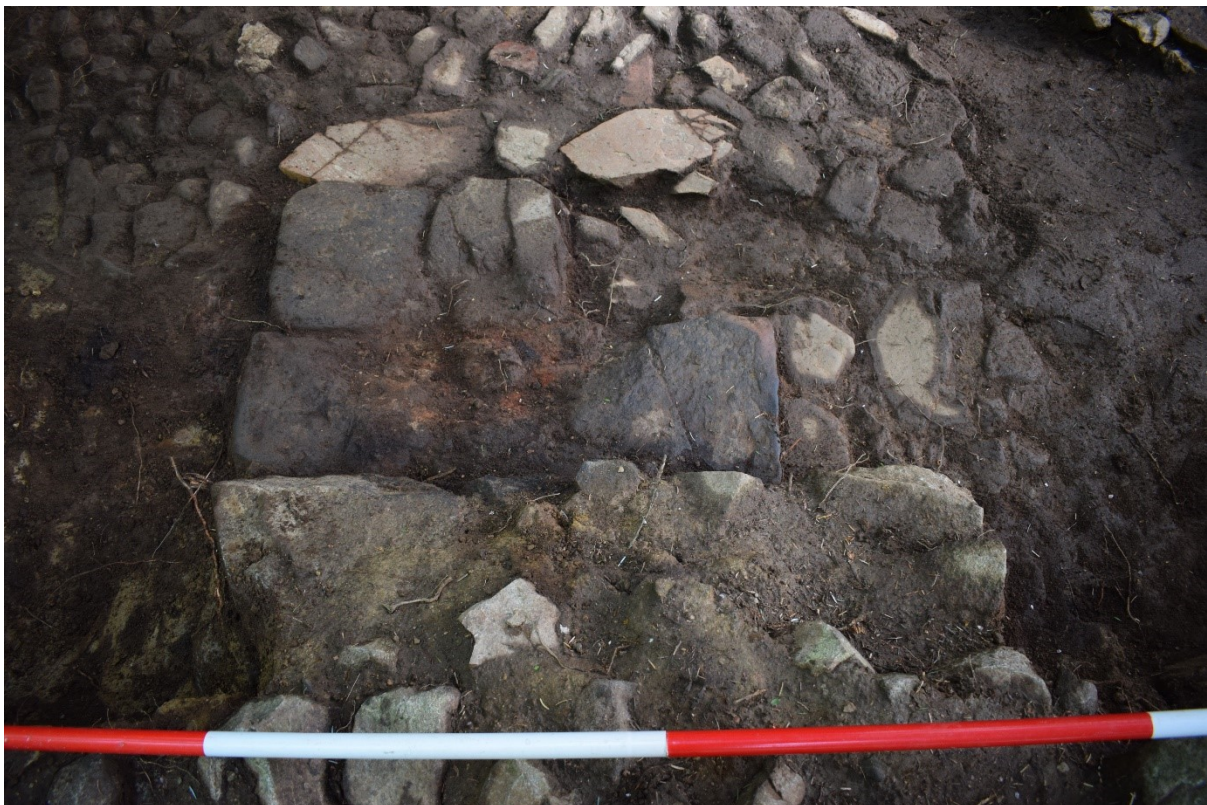
Illus 47 Detail of hearth 83 with burnt deposit 84 (centre) and wall 87 attached to main south wall 22 (bottom); facing N

The hearth has been laid in the centre of the S wall in front of a tapered wall fragment attached to the interior of the main south wall (87; Illus 47). There was a deposit of charcoal and burnt sand on top of the flagstones. The floor around the cobbled surface was light brown sandy clay (86) and in the interior SW corner of the building was a large flat slab (85; Illus 40). There is an area stones at floor level on the E side of the room (90; Illus 40) and these may be part of a disturbed floor or stones pushed from the E wall by an adjacent tree. The fireplace has been interpreted as the remains of a hanging lum as the remains do not fit with a more traditional fireplace. The hood of the lum would have hung over the area of 83 where the fire had been set.

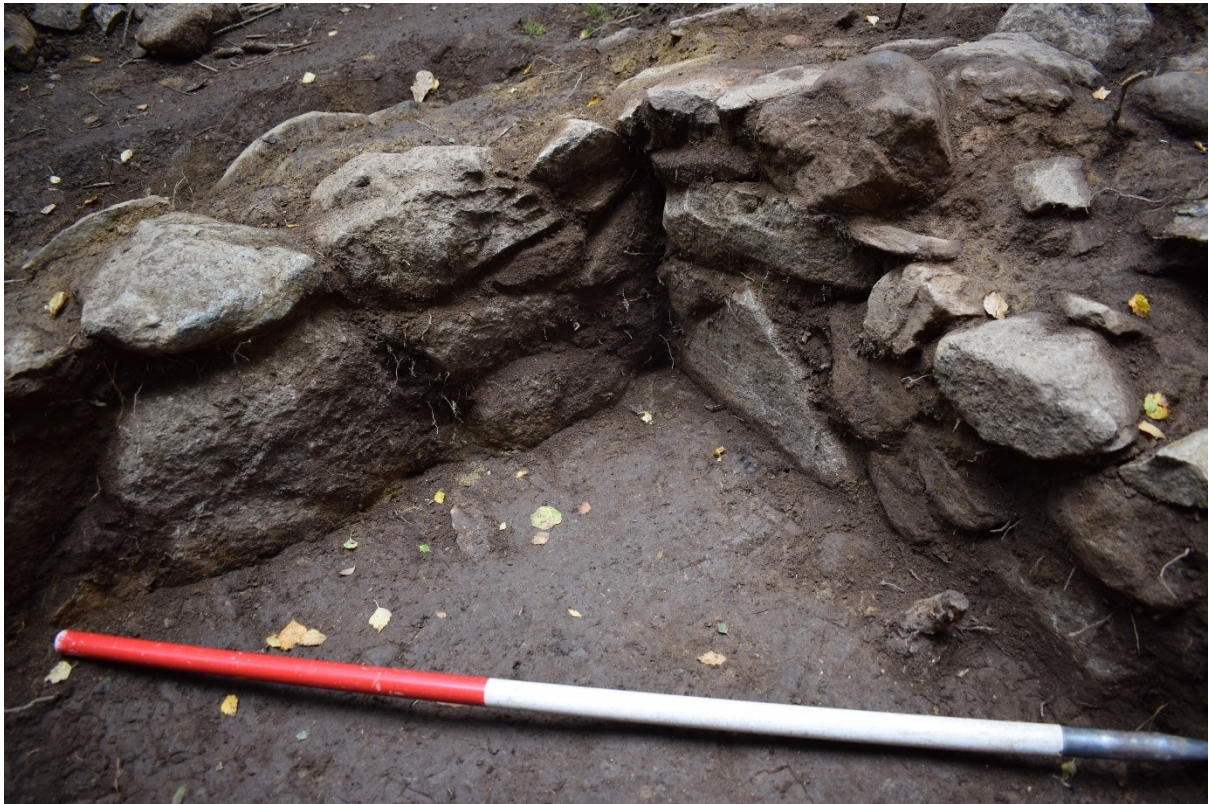
Illus 57 W wall [506] left contemporary with partition wall [601] (right); facing NW

Room 2 is 3.2m W-E and 3.9m N-S (Illus 55). The W wall is constructed of small and medium stones with sandy clay bonding (Illus 57); it is 0.63m wide at the N end; there is a narrower portion of wall at the S end 0.38m wide caused by an alcove or recess 0.26m wide and 1.85m long (505; Illus 56, 58). The N wall, 601, of Room 2 is 0.6m wide; stones have been removed from the central area of the wall and it was thought this was a possible door but further excavation in 2021 revealed that there is no doorway in this wall. The E wall, 507, is 0.7m wide and quite disturbed by a large tree root.

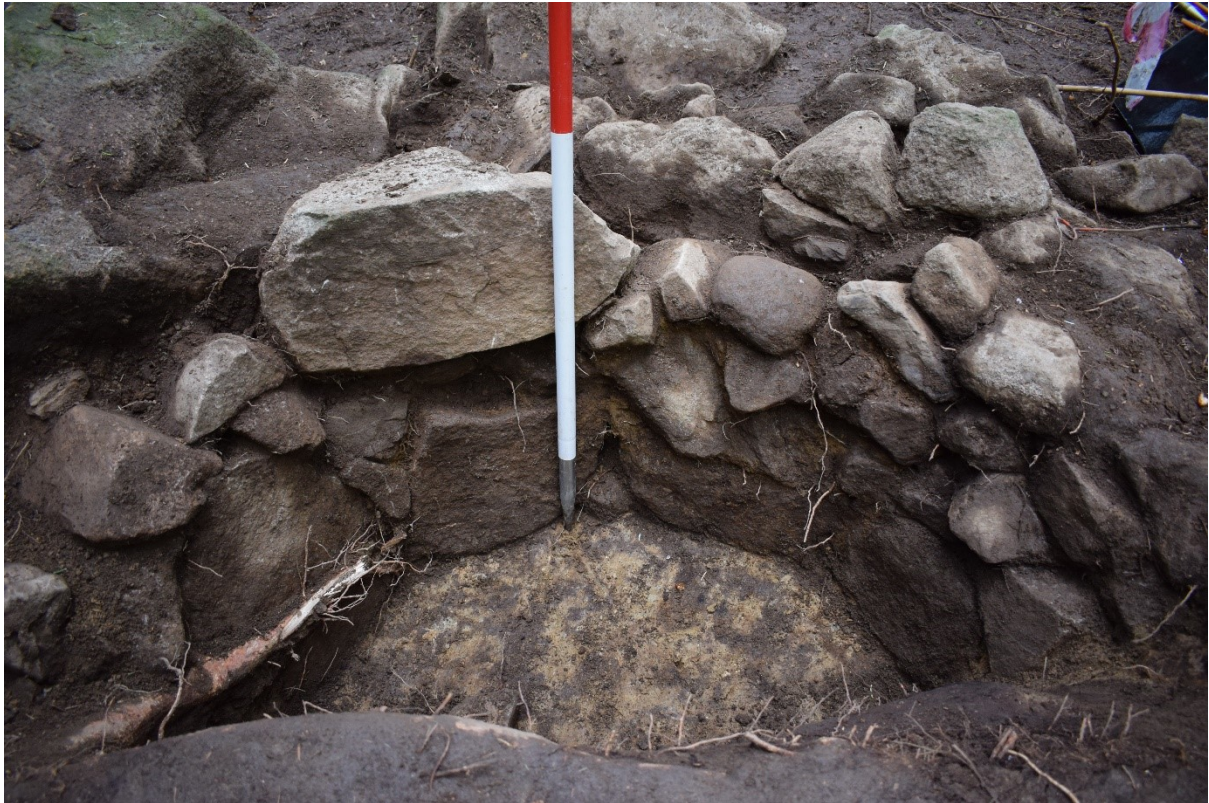
Illus 65 Stone-lined pit 553=81 showing clay bonding between stones; facing NE

In the NE corner a circular stone-lined pit, 81 (Illus 64-66) was about 1.2m diameter, although a tree was positioned on the NW edge and this had damaged the edge of the pit and loosened stones. There is a base course of large stones with upper courses in small and large stones. The stones had been bonded with light brown sandy clay mortar and the base was the natural light brown sandy clay. The fills were demolition materials including stone and sandy clay mortar lumps. The fill had been disturbed by root activity. There were no finds and nothing dateable from the fill. In 2021 the pit was investigated further and it was discovered that this pit was sitting on top of cobbled floor of Room 3 (590) and appears to be partially constructed of demolition material from Structure 2. It is therefore later than the structure and probably constructed after the building went out of use.

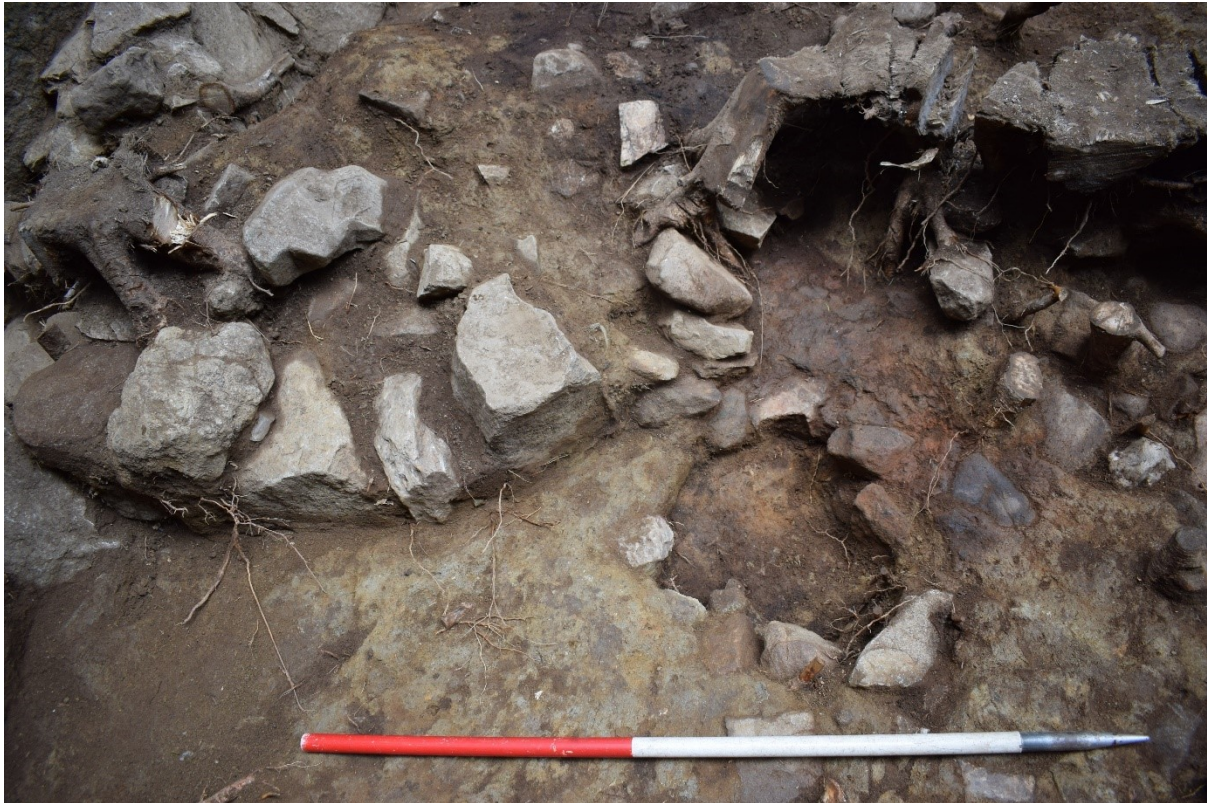
Illus 67 Fire-pit [552] with outer wall of pit 553 (top left) prior to cobbled floor 590 being uncovered; facing E

Cut into cobbled floor 590 is a shallow pit [552] which is heavily burned, surrounded by and filled with burnt clay (622) (Illus 67-68). The area between pit [533] and pit [552] is filled with roots and the stones are very disturbed but there was burning under the roots suggesting that there was probably a shallow flue joining the two pits. It was decided not to excavate further as the risk of damaging [553] was high.

Samples will be crucial to understanding this feature but it is likely to have been a corn-drying kiln with [552] being a heat source for heating the pit.

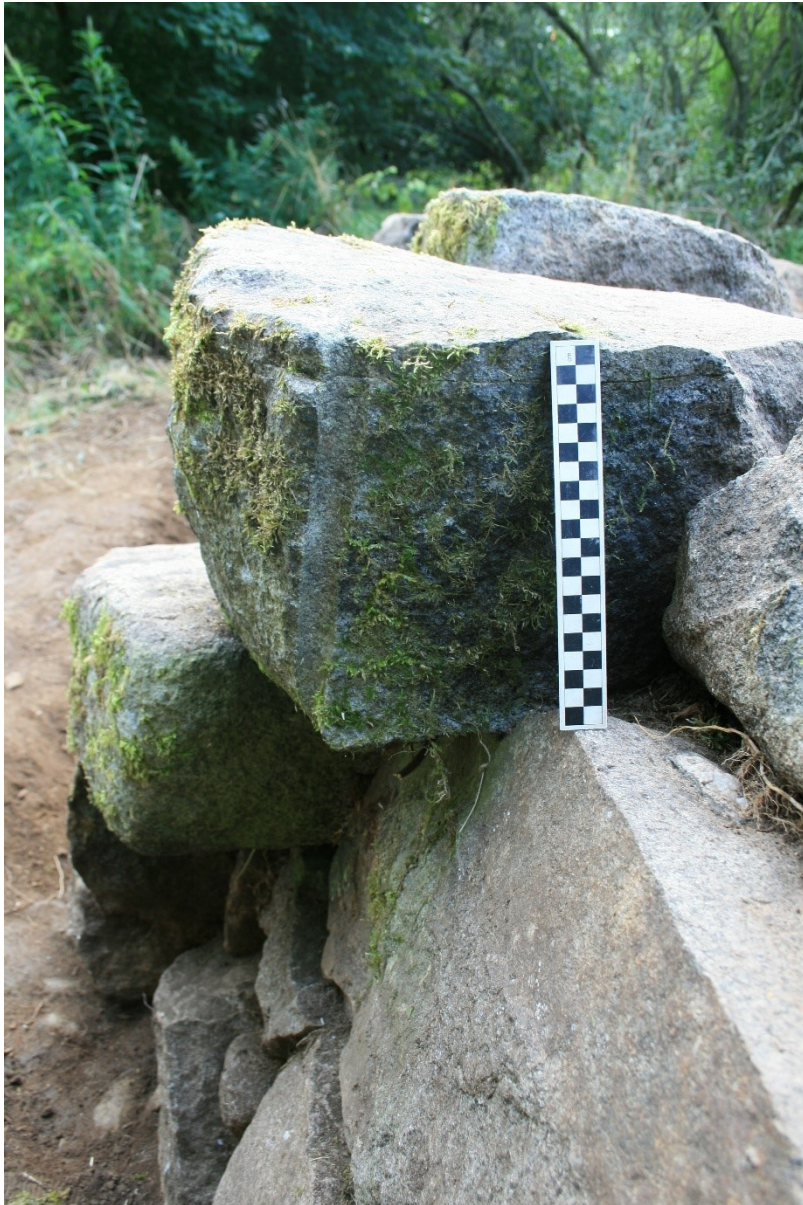
Illus 80 539 detail of drill mark on NW corner of stone on W side of Step 1; facing W

There were drill marks on some of the stones suggesting that this part of the construction was 19th-century date or later (Illus 77, 80).

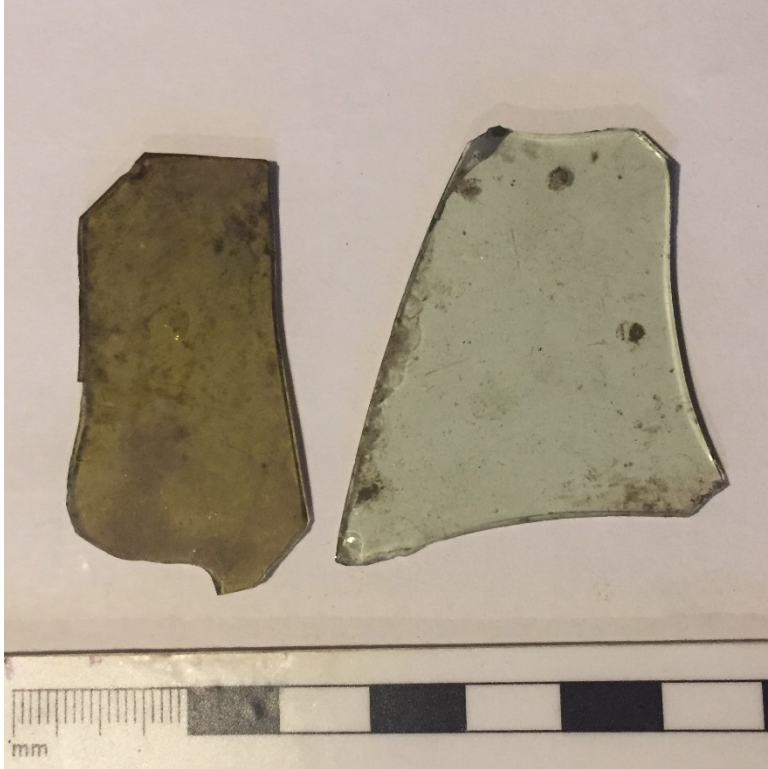
Illus 88 Example of the different colours of the two types of window glass found at Aden. Type 1 is the dark green glass on the left and Type 2 the more colourless glass on the right.

Visually the window glass can be separated into two main types of glass (Illus 88). The chemical analysis has confirmed the visual assessment that there are two types of window glass at Aden. Most of the pieces are broken in an irregular fashion. This is likely to have

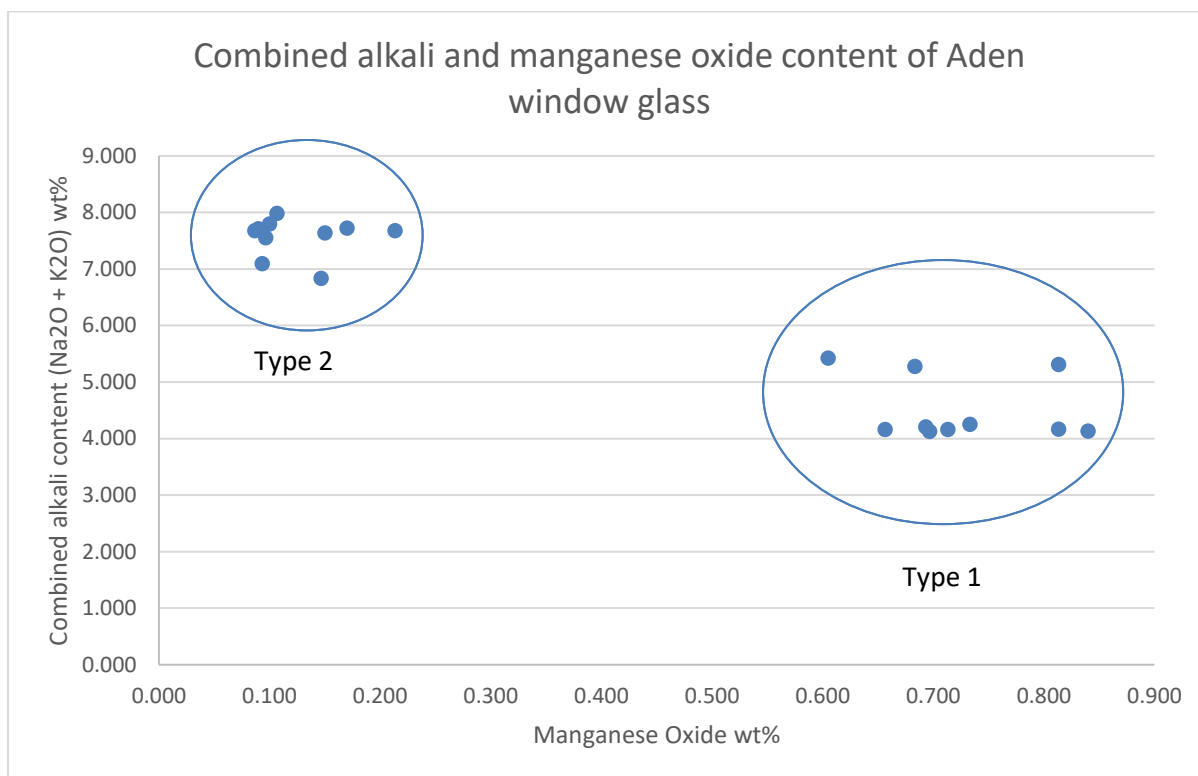
Both types of window glass are of the high lime low alkali type (HLLA) being rich in Calcium (20 – 23%). Glass of this composition was only made in England from around 1567 and known to be made in Scotland from at least 1610 (possibly earlier, although neither documentary or archaeological proof of glass manufacture prior to this date has been found). Glass of this composition may also have been imported from the continent earlier than these dates. The production of HLLA window glass was discontinued around 1700 when it was replaced with glass with much lower calcium content and a higher alkali content. However, bottles were still made from HLLA glass well into the 18th C. The HLLA glass can however be split into two groups based on its chemical composition. This can be clearly seen on the graph below which shows a plot of the combined alkali content (sodium and potassium oxides) compared to manganese oxide.

Illus 89 Combined alkali and manganese oxide content of Aden window glass
