# ADEN COUNTRY PARK, ABERDEENSHIRE, AB42 5FQ

## Data structure report (29 April-12 May 2019 excavation)

**Alison Cameron  
Cameron Archaeology  
13 June 2019**

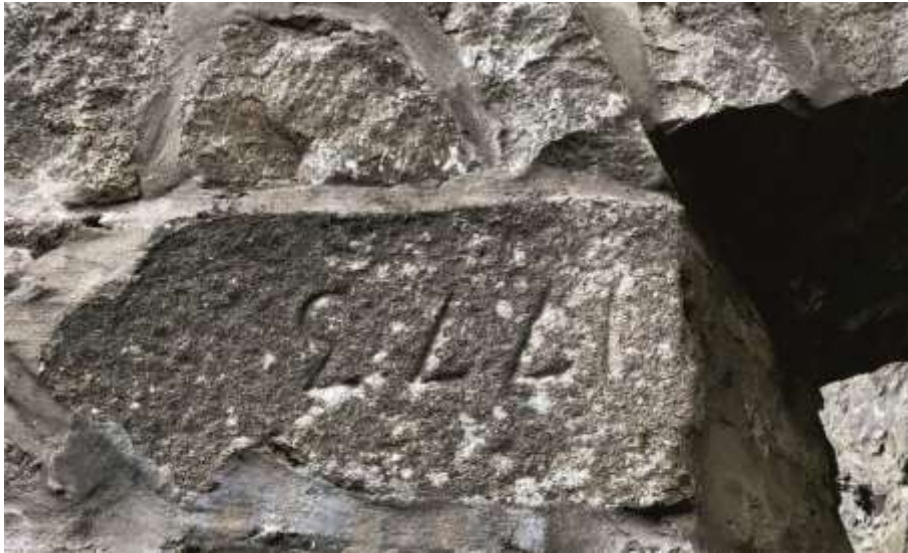
Illus 2 1773 incised date stone reused upside down as the springer for an arch; facing W

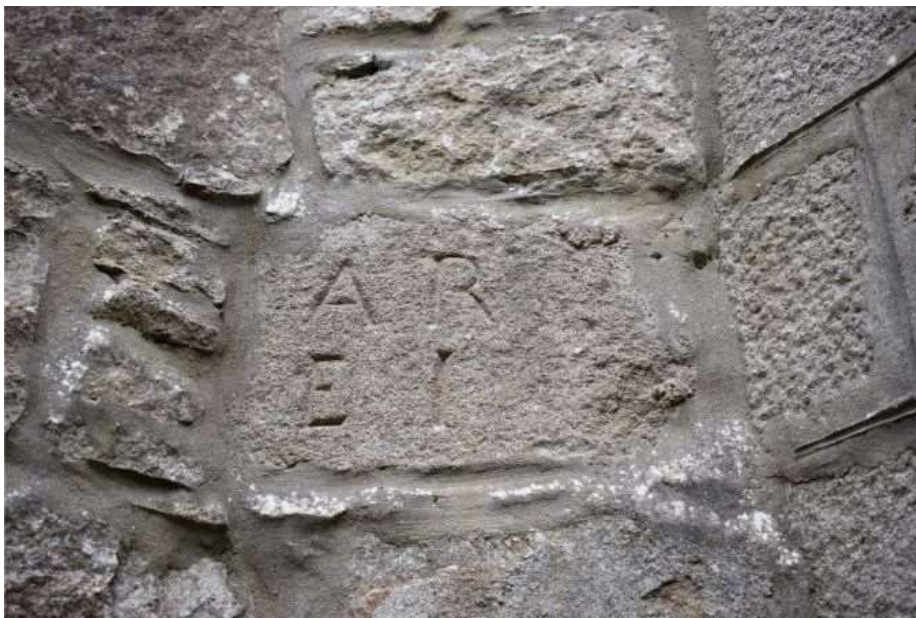
Illus 3 AR (Alexander Russel) and EI (Eliza Innes) inscribed stone; facing SE

Trench 6 was located at a corner of the house on the N wall where there is an unusual stone feature angled at 45 degrees to the current house with a stone inscribed 'AR/EI' (Alexander Russel and Eliza Innes, Illus 3). The trench had layers of slate, coal and linoleum on top of *in situ* drain pipes and dumped stone and loam. Under the current structure is what appeared to be a stepped foundation but removal of drain pipes revealed that it was the corner of an earlier building (611/612; Illus 22-23).

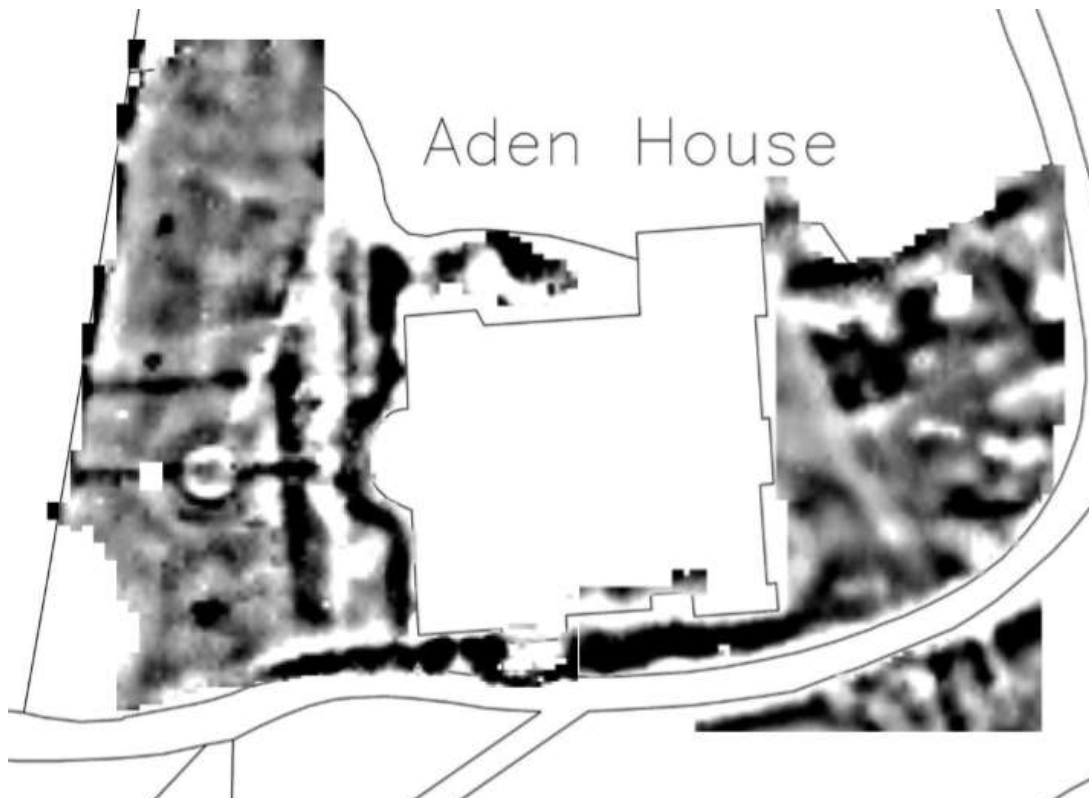
Illus 4 Resistivity survey results, Rose Geophysical Consultants

Previous work at the site included geophysical survey by Rose Geophysical Consultants (Illus 4, 5)

Trench 1 was 15 x 11m in size and positioned on the W side of Aden House to identify the anomalies seen on the geophysical survey (Illus 4, 5). Large stone-lined drain was recorded in Trench 1. The capping stones (124) were at least 0.8m long and the stone-lined passage was 0.6m wide at the top, 0.3m wide at the base and 1.05m deep (Illus 10-13). There was a silt layer in the base which was sampled, and the base had a layer of at least 0.4m of sand which was trenched but not bottomed. The capping stones were traced through Trench 1, into Trench 2, Trench 9, 11, 18 and 19 (see below). The sides are constructed of larger fieldstones with smaller packing stones.

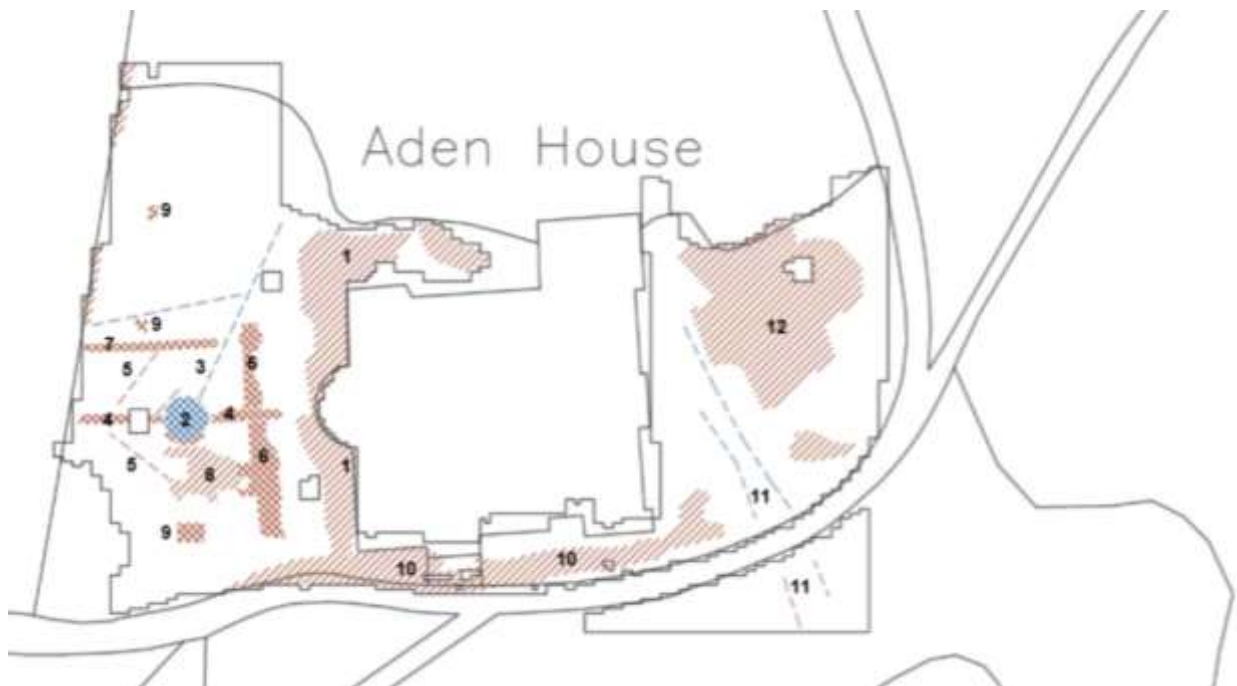
Illus 5 Interpretation of resistivity survey results, Rose Geophysical Consultants

The resistance survey showed a possible fountain or pond (Anomaly 2; Illus 5) and a central focus can be seen on the w side of the house on the First Edition OS map (Illus 15). A circular 4m diameter 0.7m deep pit had been cut into the centre of the garden aligned with the central bay window on the W façade. The pond was not *in situ* but a large section of concrete fountain base (Illus 13) was found dumped into the base of the pit. The base had been 3m diameter internally and probably dates to the late 19<sup>th</sup> or early 20<sup>th</sup> century. By the mid 20<sup>th</sup> century photographs (eg Illus 14) the pond and fountain have been removed. During removal lumps of concrete foundation, fountain base, ceramic garden ornaments and bricks had been dumped into the foundation pit. A cast iron valve box was uncovered (108; Illus 17) which would have regulated the water going into the fountain.

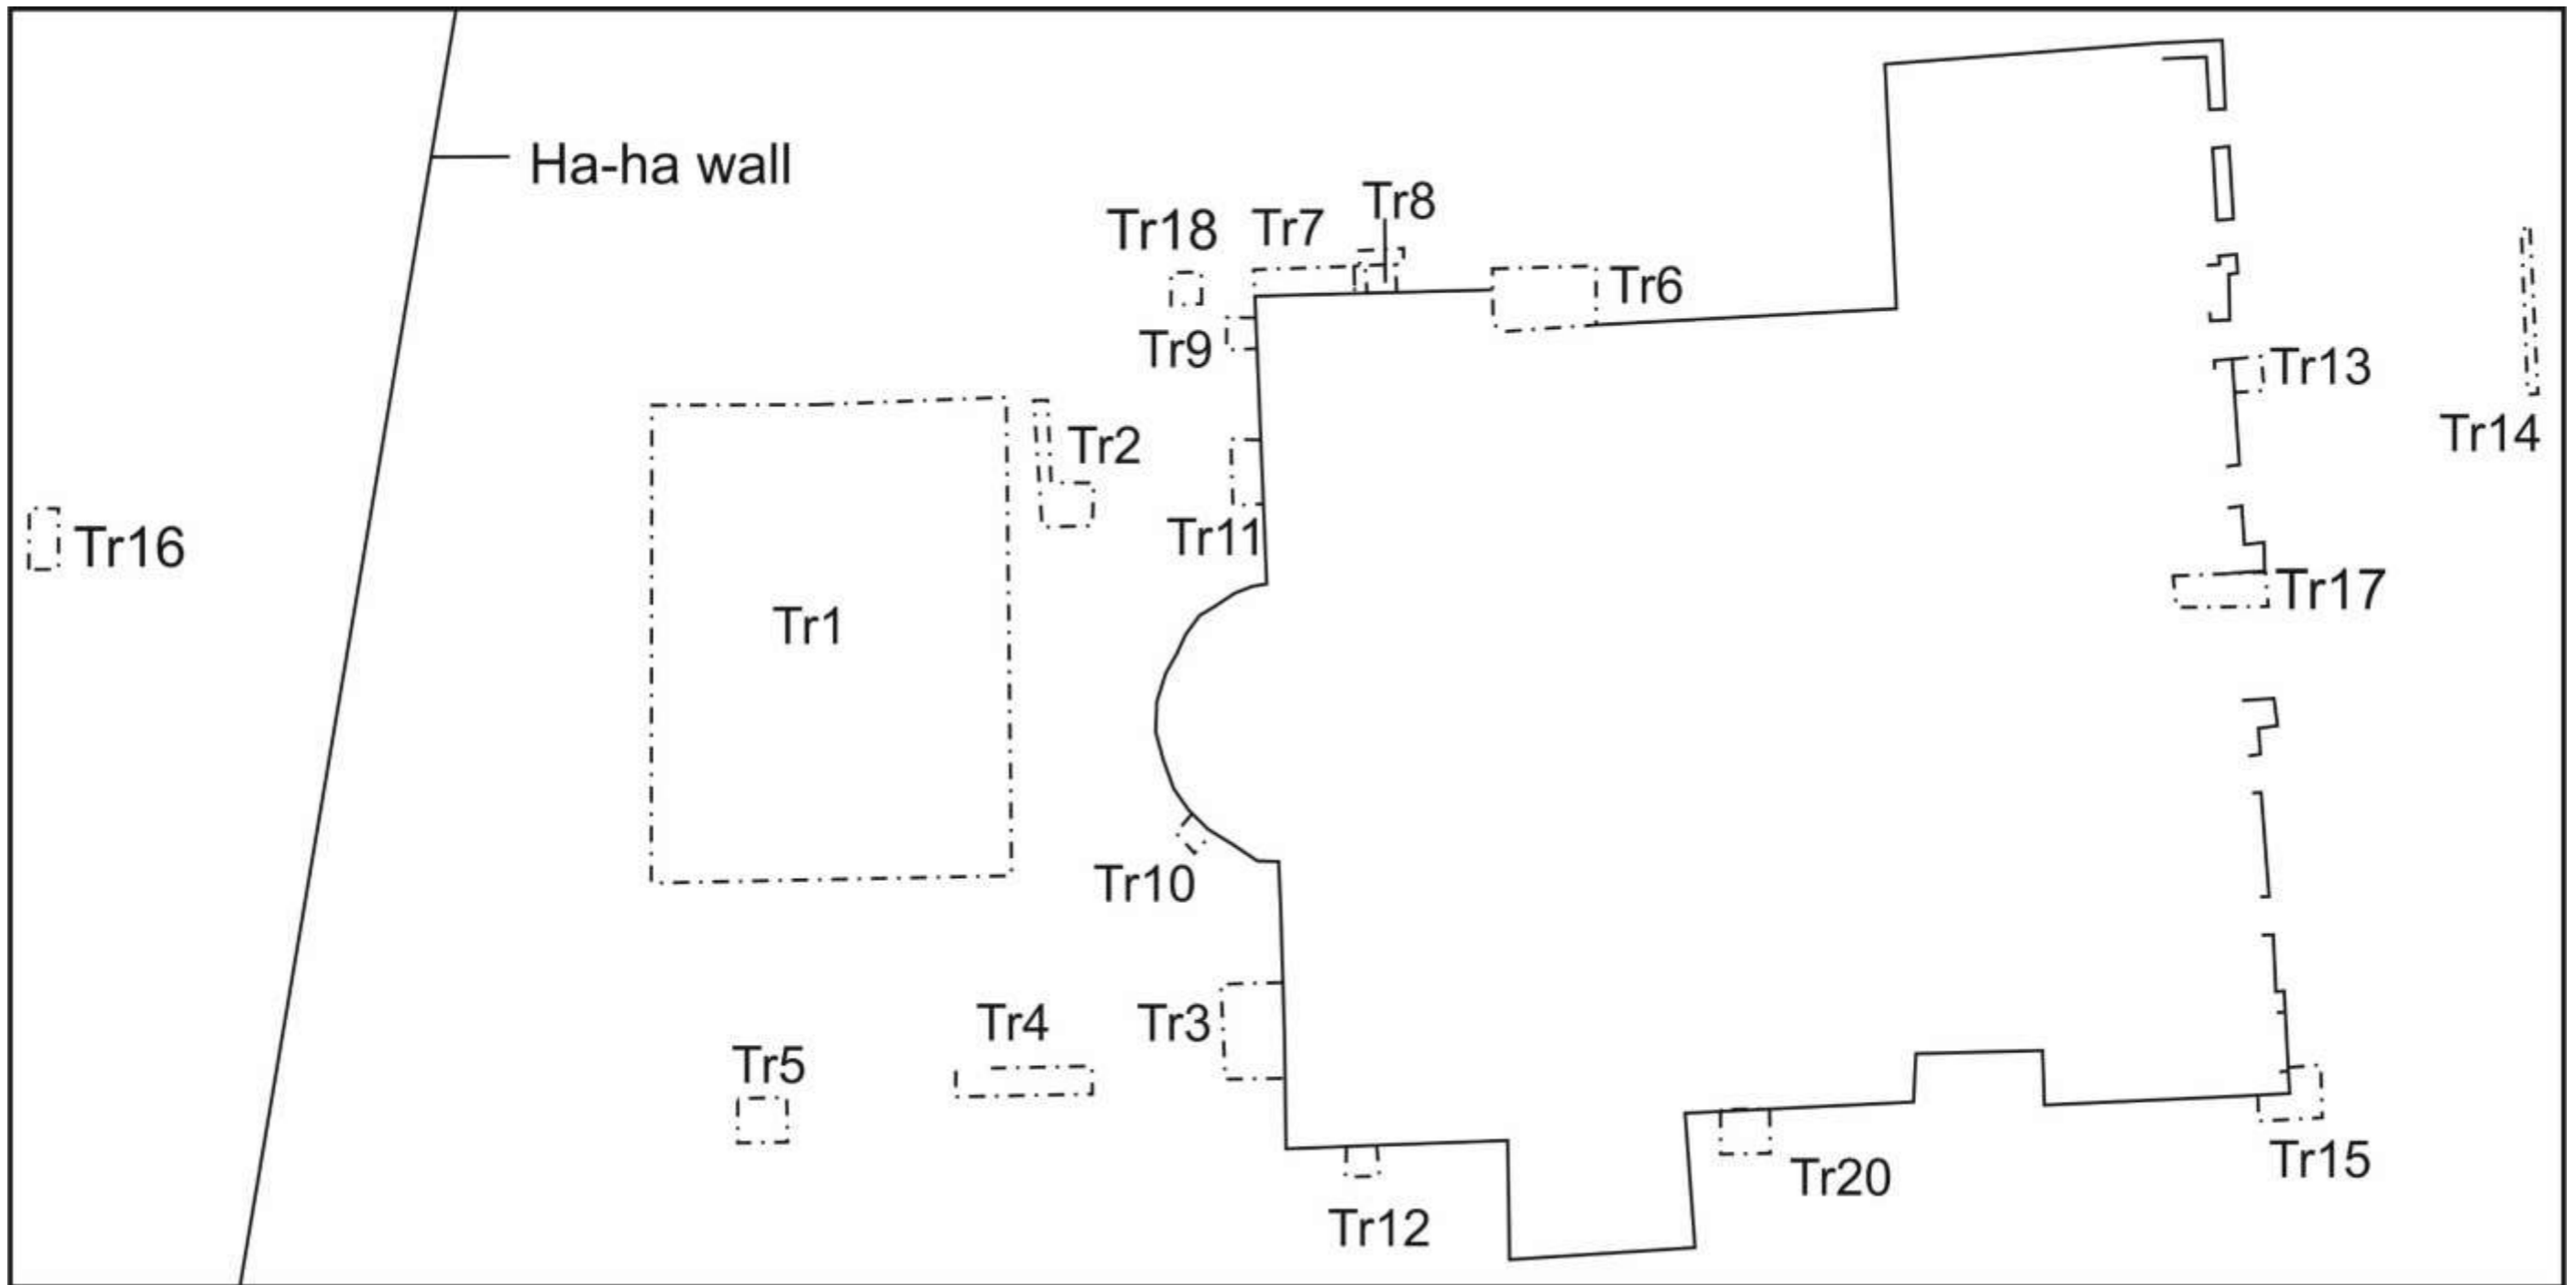
Illus 8 Plan showing 2019 trenches

Trench 9 was excavated on the W wall of the mansion house (Illus 8) to investigate the foundations of this structure. The stone foundation was 0.9m deep and capping stones from drain 1109 (see below) were recorded. These were bond into the foundation; the capping stones were not removed in Trench 9 and the drain was accessed only by drain rods and remote photography from Trench 11.

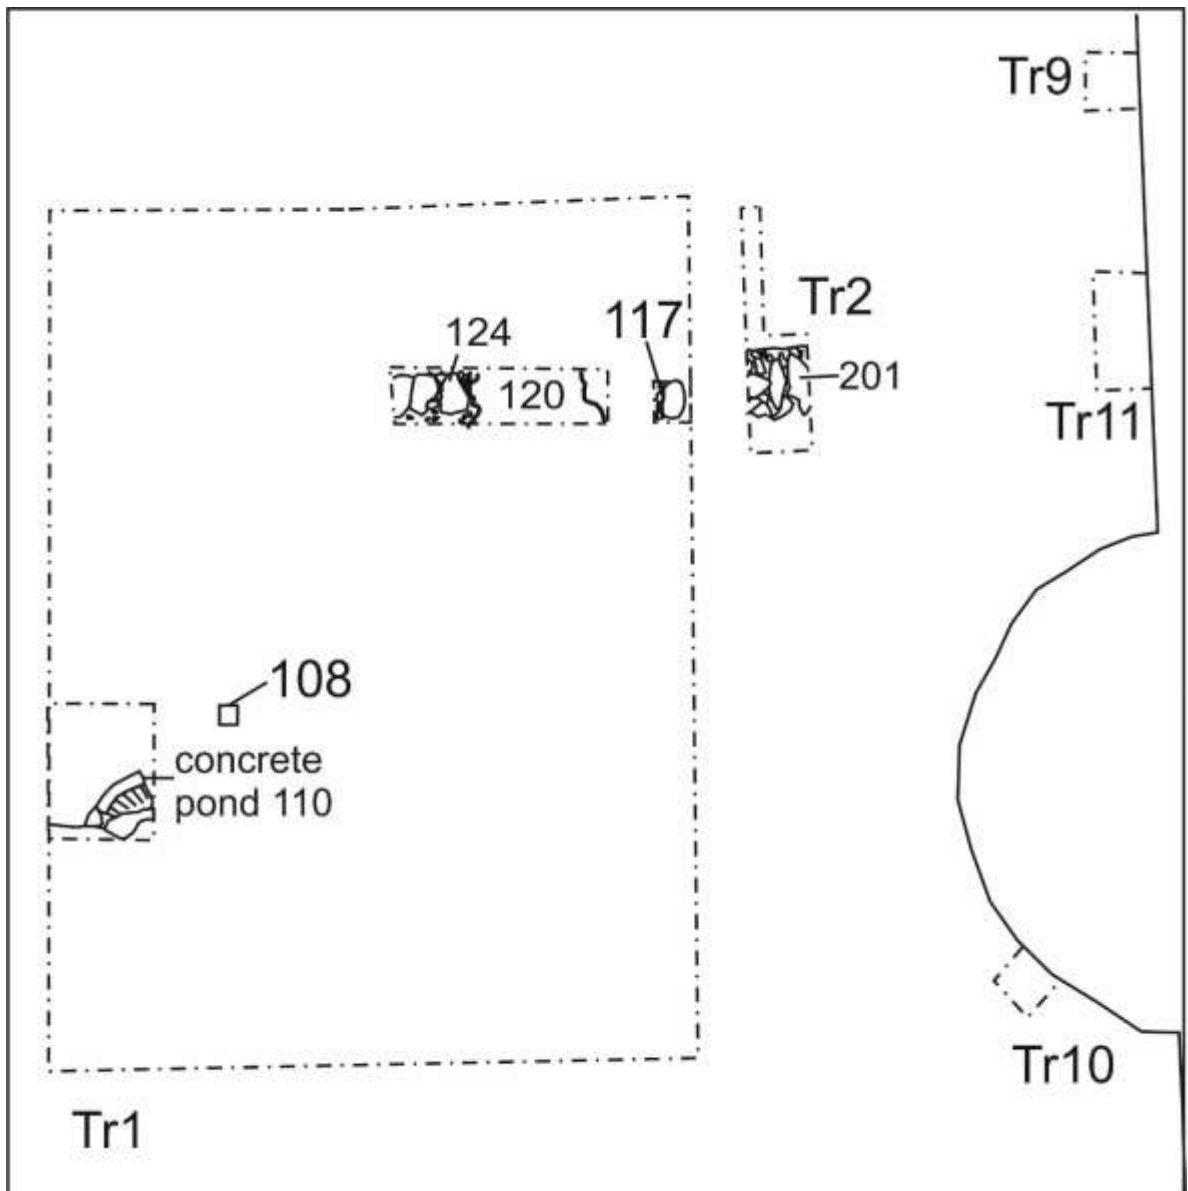
Illus 9 W side of mansion showing trenches and main features

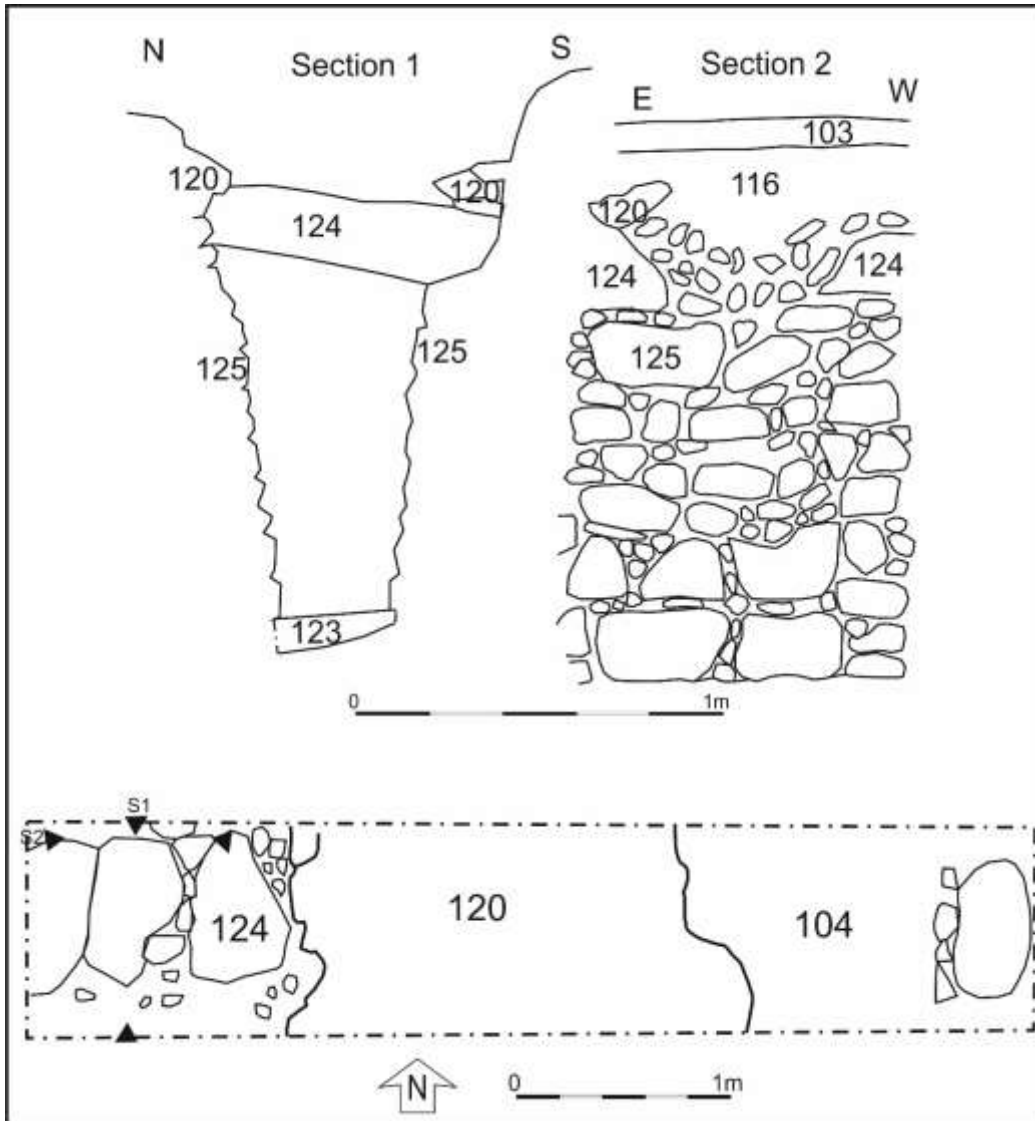
Illus 10 Section and side elevation of drain 122

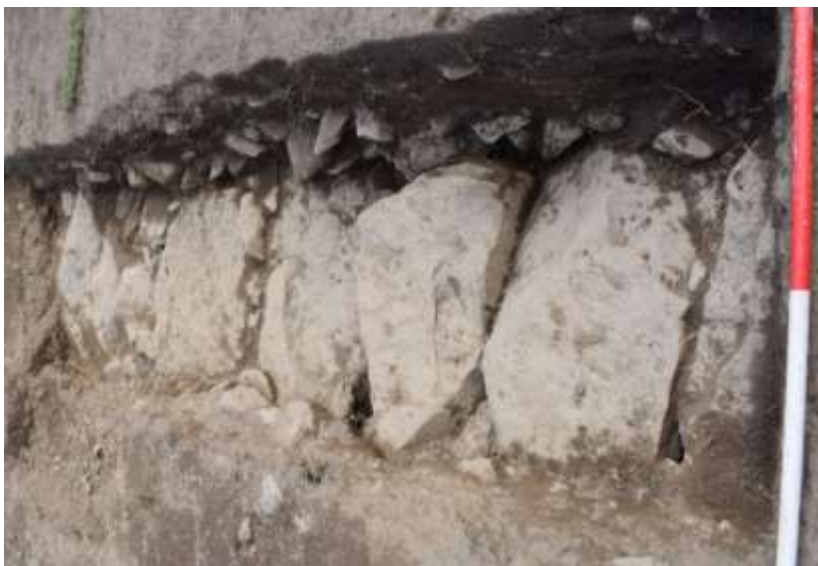
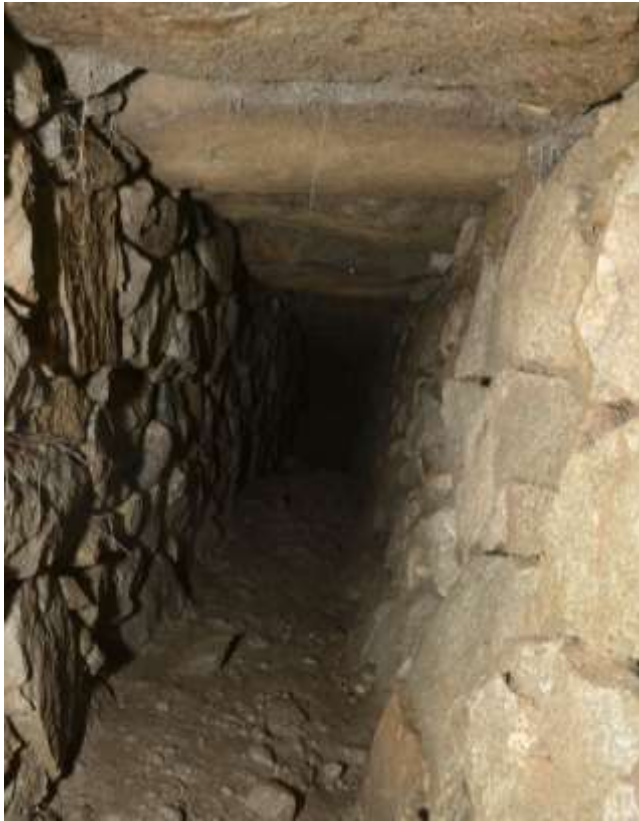
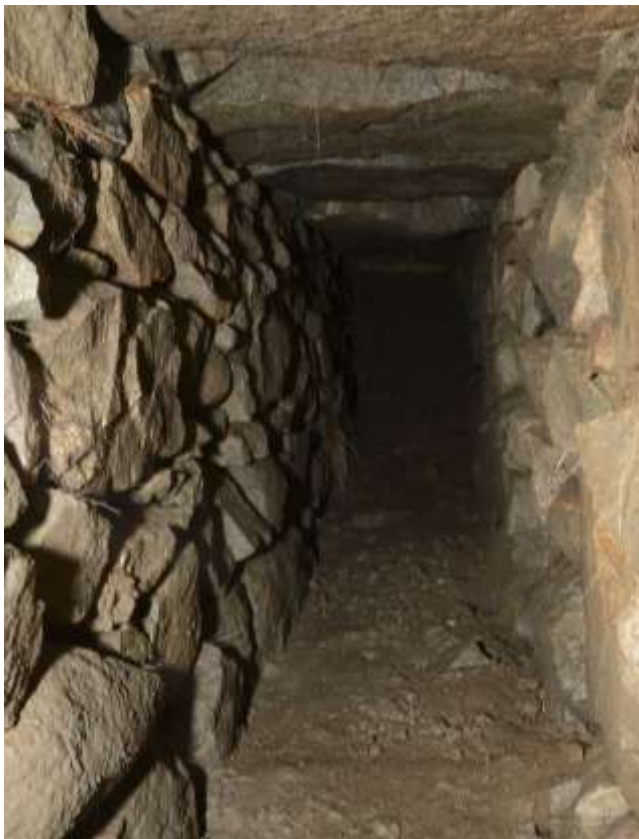
Illus 11 Capping stones drain 122; facing E

Illus 12 Drain 122 facing W (thanks to Jamie Cutts, Aberdeenshire Council)

Illus 13 Drain 122 facing E (thanks to Jamie Cutts, Aberdeenshire Council)

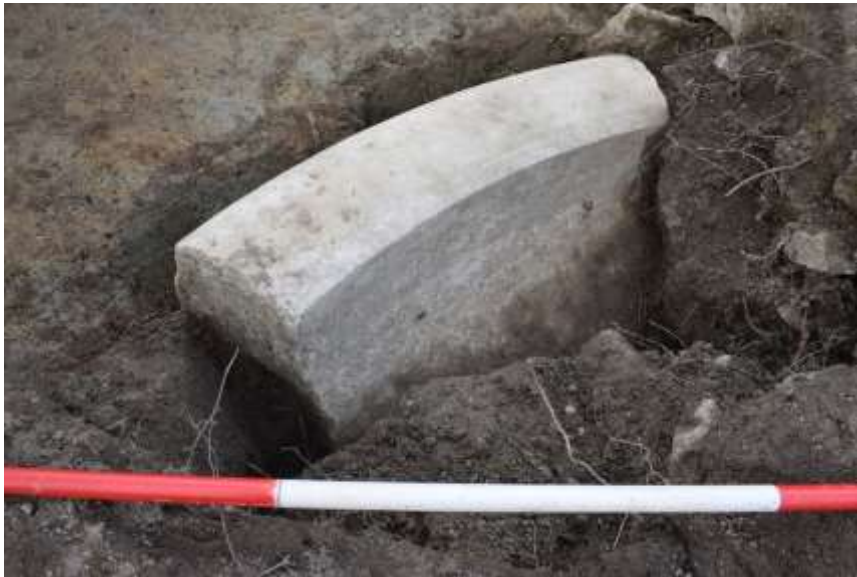
Illus 14 Concrete fountain base 110; facing N

The excavation of the pond/fountain revealed that the concrete base for the fountain was 3m diameter and the original pit for the structure was 4m diameter. A central garden feature is recorded on the First Edition OS map but it likely that this pond was built in the late 19<sup>th</sup>-century and removed in the early 20<sup>th</sup> century prior to a series of photographs. There is no photograph of this pond/fountain although there are postcards showing the N end of the

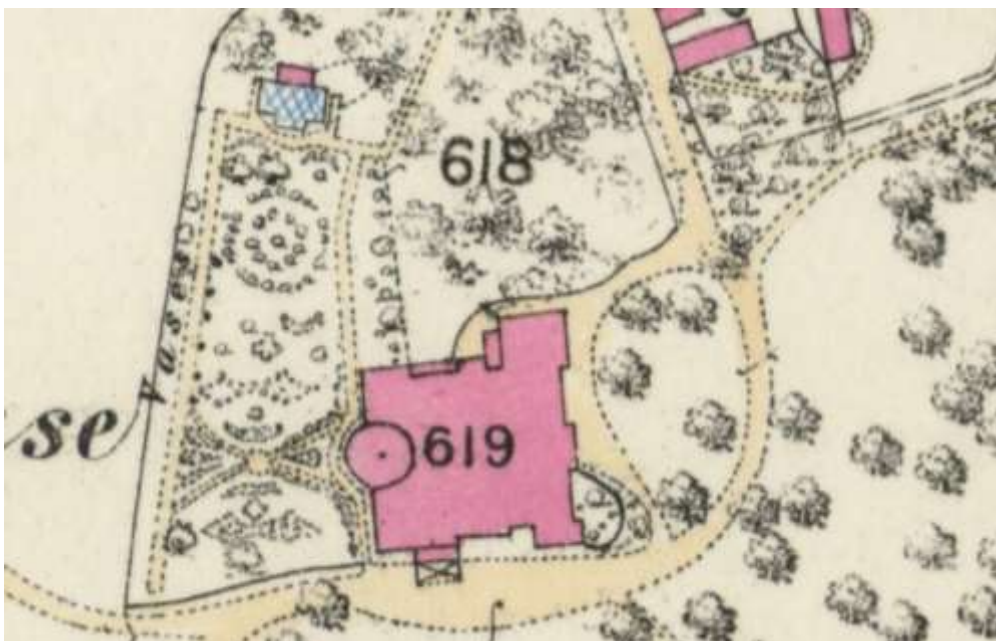
Illus 15 First Edition OS map showing garden layout (copyright National Library of Scotland)

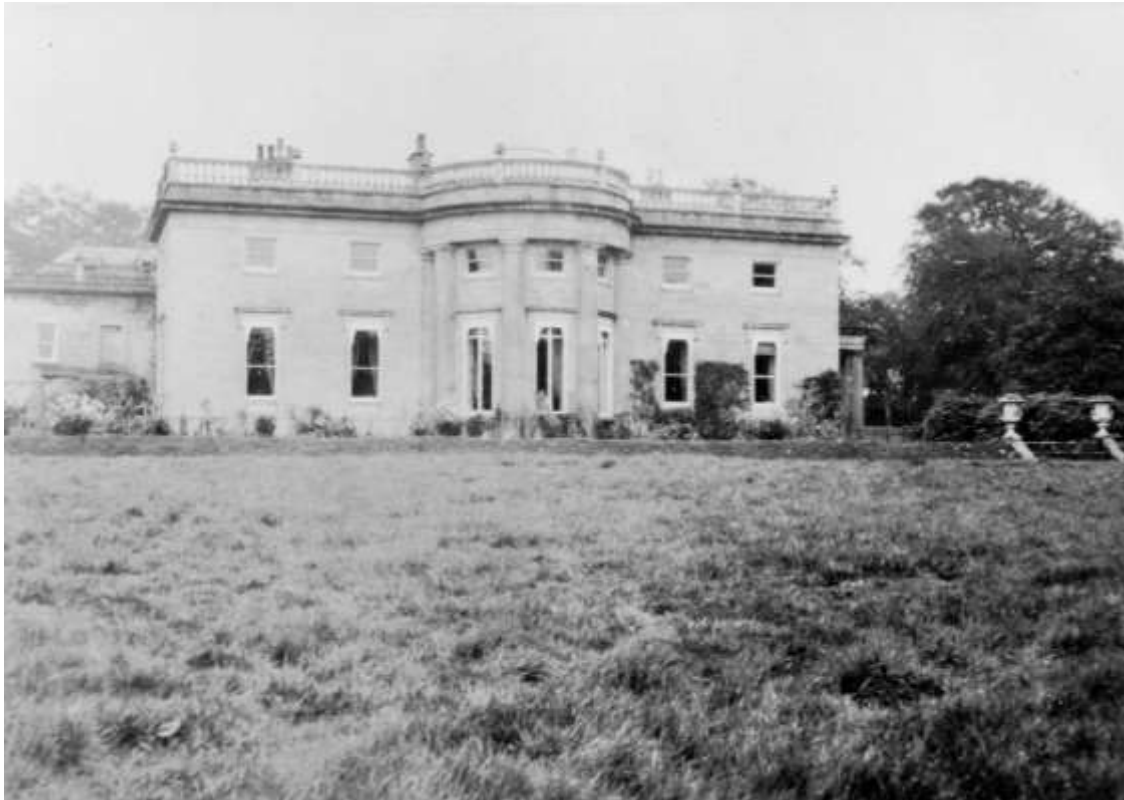
Illus 16 Mid 20<sup>th</sup>-century photo of W façade of Aden House (Courtesy of Aberdeenshire Council)

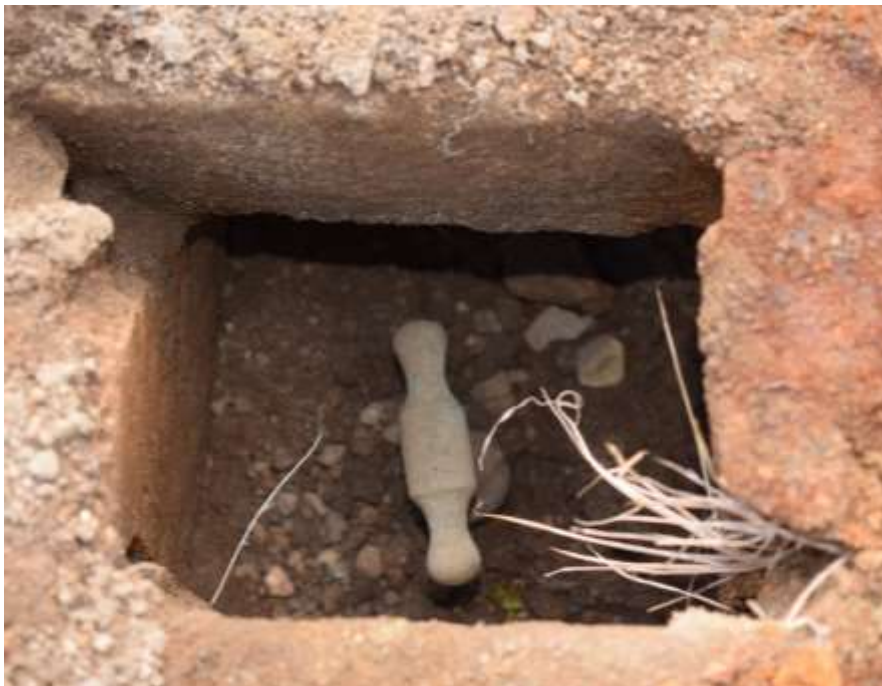
Illus 17 Cast iron hatch 108 with copper tap at base for regulating water to the pond 110; facing E

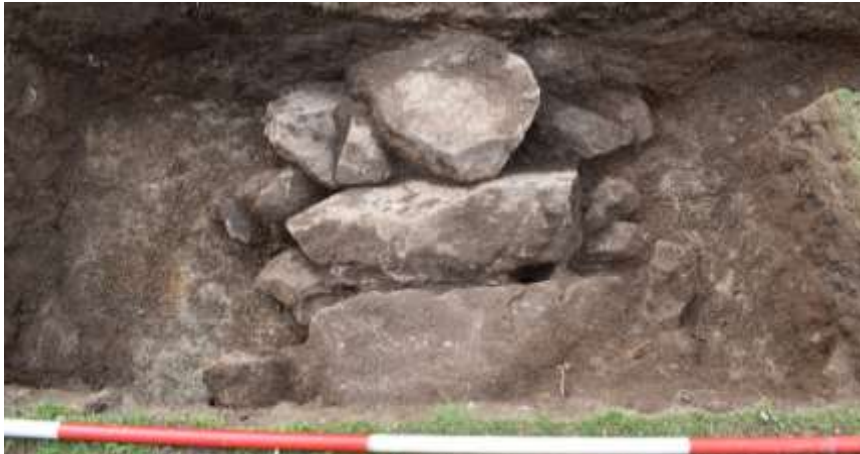
Illus 18 Trench 2 drain capping stones 201; facing W

Trench 2 was excavated between Trench 1 and the mansion house to investigate the drain feature 122. Capping stones 201 (Illus 18) were uncovered but they were not lifted and the trench was backfilled.

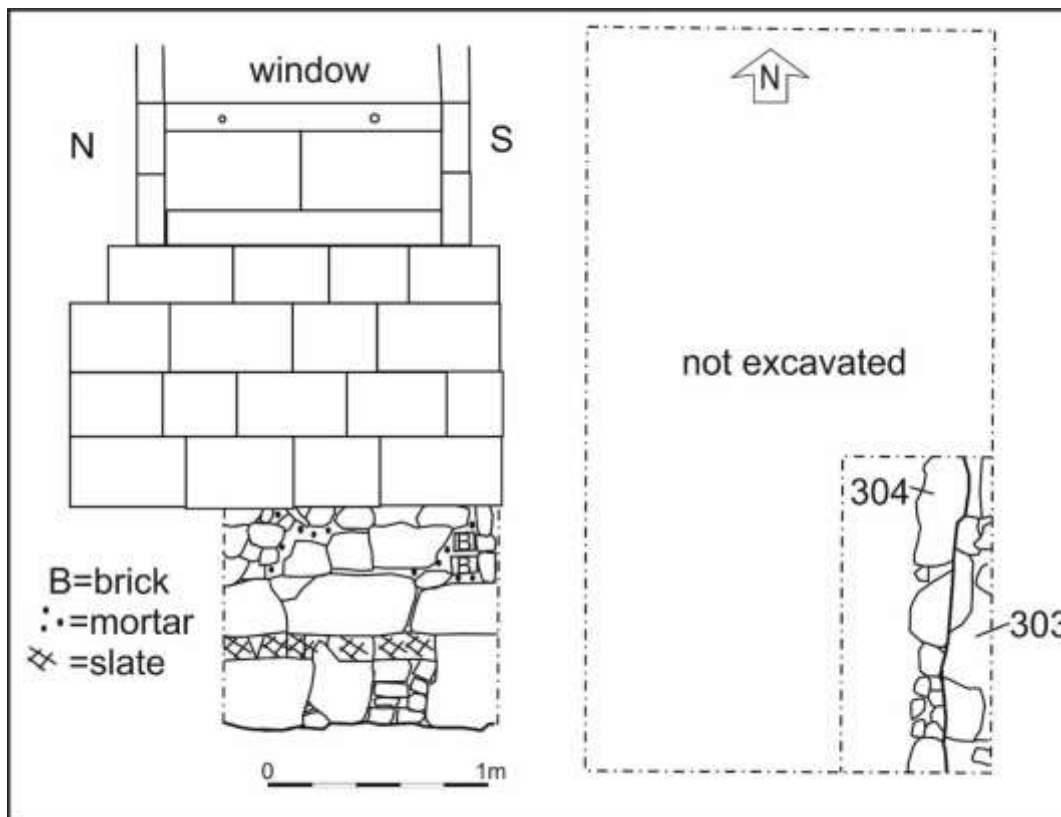
Illus 19 Trench 3 plan and elevation

Trench 3 was excavated on the W side of the house to investigate the foundations and any earlier structures. A mortared stone stepped foundation (304; Illus 19) was uncovered and it is possible that this is from an earlier structure.

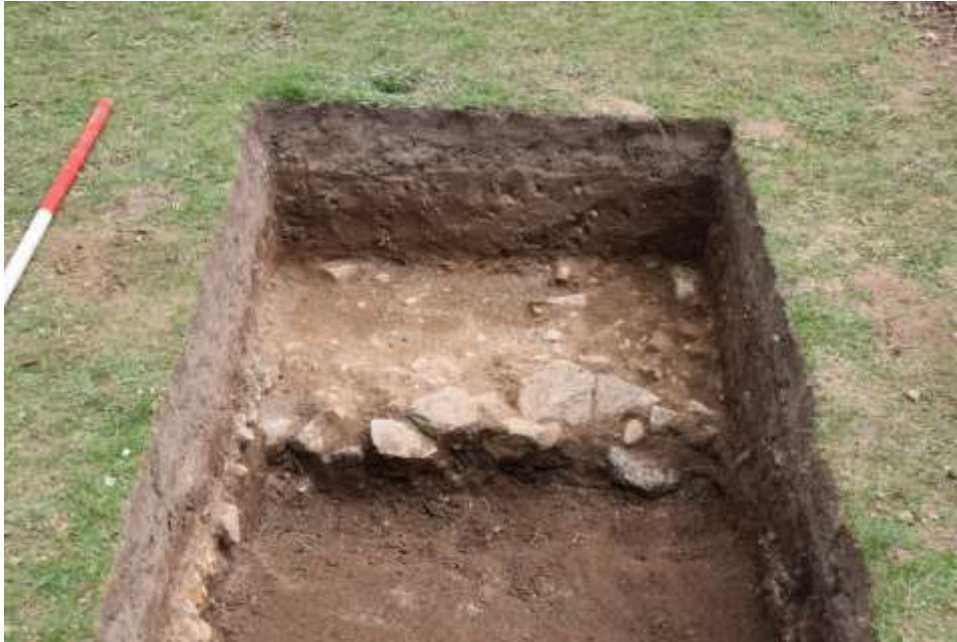
Illus 20 Trench 4 spread of stone and mortar; facing E

Trench 4 was excavated to investigate an anomaly on the geophysical survey (Illus 4, 5). There was a demolition layer of small stones and mortar (401) at the E end of the trench (Illus 20) with garden soil above and below. This may have been laid as a path or surface.

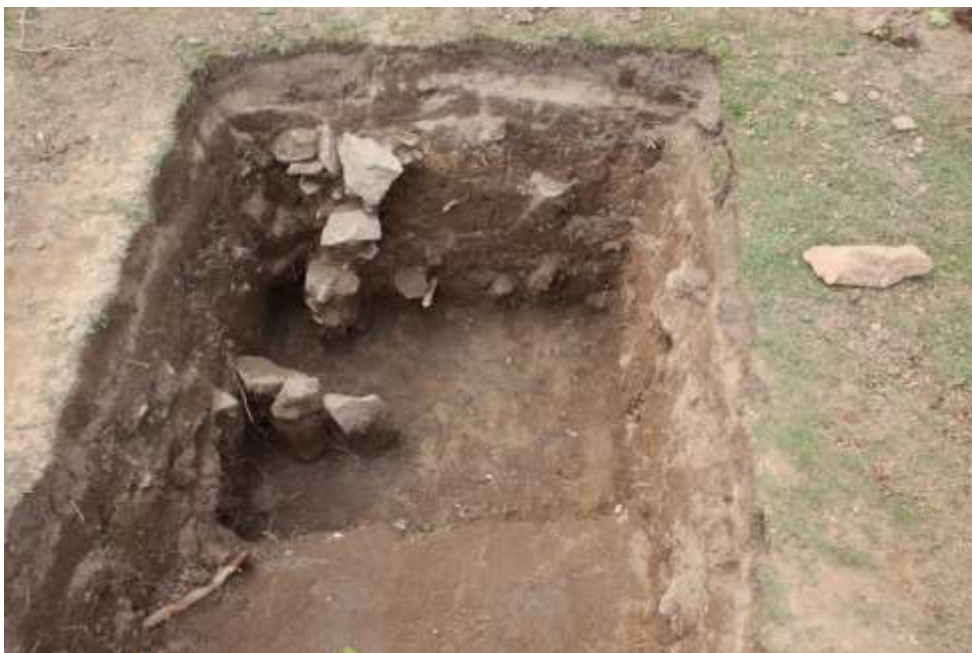
Illus 21 Tr 5 showing garden soil and loose stones; facing W

Trench 5 was excavated to investigate an anomaly on the geophysical survey (Illus 4, 5). Here was 0.5m of garden soil with a dump of stones at the W end (Illus 21) but no other archaeological deposits were recorded.

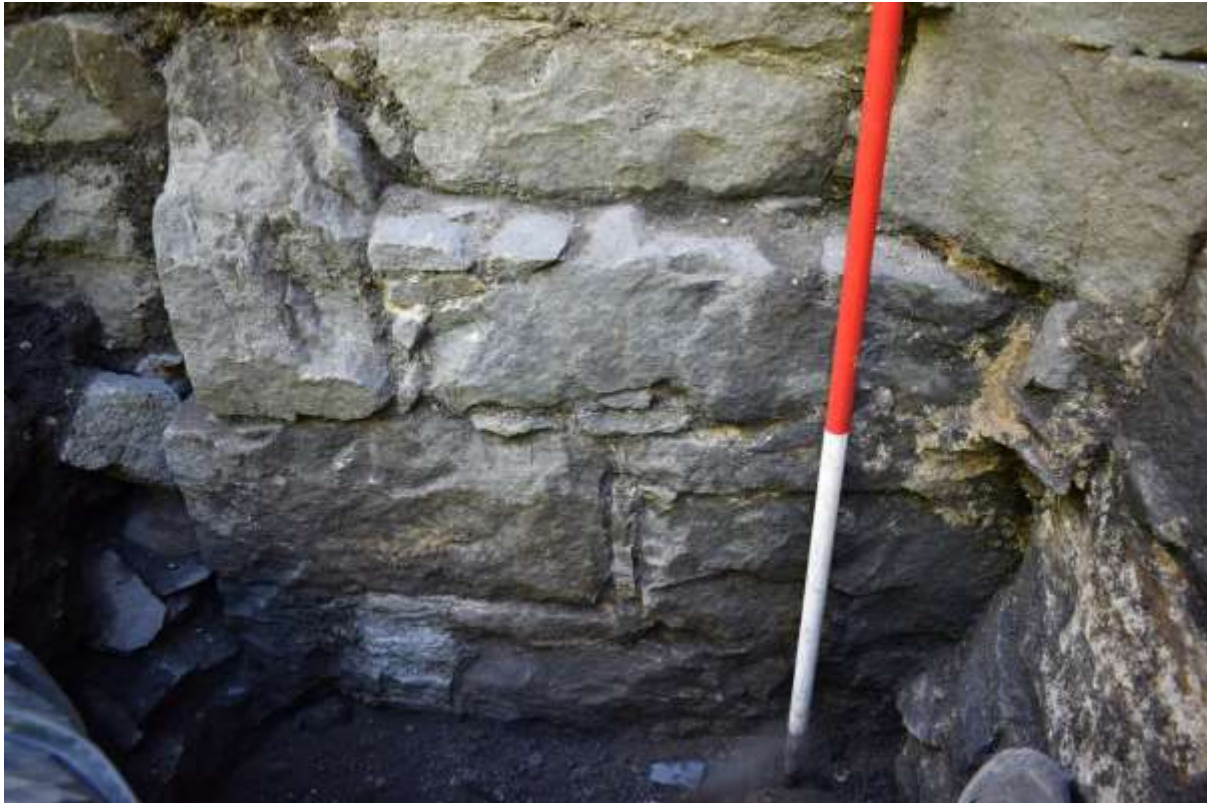
Illus 23 Trench 6 wall 610 (bottom right); not the stone top right is angled at 45 degrees to the current building and features AR/EI incised stone above; facing S

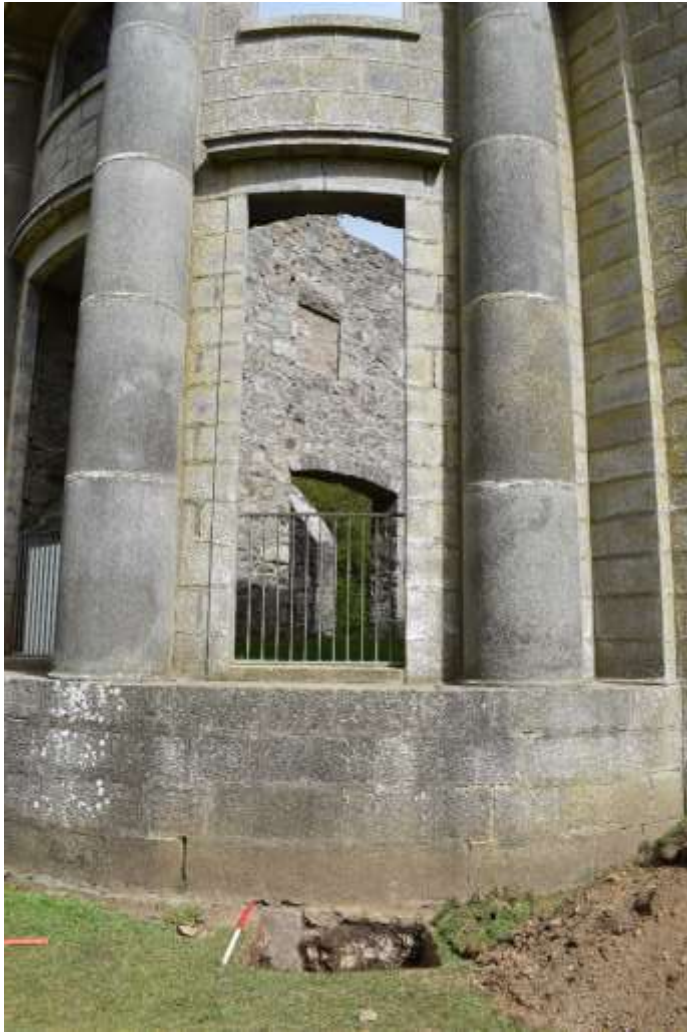
Illus 24 Trench 10 location under ashlar bay window; facing NE

Trench 10 was excavated on the bay windows on the W wall of the mansion house (Illus 24) to investigate the foundations of this structure. The stone foundation was 0.3m deep and built onto the natural bedrock (Illus 25).

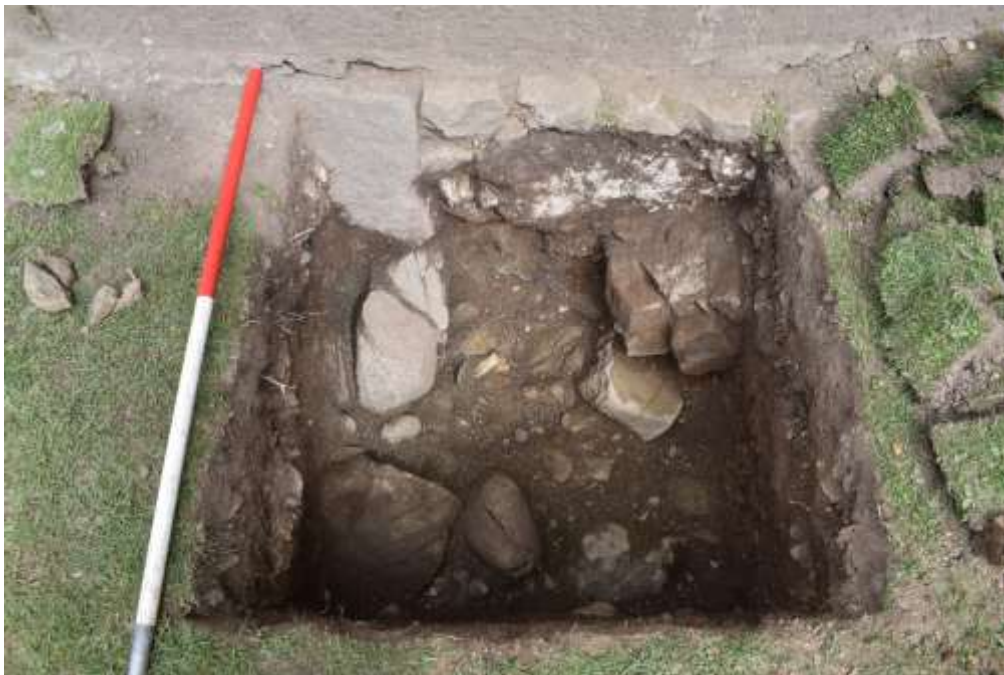
Illus 25 Trench 10 foundation of bay window (top); facing NE

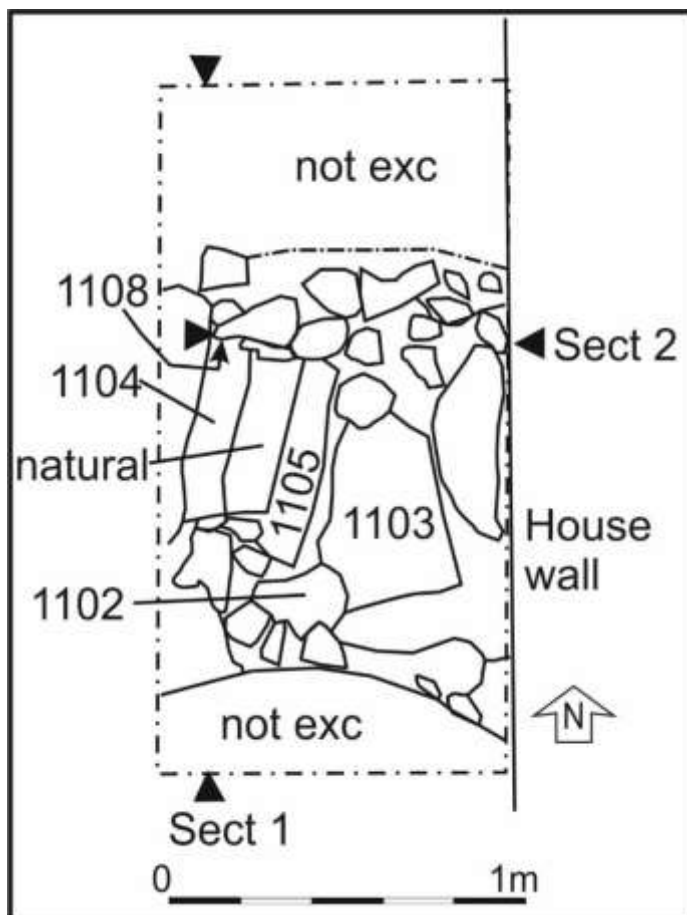
Illus 26 Trench 11 plan

Trench 11 was excavated next to the W wall of the mansion house to investigate the drain feature 122 and the foundations of the house. Two drains were recorded in this trench. One (1106 runs W-E and joins with the drain in Trenches 1 and 2 (Illus 26, 28). It is stone-lined and 0.5m wide and 1.25m high although to the W of this trench the roof lowers to 0.95m deep. This may be the original height of the drain and the deeper section was rebuilt when a drain was joined in from the N. This is drain 1109 which is 0.45m wide and at least 0.6m deep; the capping stones of this drain were recorded in trenches 9, 11 and 18. All drains are stone lined with large granite capping stones. There was little access to the interior of the structure and drain rods with camera which were inserted into all structures was partially successful but no photographic recording of this was captured (as it was thought to be being recorded on an SD card but there was nothing on the card).

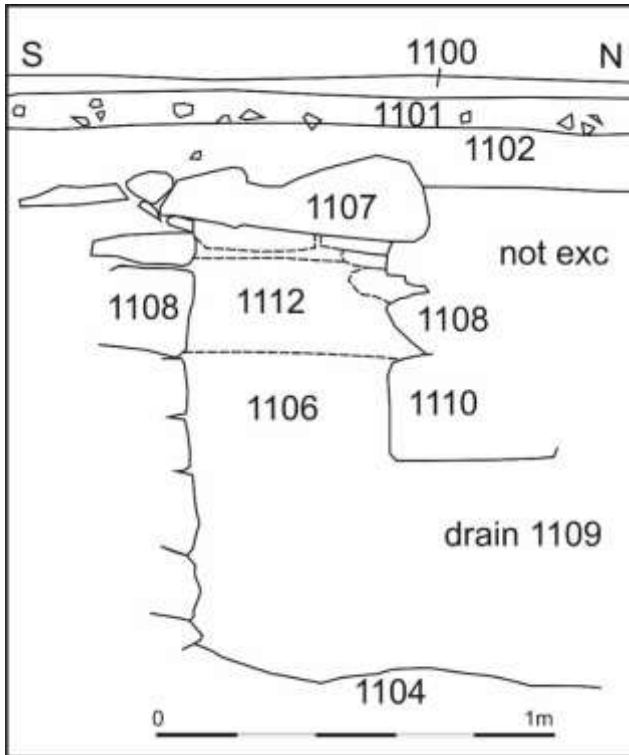
Illus 27 Trench 11 Section 1

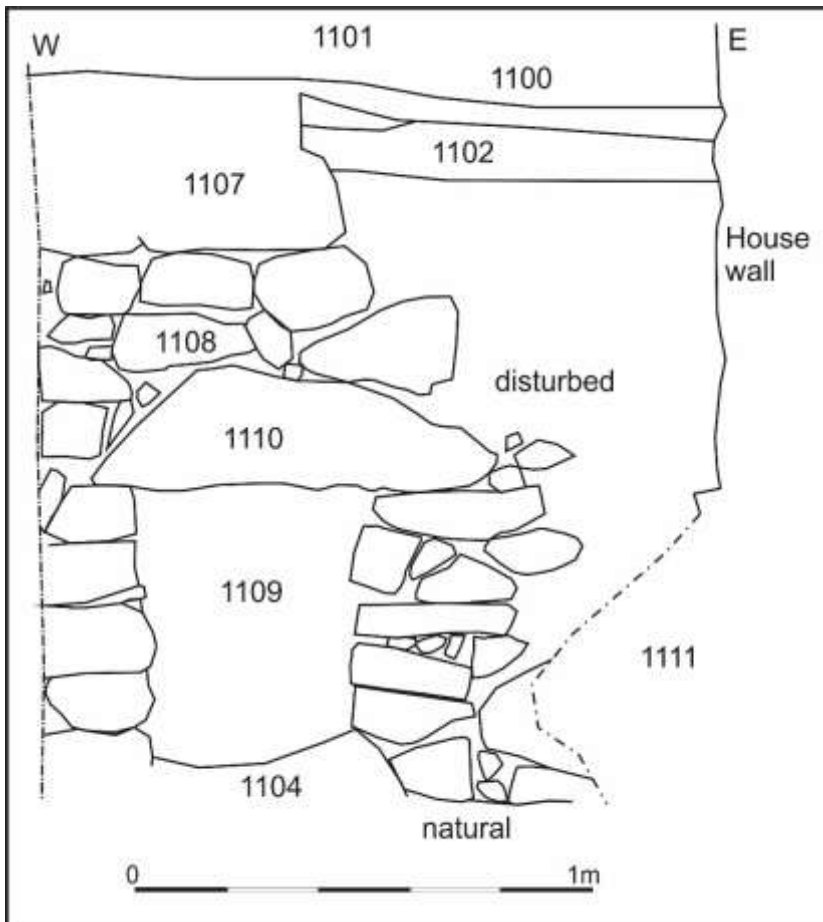
Illus 28 Trench 11 Section 2

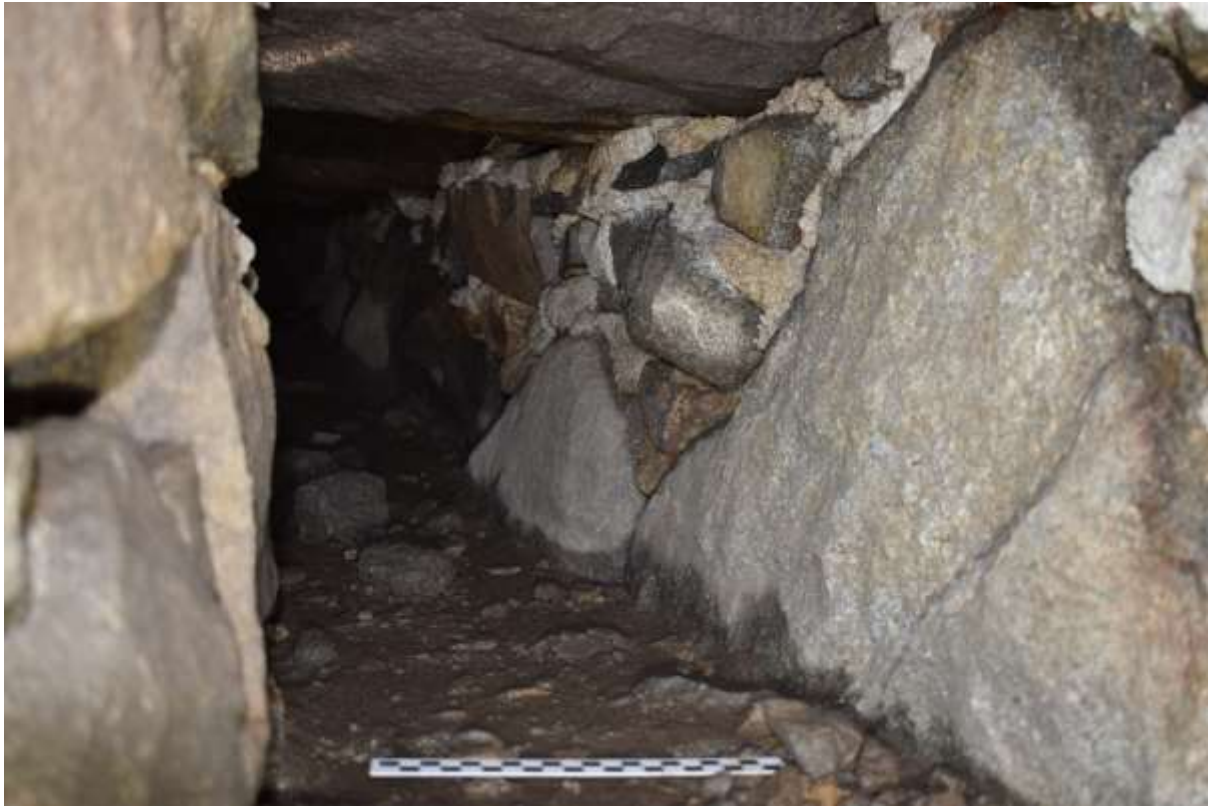
Illus 29 Trench 11 drain 1109 E wall mortared into Mansion W wall foundation

The N drain 1109 comes from the N and possibly around the NW corner of the house. It may be for taking excess water from the mid 18<sup>th</sup>-century laundry or from the laundry attached to Aden House. The W-E drain 1106 was blocked by the W foundation of the house (Illus 30) and is therefore associated with this structure or earlier than the house. Excavation within the house may reveal further evidence of the drain as it is too deep to appear on the ground radar survey.
