# ADEN COUNTRY PARK, ABERDEENSHIRE, AB42 5FQ

## Data structure report (29 April-12 May 2019 excavation)

**Alison Cameron  
Cameron Archaeology  
13 June 2019**

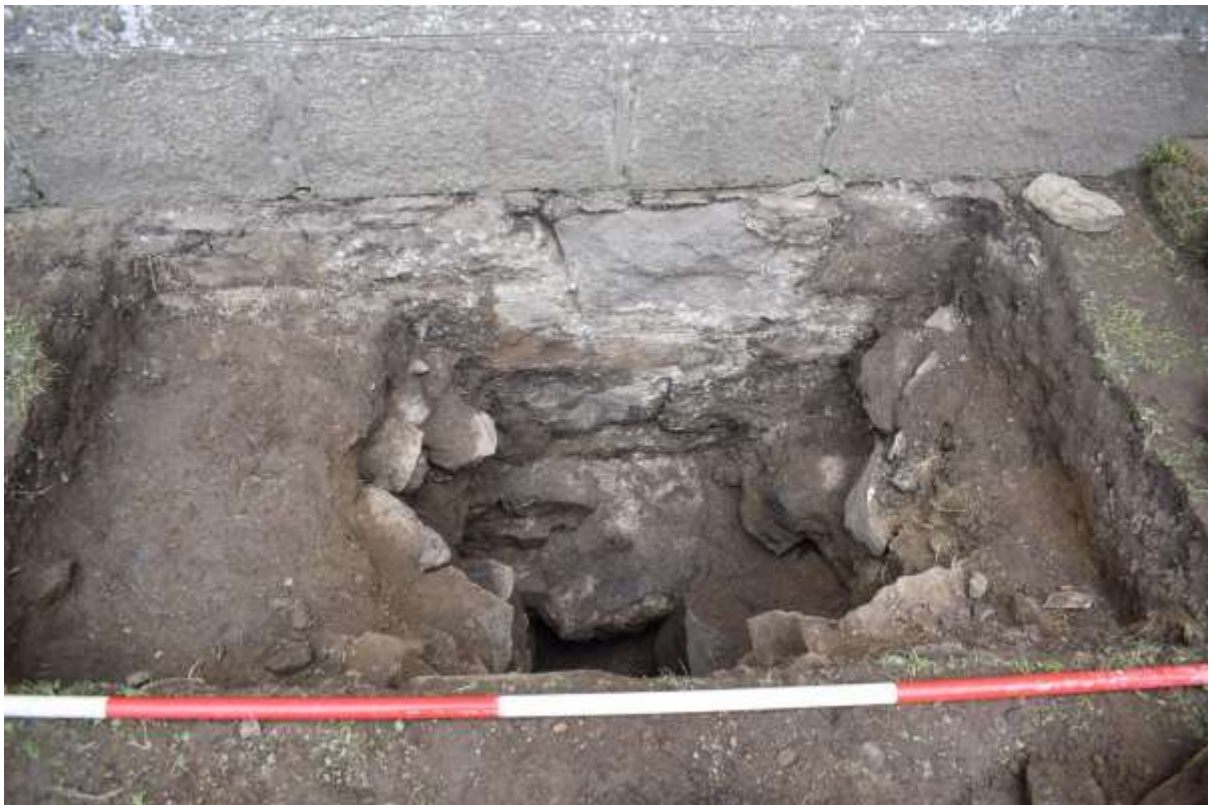
Illus 30 Trench 11 relationship of Mansion wall and foundation to drain 1106; facing E

Trench 11 was excavated next to the W wall of the mansion house to investigate the drain feature 122 and the foundations of the house. Two drains were recorded in this trench. One (1106 runs W-E and joins with the drain in Trenches 1 and 2 (Illus 26, 28). It is stone-lined and 0.5m wide and 1.25m high although to the W of this trench the roof lowers to 0.95m deep. This may be the original height of the drain and the deeper section was rebuilt when a drain was joined in from the N. This is drain 1109 which is 0.45m wide and at least 0.6m deep; the capping stones of this drain were recorded in trenches 9, 11 and 18. All drains are stone lined with large granite capping stones. There was little access to the interior of the structure and drain rods with camera which were inserted into all structures was partially successful but no photographic recording of this was captured (as it was thought to be being recorded on an SD card but there was nothing on the card).

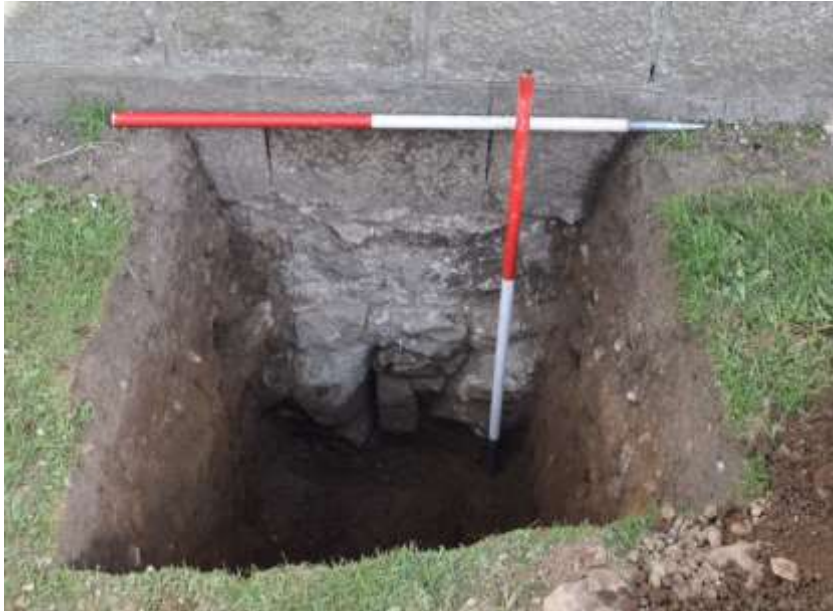
Illus 31 Trench 12 showing foundation of Mansion 0.6m deep; facing E

Trench 12 was excavated on the S side of the house to investigate the foundations and any earlier structures. There was a layer of iron, pottery, glass and other rubble under the turf and above the sand natural subsoil. The foundations were 0.6m deep (Illus 31) and there was no suggestion of an earlier structure in this trench.

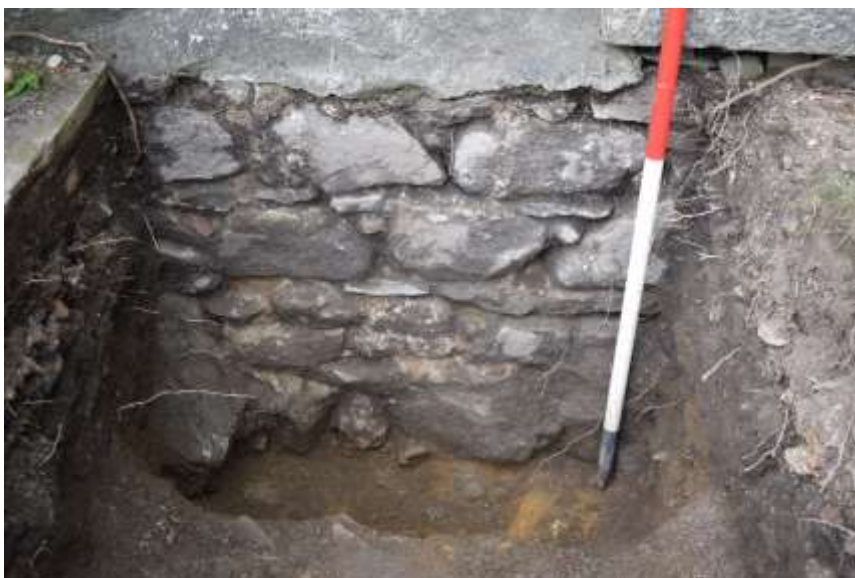
Illus 32 Trench 13 0.6m deep wall foundation under mid 18<sup>th</sup>-century Mansion wall; facing W

Trench 20 was excavated on the E side of the house to investigate the foundations and any earlier structures. The foundation was 0.6m deep (Illus 32) but there was no evidence of an earlier structure.

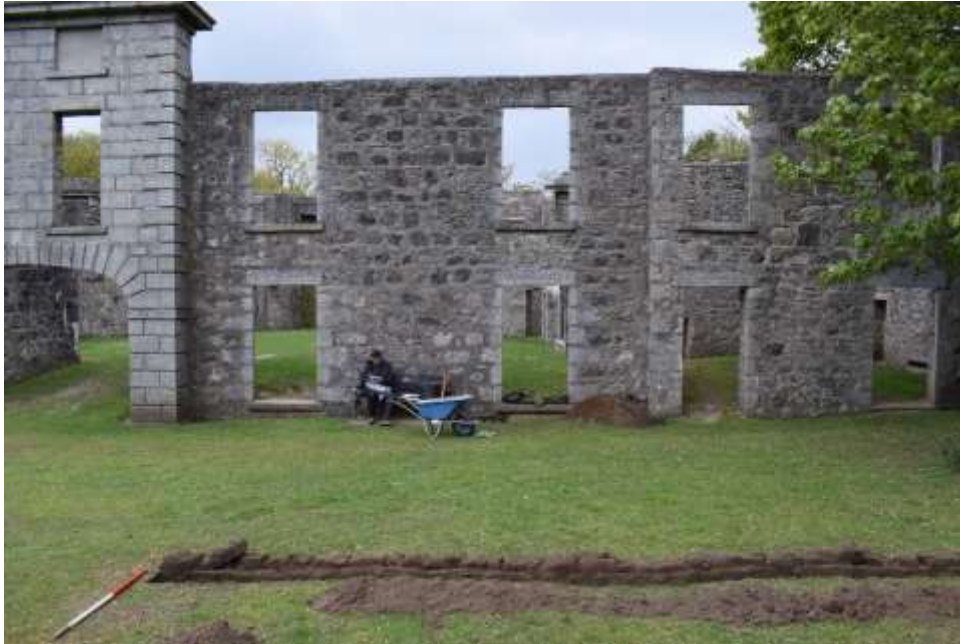
Illus 33 Trench 14 with Mansion E wall in background; facing W

Trench 14 (Illus 33) was excavated on the E side of the house in an area of possible archaeological deposits. The turf was underlain with 5sm of soil on top of natural clayey sand and the trench was recorded and backfilled.

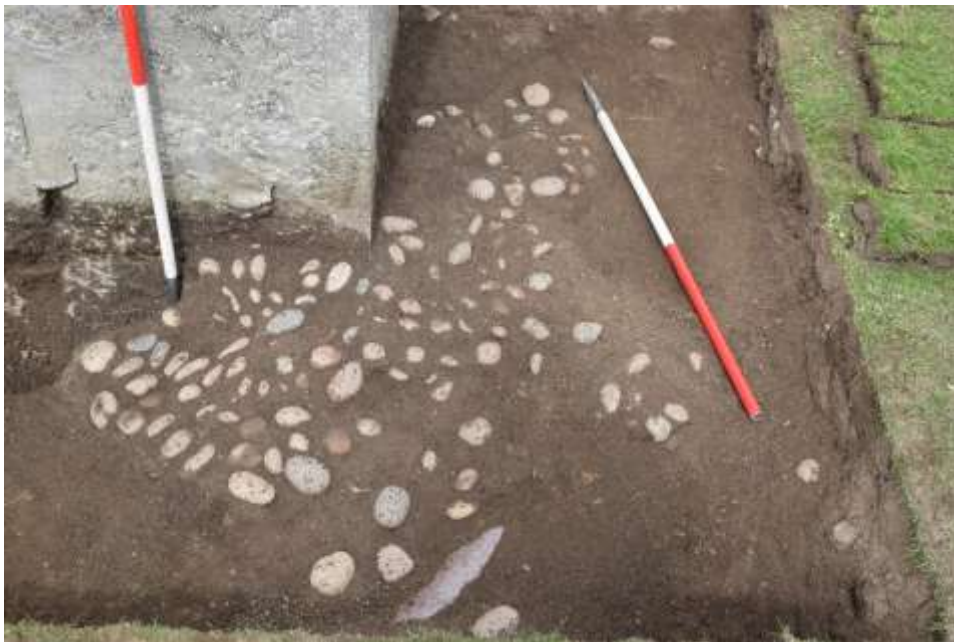
Illus 34 Pebble surface 1502; facing N

Trench 20 was excavated at the SE corner of the house to investigate the foundations and any earlier structures. The foundation of the Mansion is only one stone (0.3m) deep and there is no evidence of earlier structures. There were loam garden soil layers under the turf and a waterwashed pebble surface (1502; Illus 34). These were stratigraphically late in date (mid 20<sup>th</sup> century) and may have been laid around planting beds as a decorative feature.

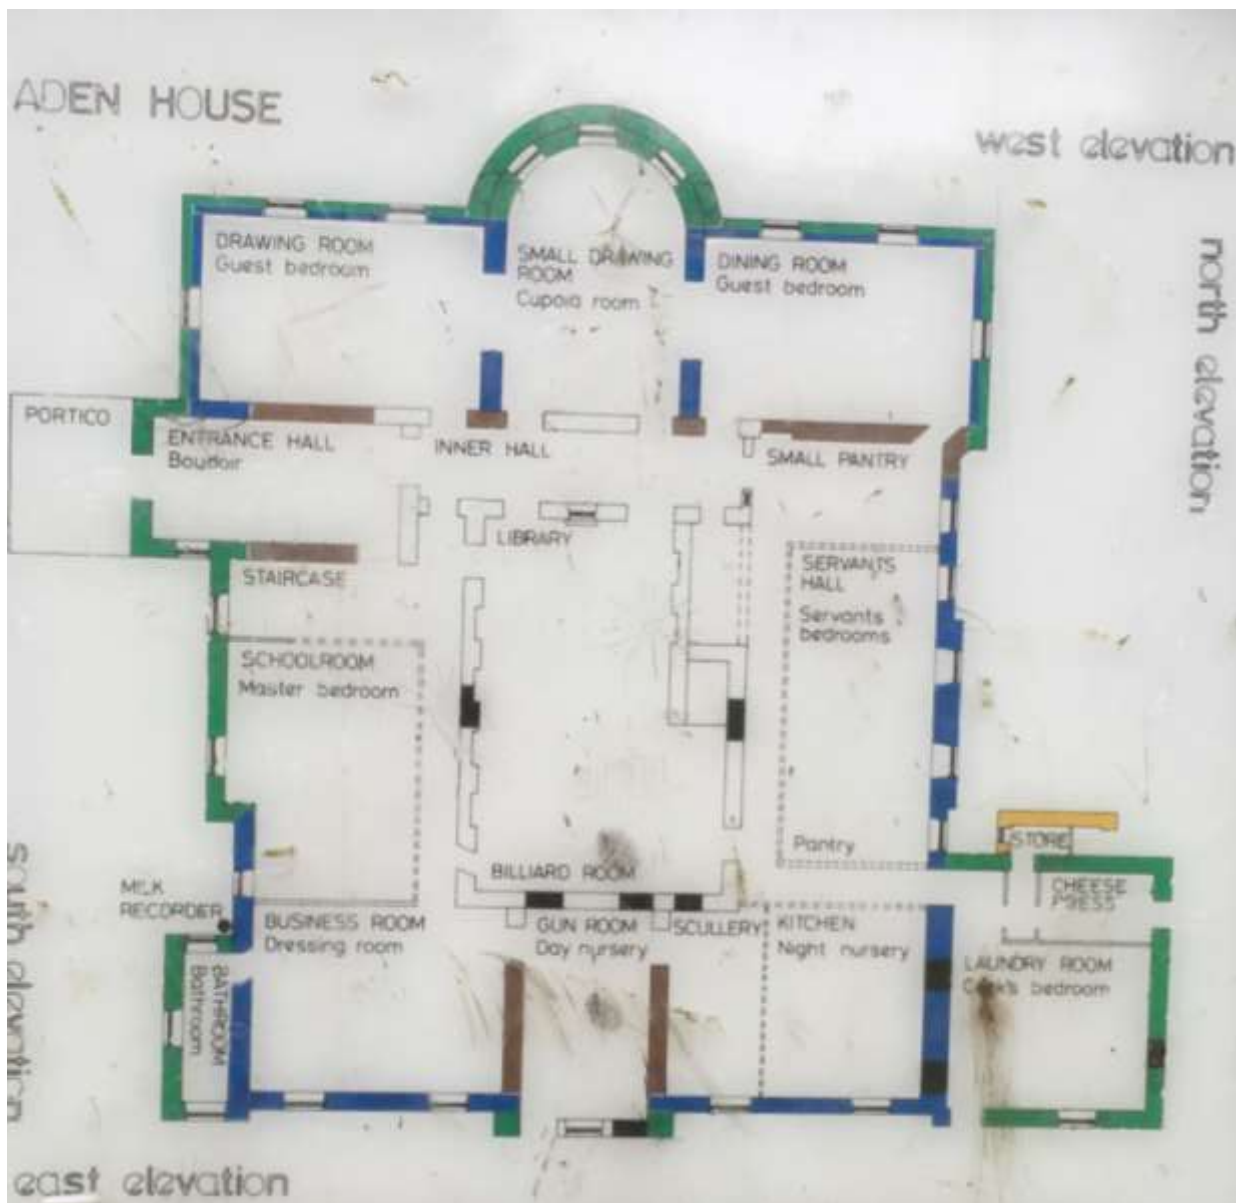
Illus 35 Plan on board within Aden House showing room names

Trench 17 was excavated in the cart door entrance to The Gun Room (Illus 35). Under a concrete floor (1702) was a stone floor (1706, possibly from the mid 18<sup>th</sup>-century house). The cart door had been blocked with wall 1703 and edged with bricks 1705 (Illus 36-37). This blockage can be seen on the mid 20<sup>th</sup>-century photograph (Illus 38). This is an area for further study as this cart door led into a central courtyard in the mid 18<sup>th</sup>-century house.

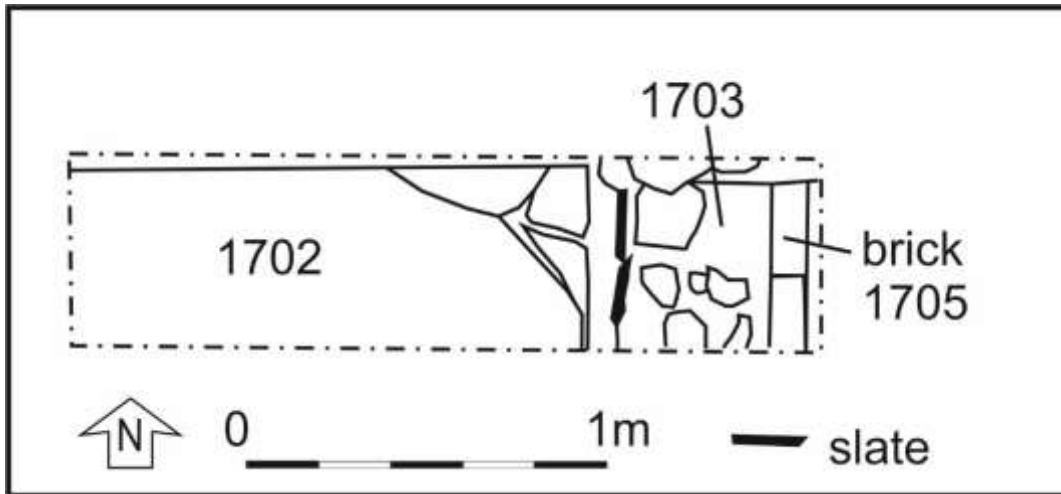
Illus 36 Trench 17 features

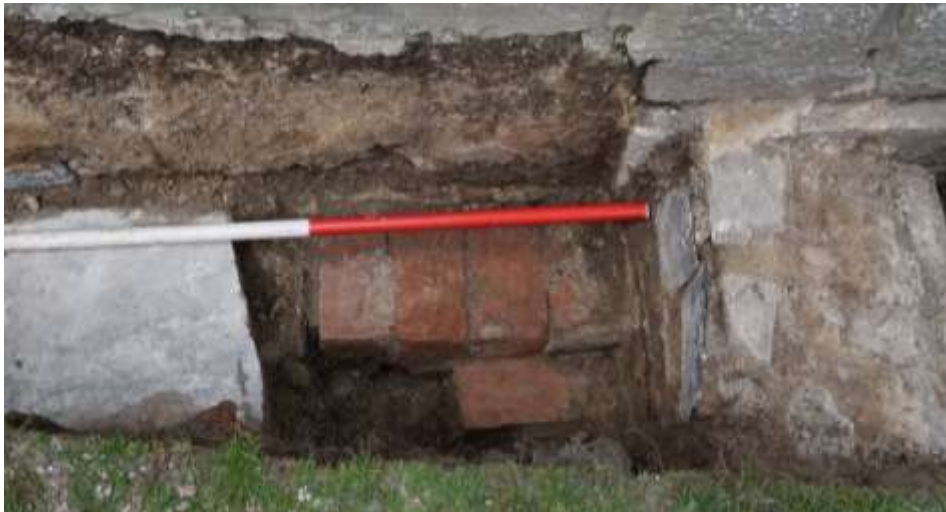
Illus 37 Trench 17 concrete floor 1702 (left) bricks underneath and stone wall foundation 1703 (right); facing N

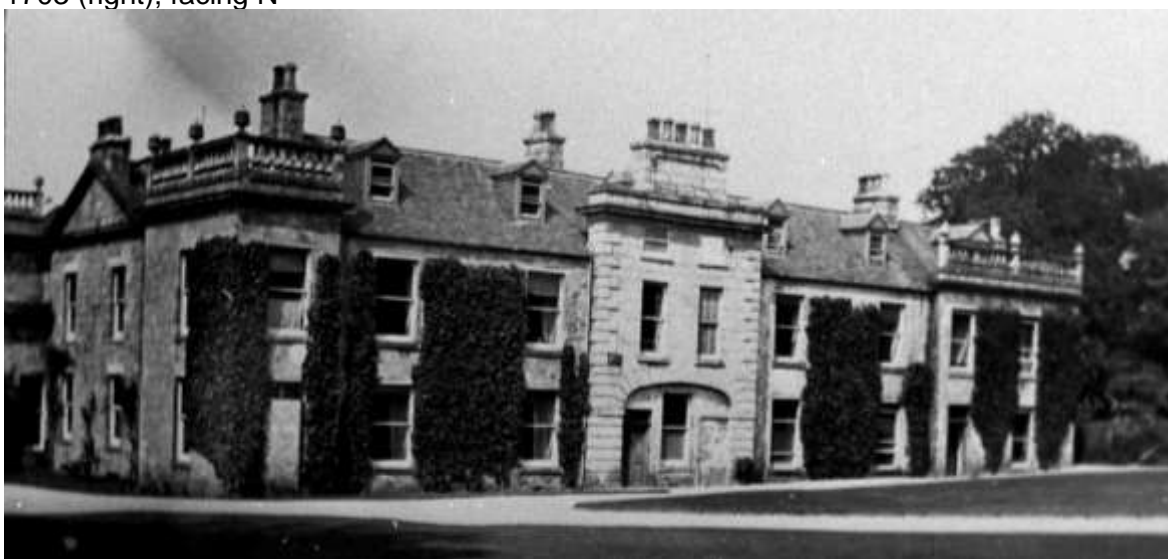
Illus 38 Cart door (centre) showing infilling with stone and brick wall (1703); facing NE (copyright Aberdeenshire Council)

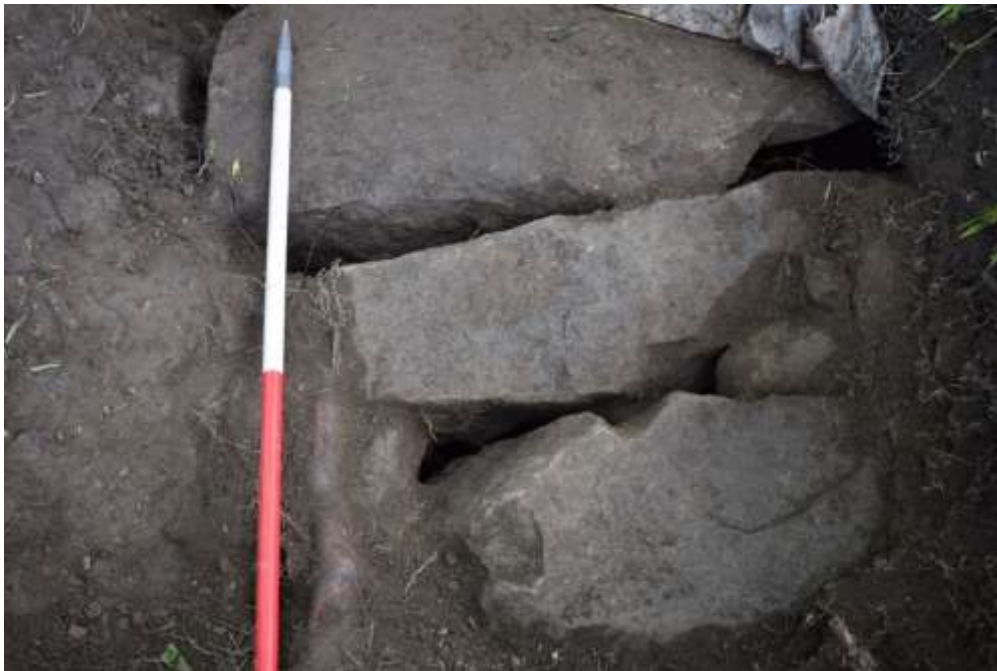
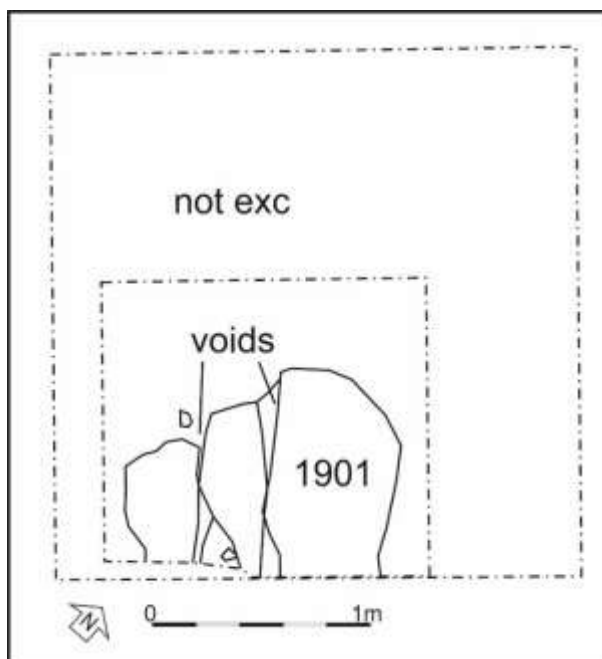
Illus 39 Stone drain capping 1901; facing NE

Illus 40 Drain capping 1901

Trench 19 was excavated at NJ97885 47790 at the location near the river that Jack Grant (park manager) dug and found a stone drain.

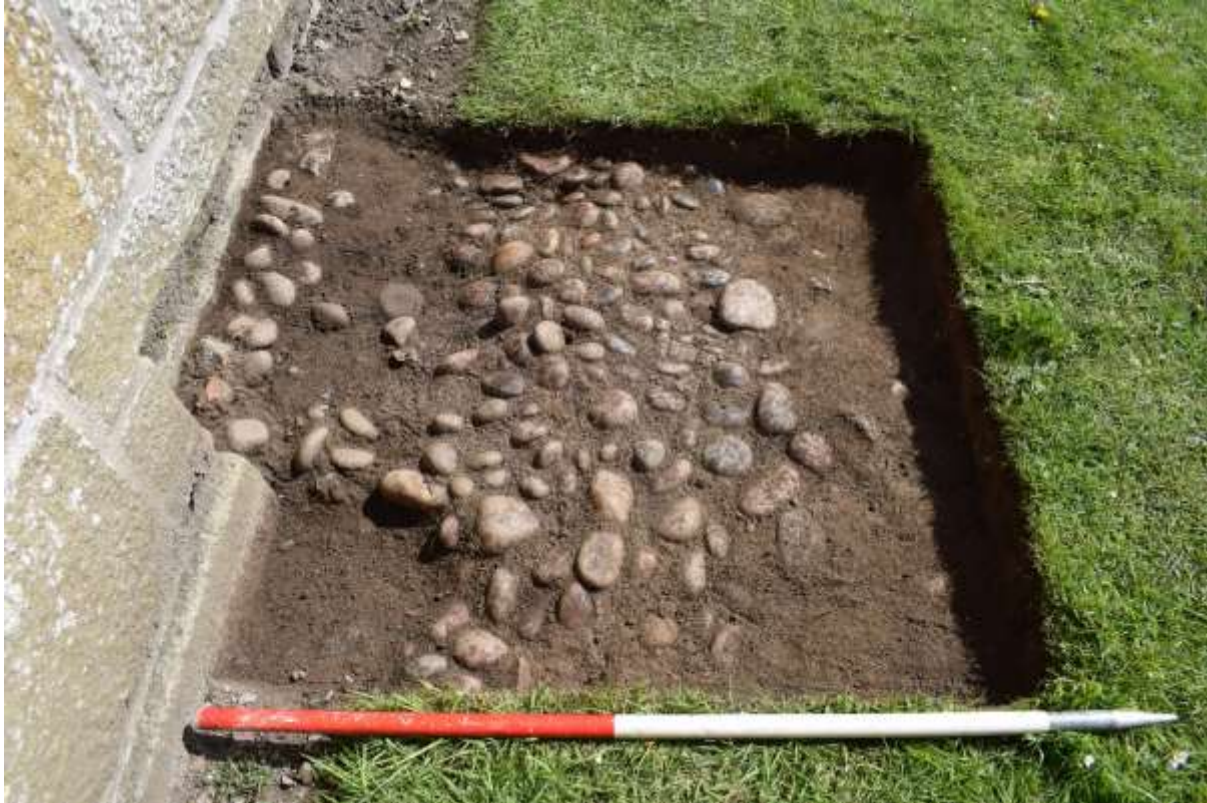
Illus 41 Trench 20 pebble surface 2002; facing E

Trench 20 was excavated on the S side of the house to investigate the foundations and any earlier structures. A shallow 0.3m foundation was recorded and a waterwashed pebble surface (Illus 41) like that seen in Trench 15. These were stratigraphically late in date (mid 20<sup>th</sup> century) and may have been laid around planting beds as a decorative feature.

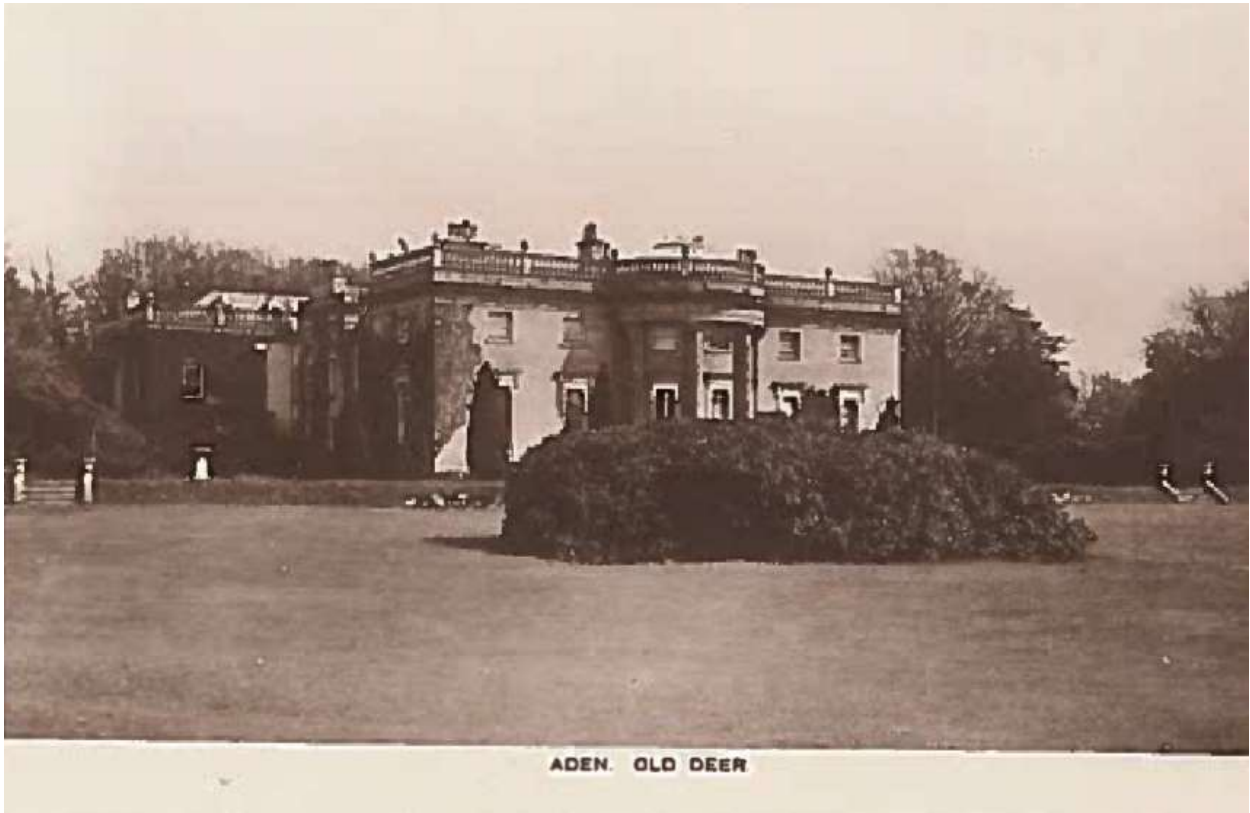
Illus 42 Postcard kindly copied by owner David Elrick showing two sets of steps from the W garden, no fountain but a smaller bird bath/planter NW of the house outwith the excavation area.

garden. These show that the Ha-ha wall (Illus 8) which is still *in situ* did have two sets of steps to access the lower gardens. These can be seen on photographs (for example Illus 43).

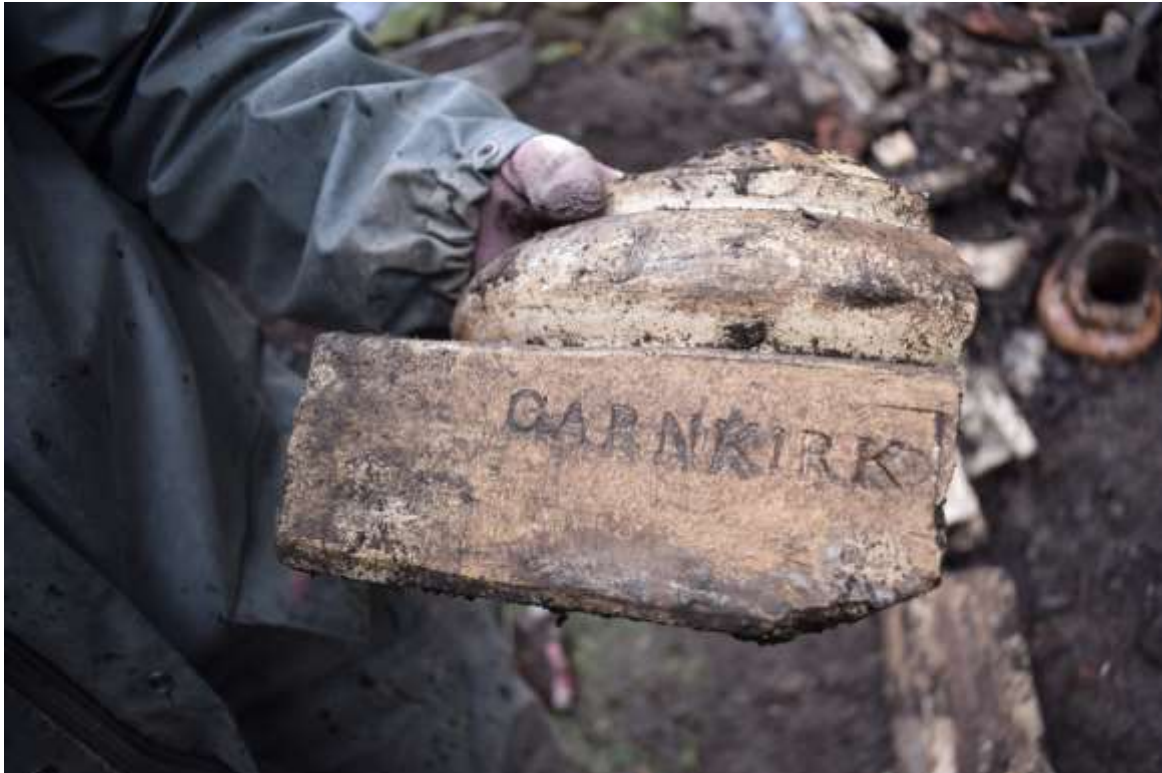
Illus 43 Garnkirk stamped fireclay roof furniture from Trench 8

Finds include 18<sup>th</sup> and 19<sup>th</sup>-century domestic waste including pottery and glass, building material including window glass, brick, ceramic roof furniture (Illus 43, 44) and garden furniture including ceramic garden planters (Illus 45) and plant pots, and concrete pond fragments.

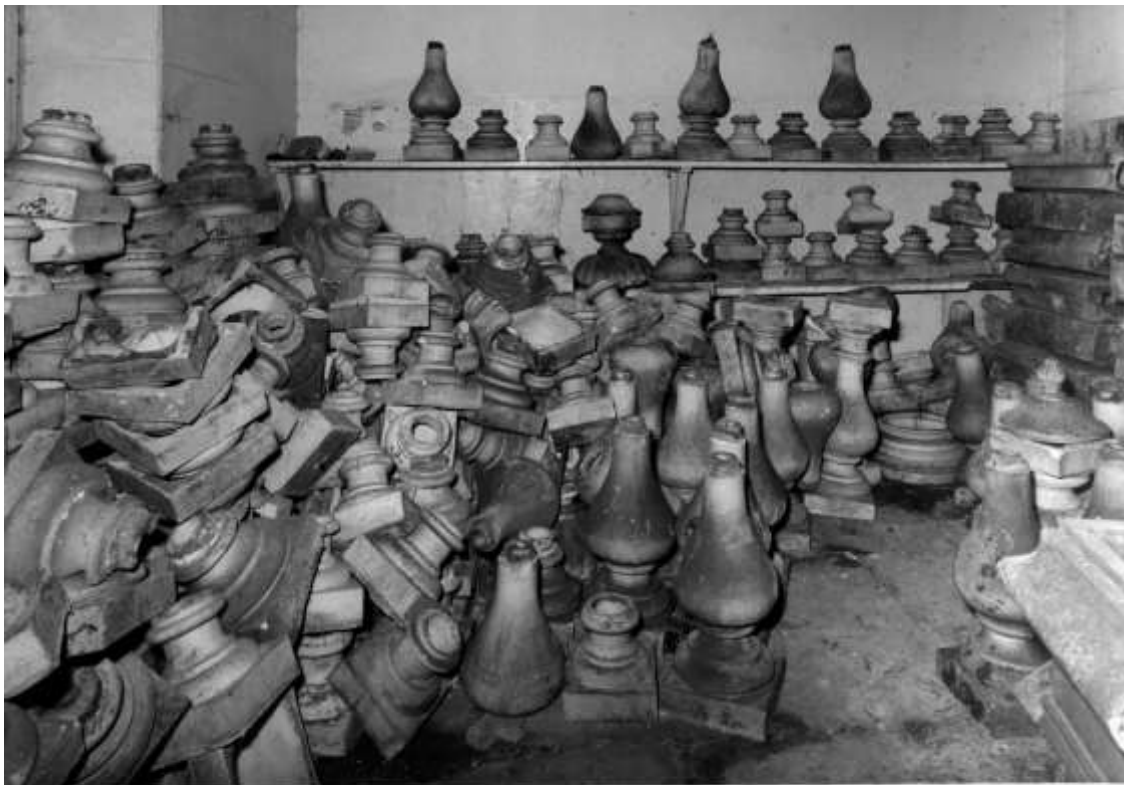
Illus 44 Fireclay pieces from the roof of Aden House photographed in mid 1970s when Aberdeenshire Council carried out a survey of the buildings; they then disappeared.

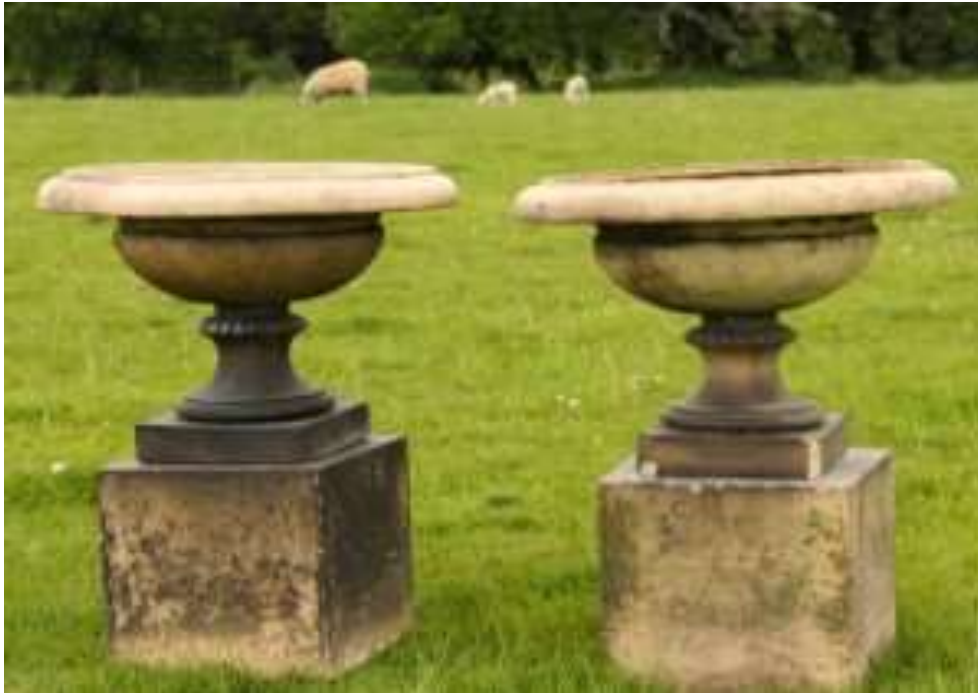
Illus 45 Garnkirk pedestal planters (years of activity 1831-1898)  
<https://www.scottishbrickhistory.co.uk/garnkirk-fireclay-works-garnkirk-north-lanarkshire-history/>

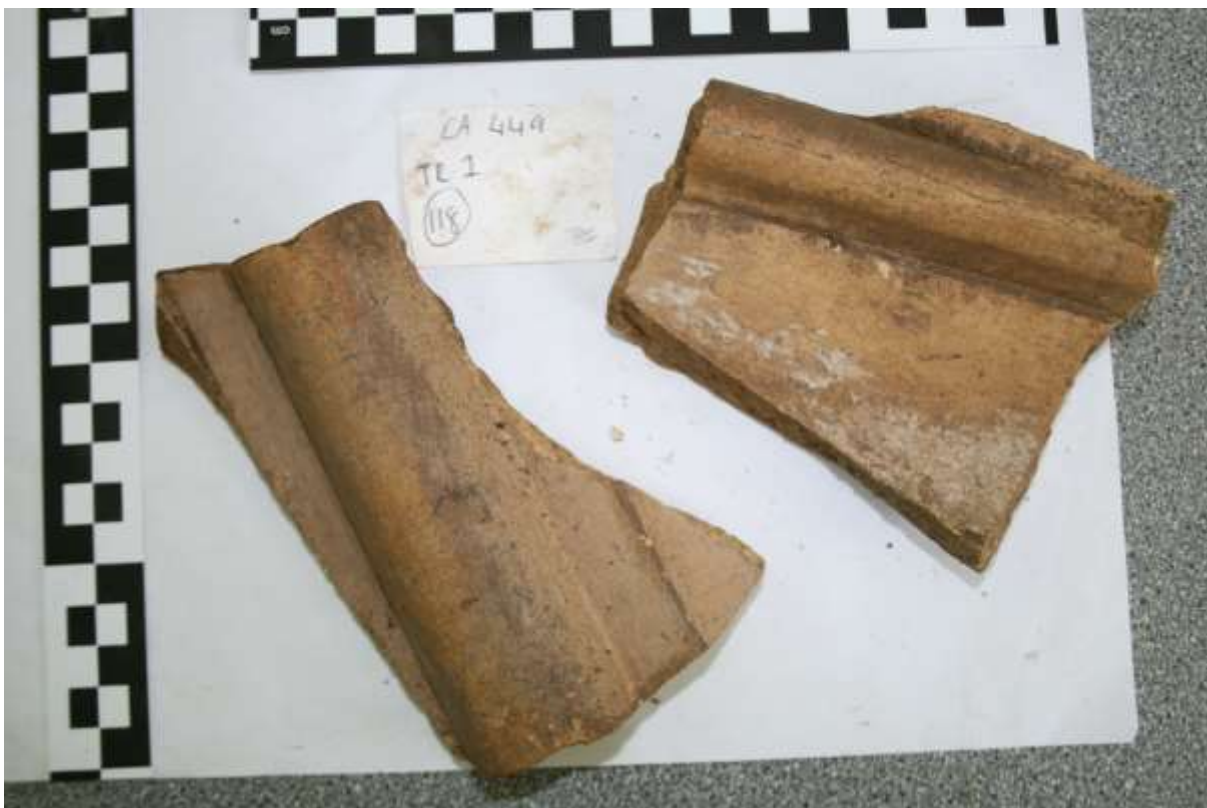
Illus 46 Fragments of ceramic garden furniture

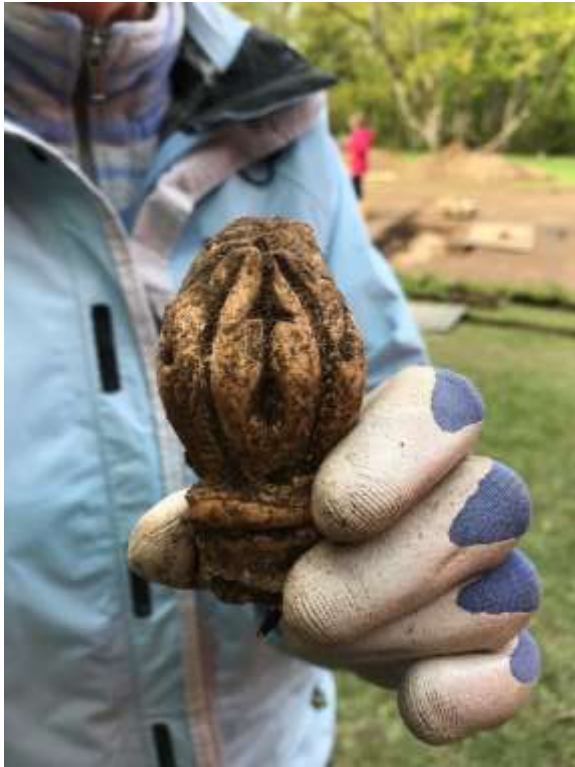
Illus 47 Fireclay finial from roof furniture
